R. T. HICKS CONSULTANTS, LTD.

September 10, 2009

RE: Seven Produced Fluid Releases at sites operated by Marks and Garner Production Ltd, Company in Eddy County, NM as follows:

R.T. Hicks Consultants is pleased to submit this response to your August 19, 2009 directive letter concerning the characterization activities on the behalf of Marks and Garner Production Ltd. Because this letter proposes collection of additional data, we request that NMOCD consider this letter an interim response. Plate 1a shows the location of the sites.

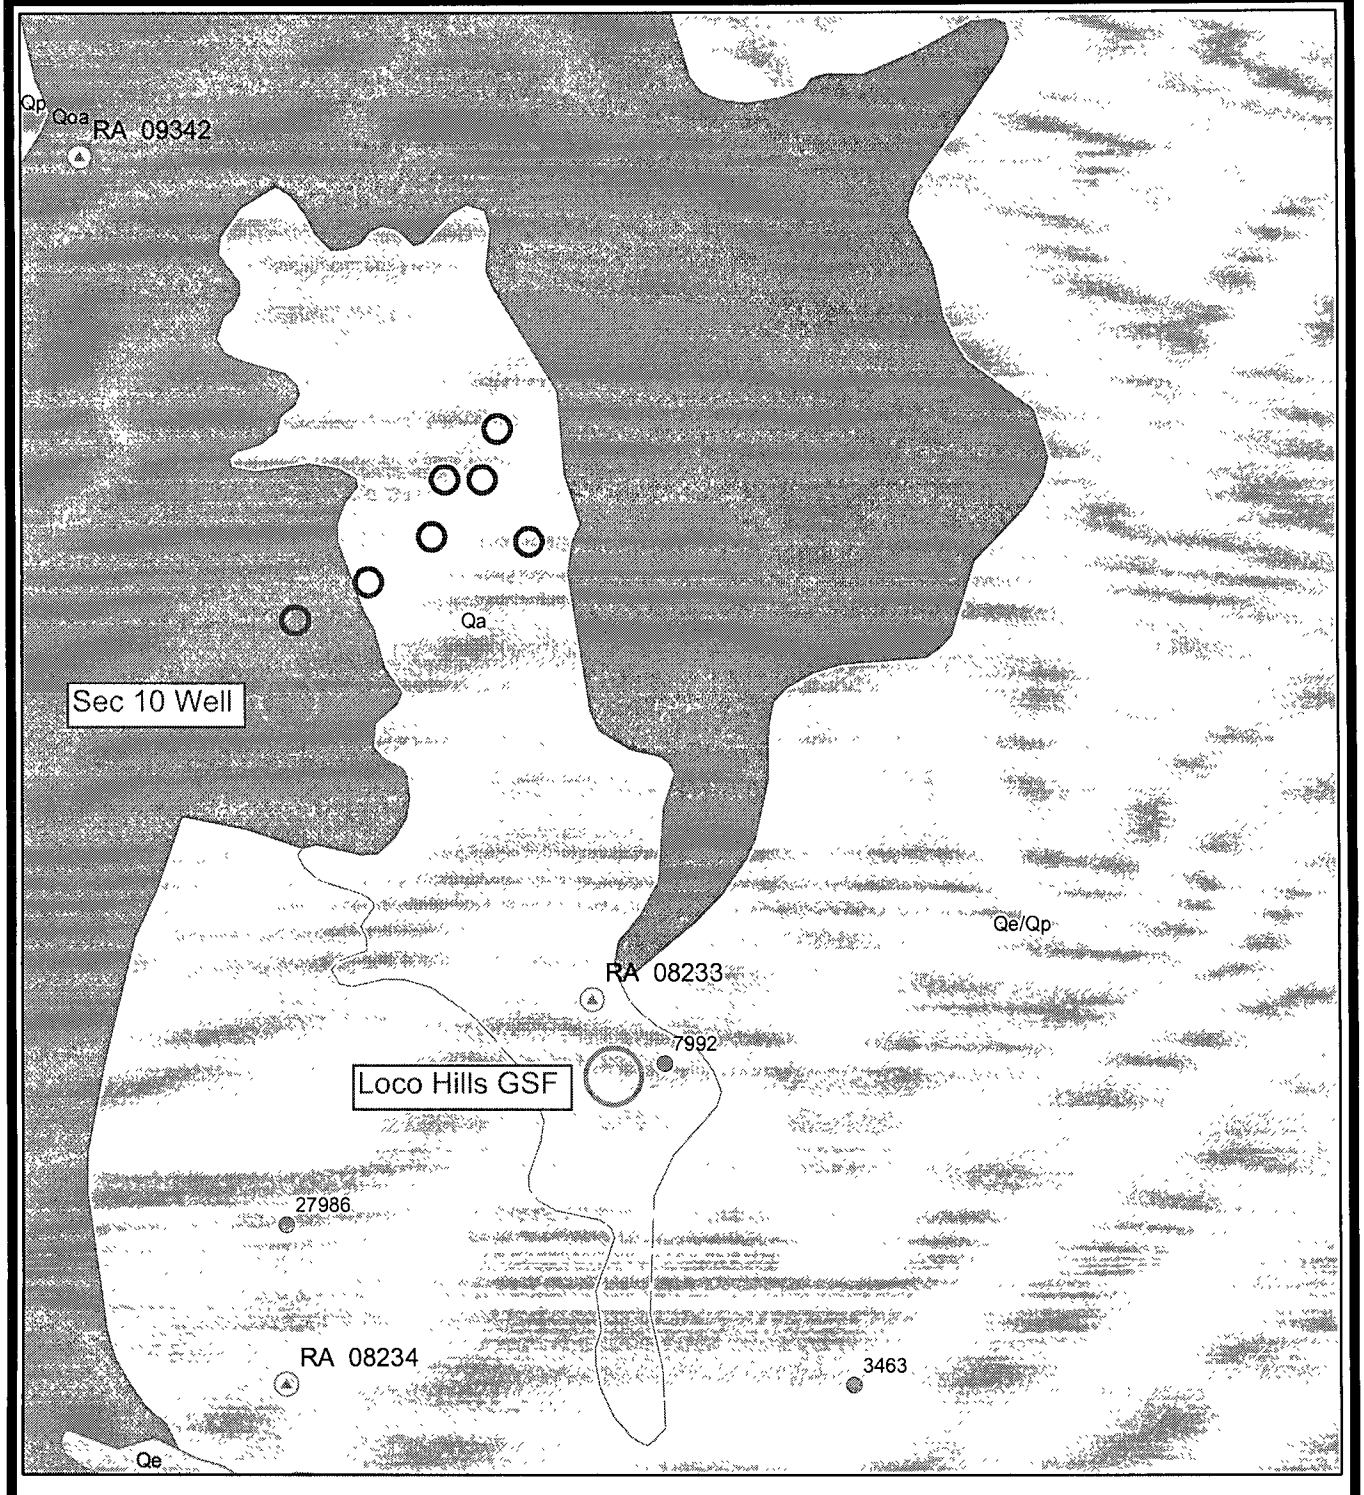
R.T. Hicks Consultants, Ltd 901 Rio Grande Blvd NW Suite F-142 Albuquerque, NM 87104 Ph: 505.266.5004	Geologic Map Showing Nearby Wells	Plate 1b
	Marks and Garner	Sept 2009

Depth to Ground Water and Ground Water Quality
Plate 1b shows the location of the Marks & Garner sites (red circles) that are the subject of investigations in support of gaining compliance with Part 29 of the NMOCD Rules. Also shown on Plate 1b are:

From these data we can conclude that the quality of ground water beneath Bear Grass Draw in the area of the Marks & Garner sites is probably similar to that observed at RA 8233. No evidence from the PTTC data suggests that ground water in the area of the Marks & Garner sites is not confined.

Plate 1b shows two other wells from the PTTC database south of the Loco Hills Gas Storage Facility. According to the PTTC database, both of these wells are screened below the alluvial cover in the Triassic Dockham group or the Rustler. These two aquifers are confined in this area.

Because all evidence shows that ground water in the area is confined, we have assigned a "Depth to Ground Water" ranking score of zero (0).

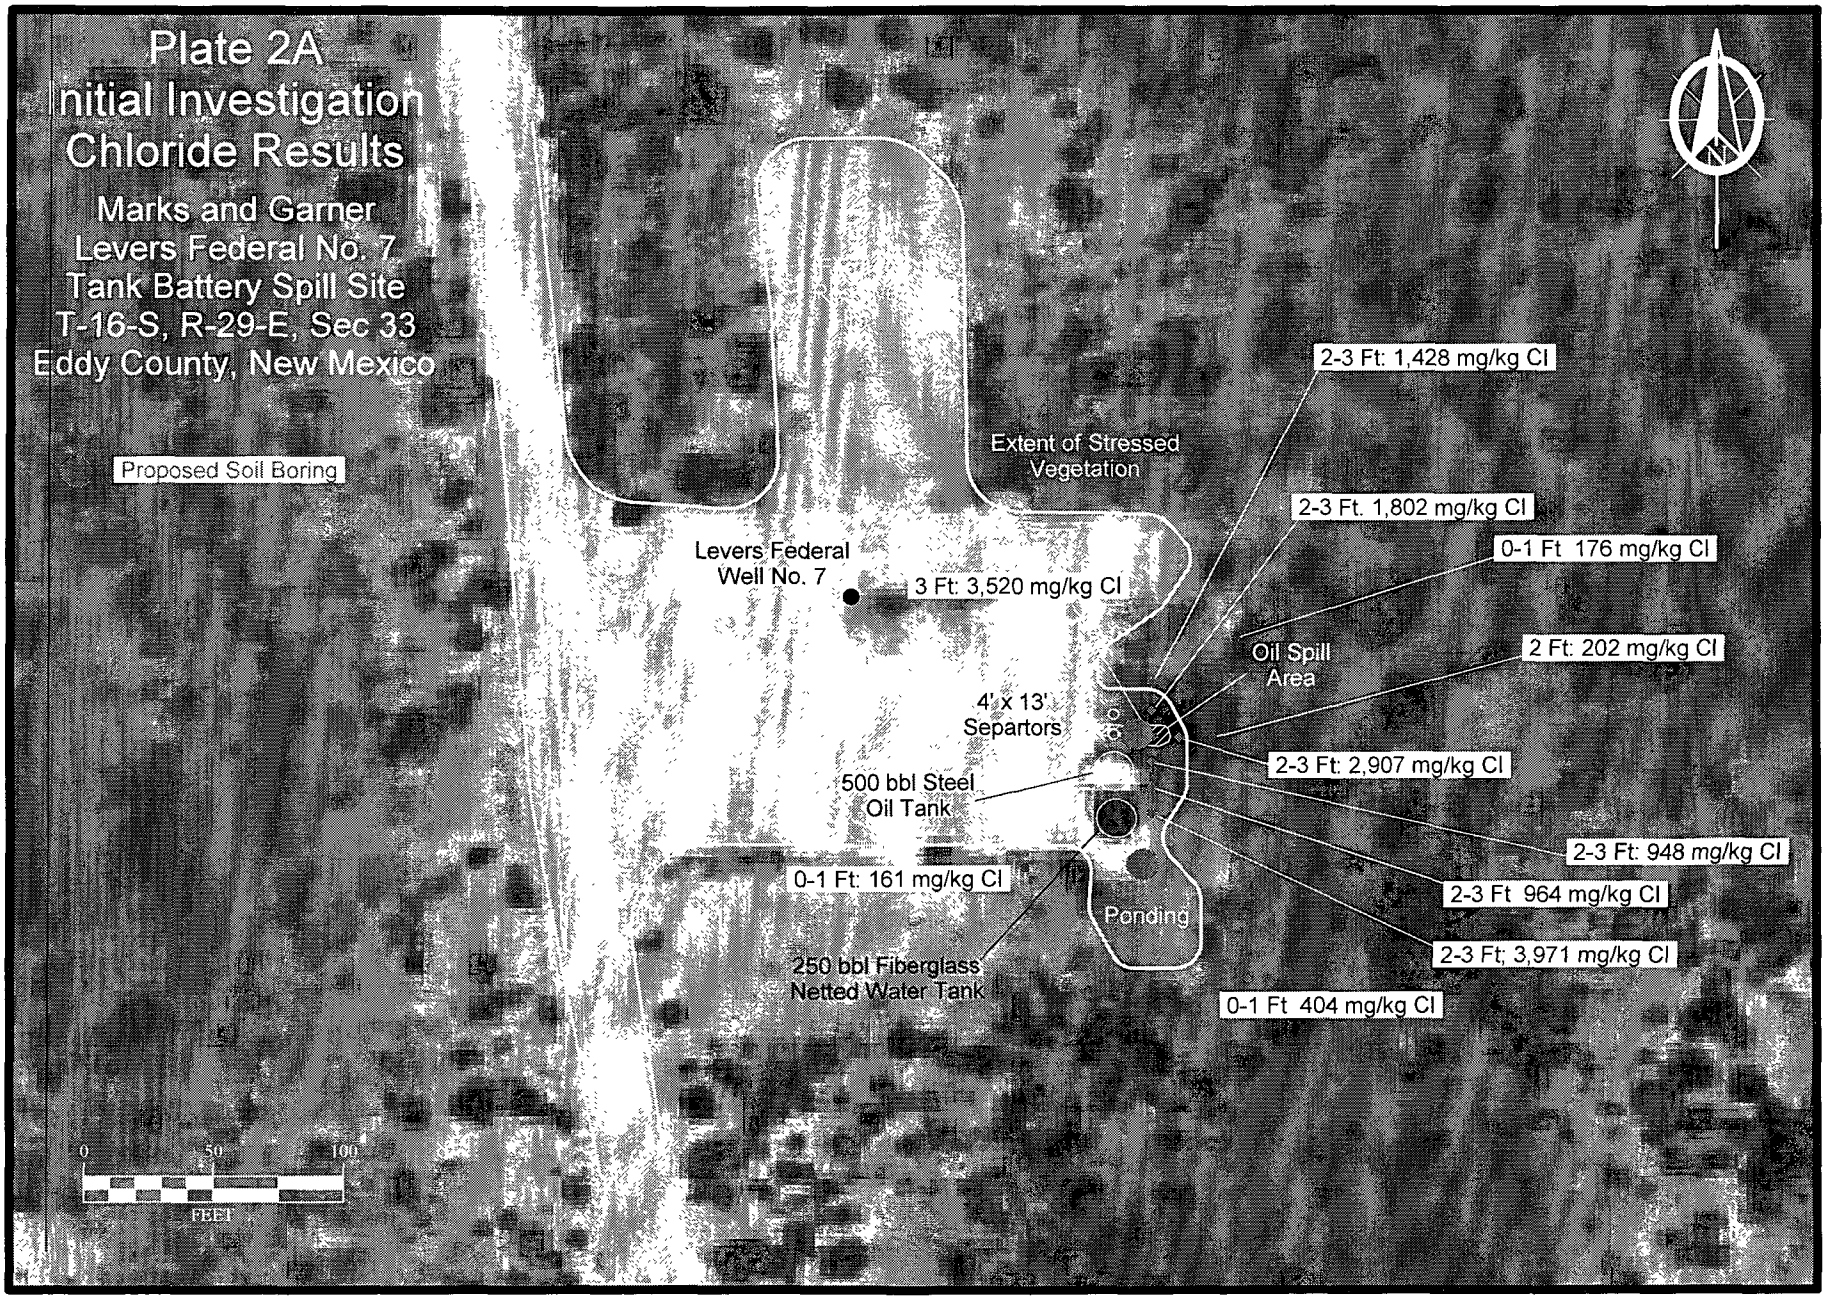
Sample Location	Depth (feet)	Sample Date	Field Cl (mg/kg)	Lab Cl (mg/kg)	PID (ppm)	Benzene (mg/kg)	Toluene (mg/kg)	Ethylbenzene (mg/kg)	Xylenes (mg/kg)	BTEX (mg/kg)	C_{6-12} (mg/kg)	C_{12-28} (mg/kg)	C_{28-35} (mg/kg)
Center Oil Spill	0 5	6/23/09	--	--	10	<0 0011	<0 0022	0 0015	<0 0011	<0 006	<16 4	461	61 6
	1 0	6/23/09	--	--	0	--	--	--	--	--	--	--	--
	3 0	6/23/09	--	3,520	0	<0 0011	<0 0022	<0 0011	<0 0011	<0 006	<16 7	20 9	<16 7
10-Ft North	2-3	8/27/09	1,802	--	0	--	--	--	--	--	--	--	--
20-Ft North	2-3	8/27/09	1,428	--	0	--	--	--	--	--	--	--	--
10-Ft South	2-3	8/27/09	948	--	0	--	--	--	--	--	--	--	--
20-Ft South	2-3	8/27/09	964	--	0	--	--	--	--	--	--	--	--
30-Ft South	2-3	8/27/09	3,971		0	--	--	--	--	--	--	--	--
10-Ft East	2-3	8/27/09	2,907	--	0	--	--	--	--	--	--	--	--
20-Ft East	2	8/27/09	202	--	0	--	--	--	--	--	--	--	--
50-Ft Northeast	0-1	8/28/09	176	--	0	--	--	--	--	--	--	--	--
70-Ft Southeast	0-1	8/28/09	161	--	0	--	--	--	--	--	--	--	--

100-Ft Southeast	0-1	8/28/09	404	--	0	--	--	--	--	--	--	--	--
NMOCD 1993 Guideline RRALs			250*	--		10	--	--	--	50		5,000

Plate 2A
nitial Investigation
Chloride Results
Marks and Garner
Levers Federal No. 7
Tank Battery Spill Site
T-16-S, R-29-E, Sec 33
Eddy County, New Mexico
Proposed Soil Boring
Extent of Stressed Vegetation
Levers Federal Well No. 7
3 Ft: 3,520 mg/kg Cl
2-3 Ft: 1,428 mg/kg Cl
2-3 Ft. 1,802 mg/kg Cl
0-1 Ft 176 mg/kg Cl
Oil Spill Area
2 Ft: 202 mg/kg Cl
4' x 13' Separtors
500 bbl Steel Oil Tank
2-3 Ft: 2,907 mg/kg Cl
2-3 Ft: 948 mg/kg Cl
0-1 Ft: 161 mg/kg Cl
Ponding
2-3 Ft 964 mg/kg Cl
2-3 Ft; 3,971 mg/kg Cl
250 bbl Fiberglass Netted Water Tank
0-1 Ft 404 mg/kg Cl
0
50
100
FEET

Hicks Consultants recommends that a hollow-stem auger be used to complete the vertical delineation of hydrocarbon- and chloride-impacted soil at each site according to the attached plates. We anticipate that a drilling rig will be available in mid to late October 2009 and a final report for each site, including recommendations for remedial actions, will be submitted to the NMOCD by the end of 2009. In the final report we will provide remediation action levels for soil and underlying sediment based upon criteria in NMOCD Rules, science-based evaluation of the sampling data and physical setting.

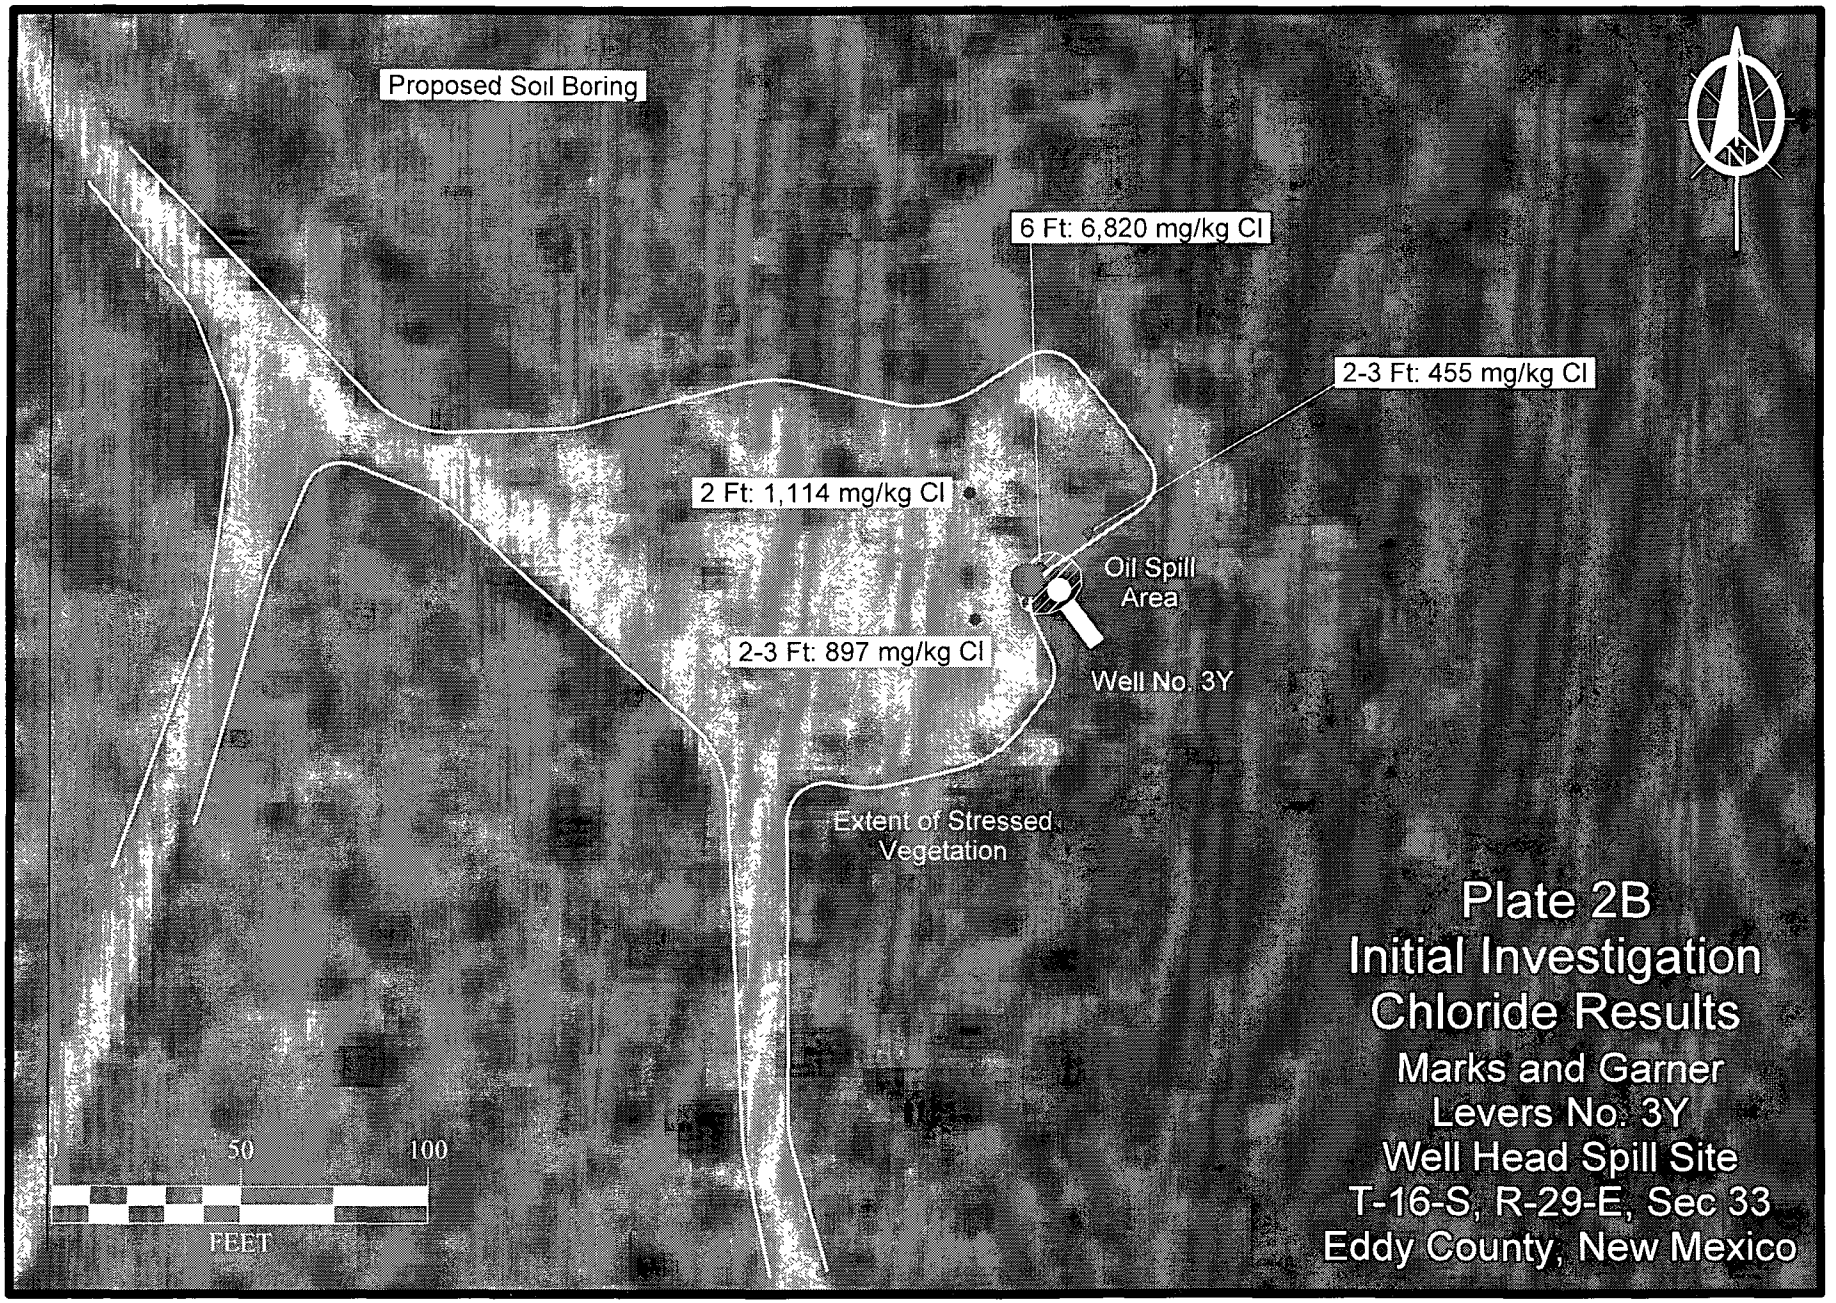
Sample Location	Depth (feet)	Sample Date	Field Cl (mg/kg)	Lab Cl (mg/kg)	PID (ppm)	Benzene (mg/kg)	Toluene (mg/kg)	Ethylbenzene (mg/kg)	Xylenes (mg/kg)	BTEX (mg/kg)	C_{6-12} (mg/kg)	C_{12-28} (mg/kg)	C_{28-35} (mg/kg)
Center Oil Spill	Surf	6/22/09	--	--	85	0 013	0 537	1 3850	3 5	5 47	1,340	44,500	3,150
	2 0	6/22/09	--	--	39	--	--	--	--	--	--	--	--
	3 0	6/22/09	--	--	64	--	--	--	--	--	--	--	--
	4 0	6/22/09	--	--	127	--	--	--	--	--	--	--	--
	5 0	6/22/09	--	--	210	--	--	--	--	--	--	--	--
	6 0	6/22/09	--	6,820	334	<0 0107	0 212	0 6995	6 553	7 47	1,690	6,640 0	581
15-Ft East	2-3	8/27/09	455	--	0	--	--	--	--	--	--	--	--
20-Ft West	2-3	8/27/09	897	--	0	--	--	--	--	--	--	--	--
25-Ft North	2	8/27/09	1,114		0	--	--	--	--	--	--	--	--
NMOCD 1993 Guideline RRALs			250*	--		10	--	--	--	50		5,000

Proposed Soil Boring
6 Ft: 6,820 mg/kg Cl
2-3 Ft: 455 mg/kg Cl
2 Ft: 1,114 mg/kg Cl
Oil Spill Area
2-3 Ft: 897 mg/kg Cl
Well No. 3Y
Extent of Stressed Vegetation
0
50
100
FEET
Plate 2B
Initial Investigation
Chloride Results
Marks and Garner
Levers No. 3Y
Well Head Spill Site
T-16-S, R-29-E, Sec 33
Eddy County, New Mexico

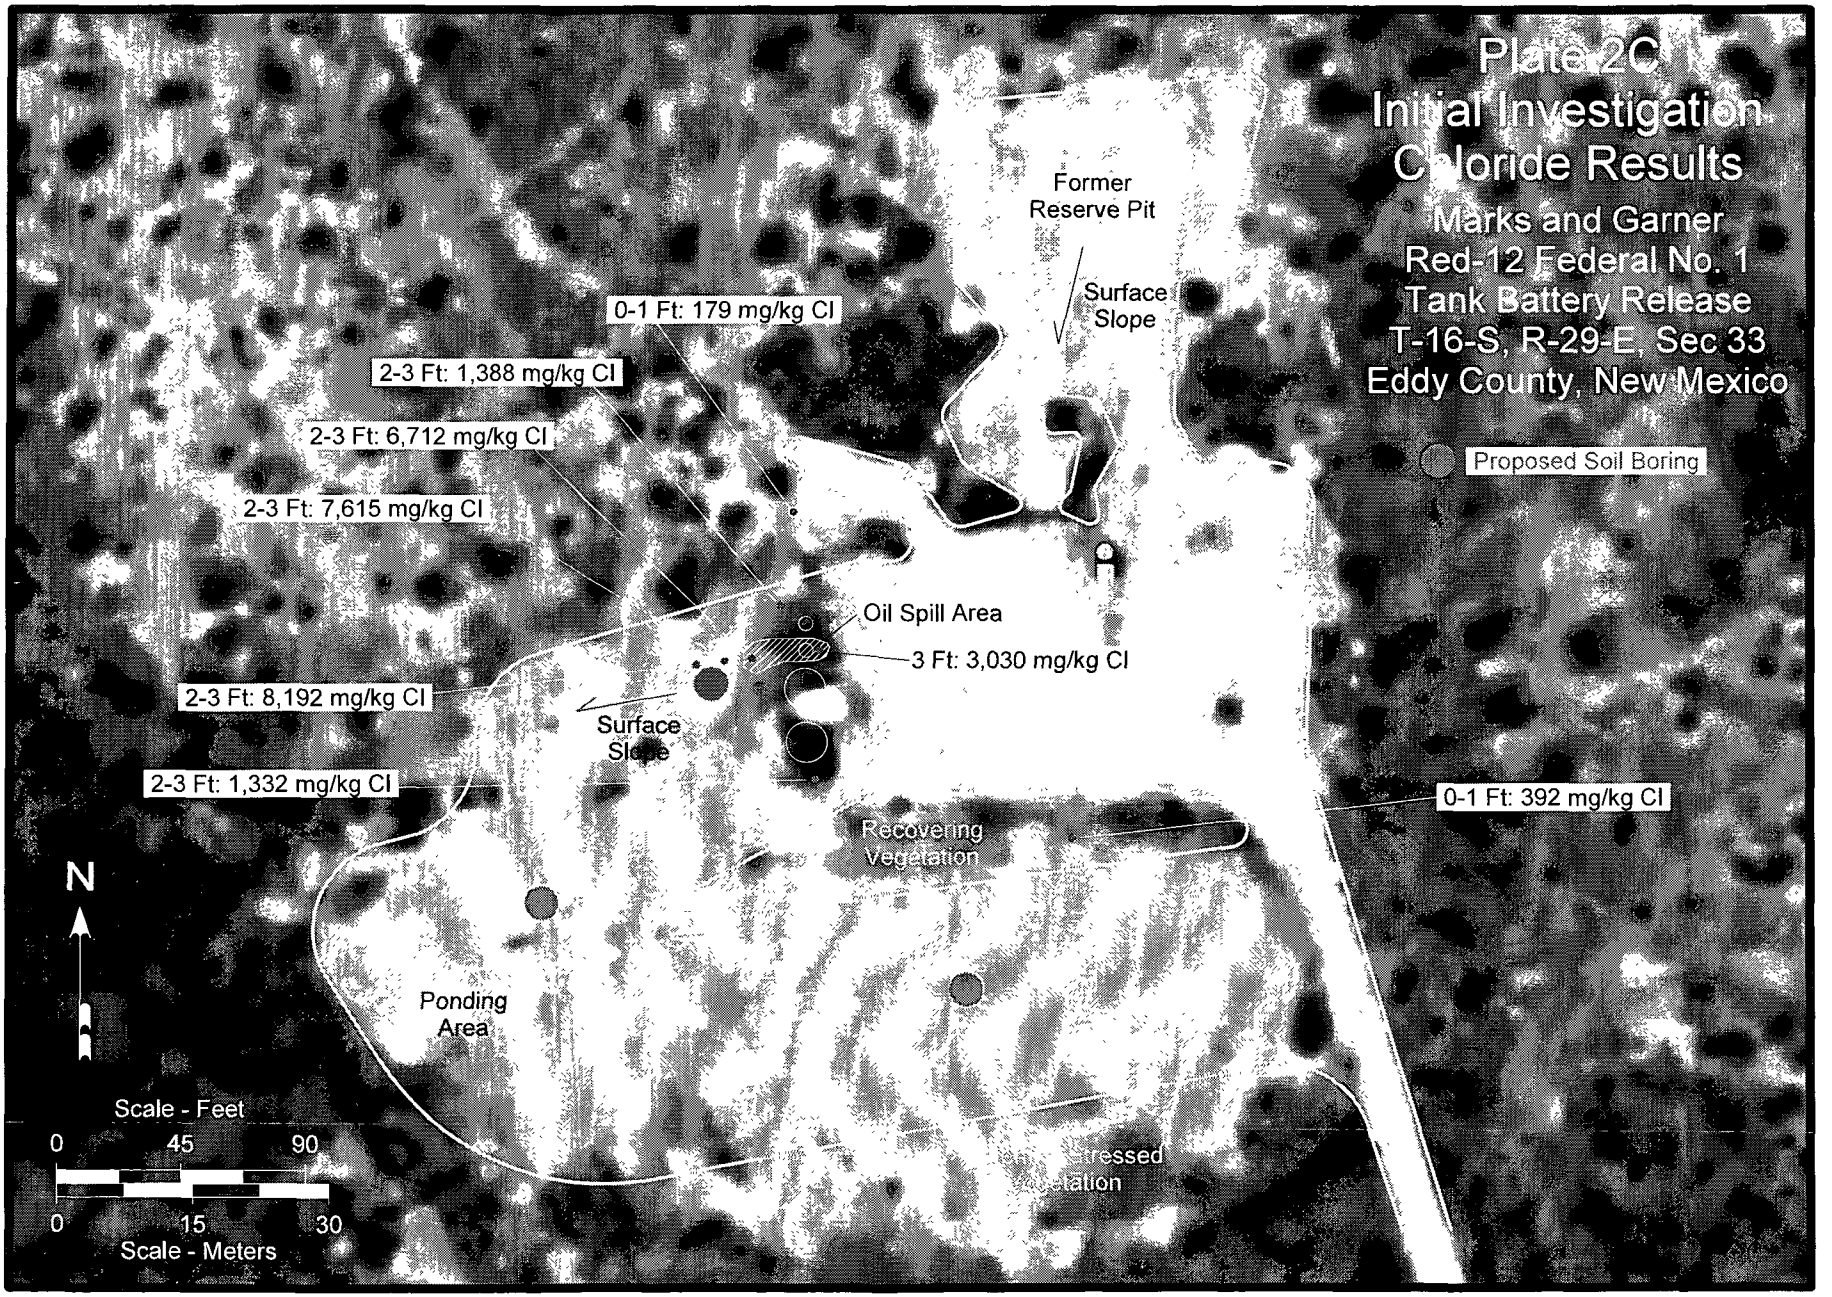
Sample Location	Depth (feet)	Sample Date	Field Cl (mg/kg)	Lab Cl (mg/kg)	PID (ppm)	Benzene (mg/kg)	Toluene (mg/kg)	Ethylbenzene (mg/kg)	Xylenes (mg/kg)	BTEX (mg/kg)	C_{6-12} (mg/kg)	C_{12-28} (mg/kg)	C_{28-35} (mg/kg)
Oil Spill Area	0 5	6/23/09	--	--	0	<0 0011	<0 0022	<0 0011	<0 0011	<0 006	<335	23,600	2,280
	1 0	6/23/09	--	--	0	--	--	--	--	--	--	--	--
	3 0	6/23/09	--	3,030	0	<0 0011	<0 0022	<0 0011	<0 0011	<0 006	<16 9	61 3	<16 9
25-Ft WSW	2-3	8/27/09	6,712	--	0	--	--	--	--	--	--	--	--
35-Ft WSW	2-3	8/27/09	7,615	--	0	--	--	--	--	--	--	--	--
45-Ft WSW	2-3	8/27/09	8,192		0	--	--	--	--	--	--	--	--
20-Ft NNW	2-3	8/27/09	1,388	--	0	--	--	--	--	--	--	--	--
45-Ft SSE	2-3	8/27/09	1,332	--	0	--	--	--	--	--	--	--	--
120-Ft Southeast	0-1	8/28/09	392	--	0	--	--	--	--	--	--	--	--
50-Ft Northeast	0-1	8/28/09	179	--	0	--	--	--	--	--	--	--	--
NMOCD 1993 Guideline RRALs			250*	--		10	--	--	--	50		5,000

Plate 2C
Initial Investigation
Chloride Results
Marks and Garner
Red-12 Federal No. 1
Tank Battery Release
T-16-S, R-29-E, Sec 33
Eddy County, New Mexico
Proposed Soil Boring
Former
Reserve Pit
Surface
Slope
0-1 Ft: 179 mg/kg Cl
2-3 Ft: 1,388 mg/kg Cl
2-3 Ft: 6,712 mg/kg Cl
2-3 Ft: 7,615 mg/kg Cl
Oil Spill Area
3 Ft: 3,030 mg/kg Cl
2-3 Ft: 8,192 mg/kg Cl
Surface
Slope
2-3 Ft: 1,332 mg/kg Cl
0-1 Ft: 392 mg/kg Cl
Recovering
Vegetation
N
Ponding
Area
Scale - Feet
0
45
90
0
15
30
Scale - Meters

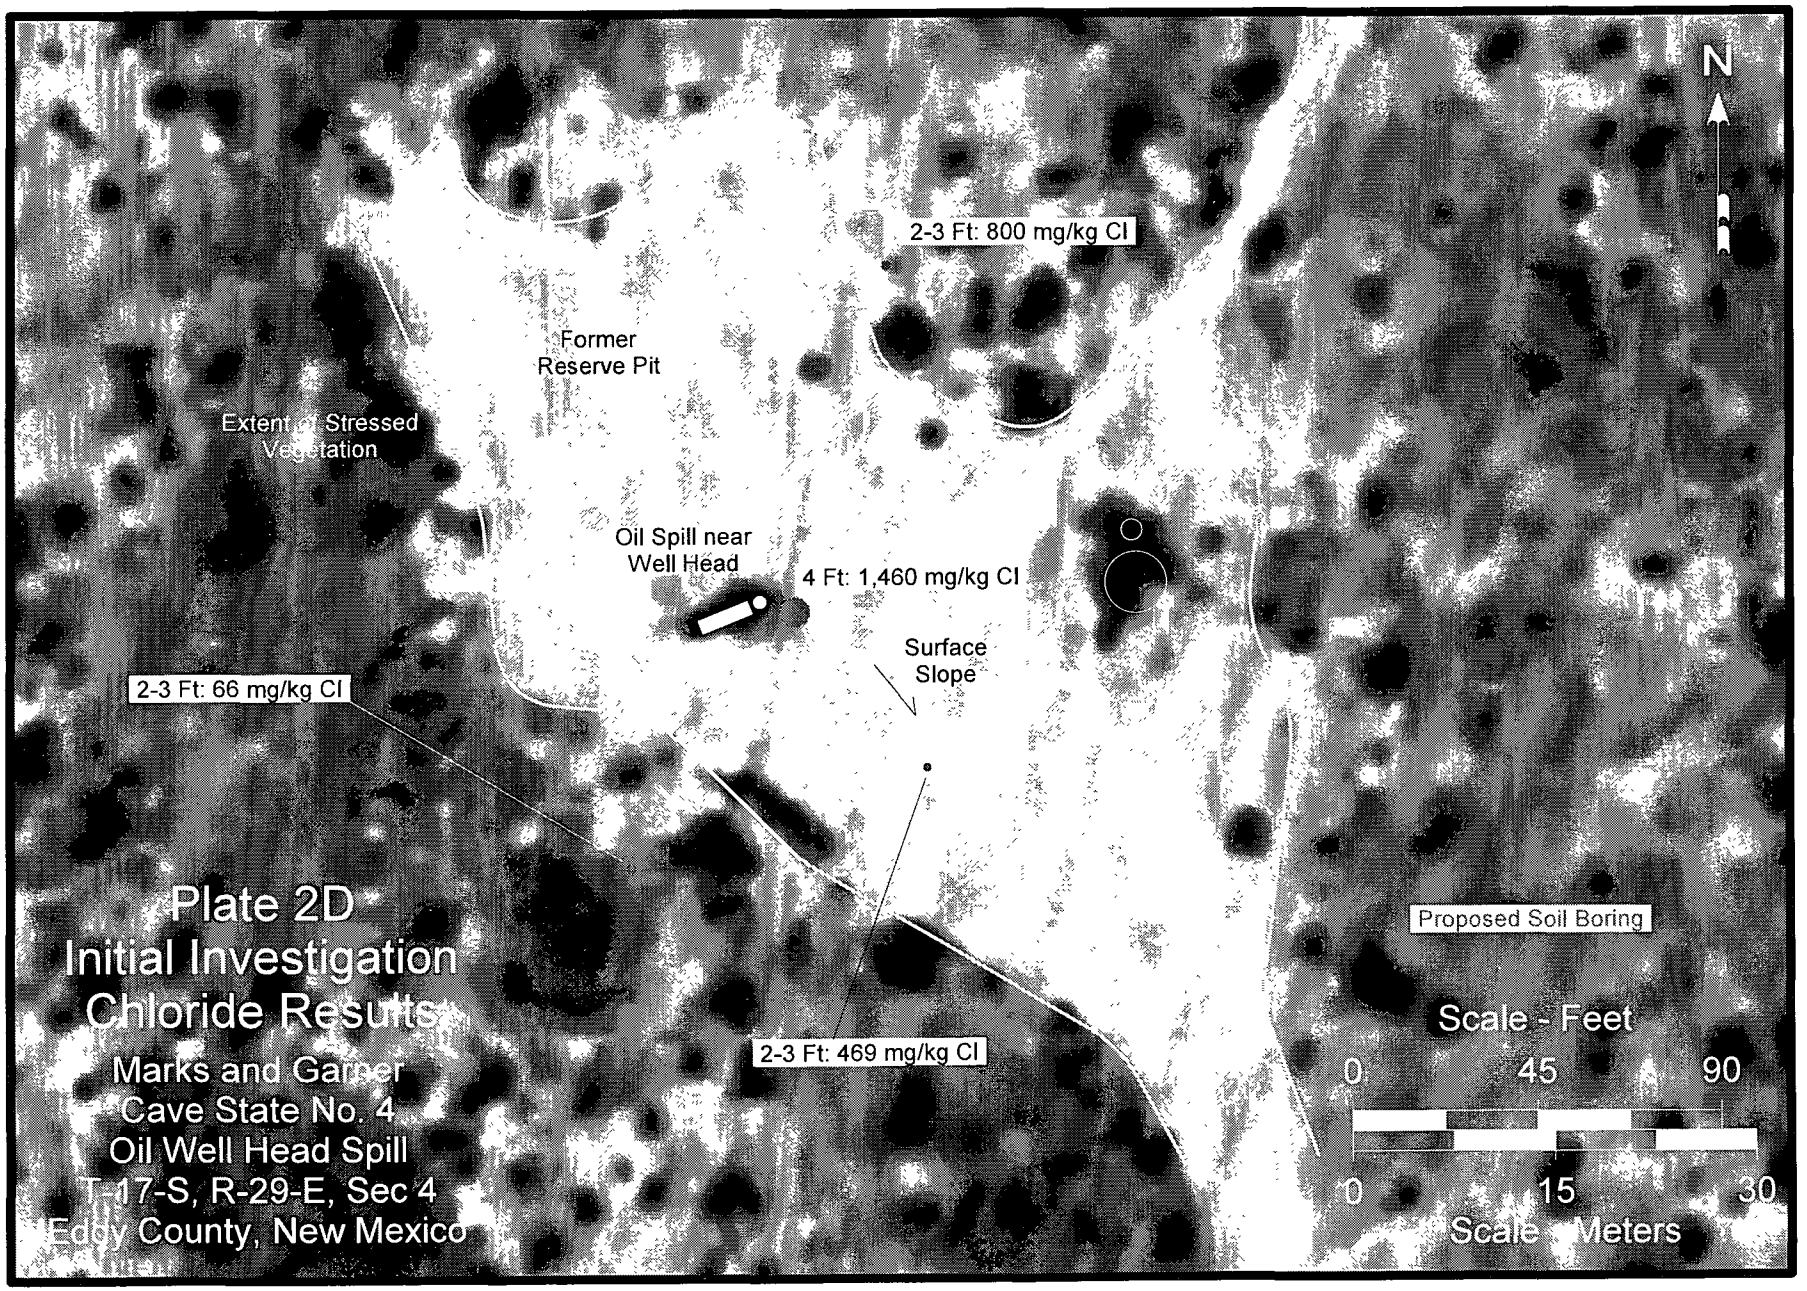
Sample Location	Depth (feet)	Sample Date	Field Cl (mg/kg)	Lab Cl (mg/kg)	PID (ppm)	Benzene (mg/kg)	Toluene (mg/kg)	Ethylbenzene (mg/kg)	Xylenes (mg/kg)	BTEX (mg/kg)	C_{6-12} (mg/kg)	C_{12-28} (mg/kg)	C_{28-35} (mg/kg)
Stockpile Soil	--	6/22/09	--	--	185	0 0519	1 22	4 45	9 284	15 0	2,050	**38,400**	2,820
Oil Spill Area	2 0	6/22/09	--	--	0	--	--	--	--	--	--	--	--
	4 0	6/22/09	--	1,460	0	<0 0012	<0 0024	<0 0012	<0 0024	<0 008	<17 8	18 7	<17 8
55-Ft Southeast	2-3	8/28/09	**469**		0	--	--	--	--	--	--	--	--
85-Ft Northeast	2-3	8/28/09	**800**	--	0	--	--	--	--	--	--	--	--
75-Ft Southwest	2-3	8/28/09	66	--	0	--	--	--	--	--	--	--	--
NMOCD 1993 Guideline RRALs			**250***		--	**10**	--	--	--	**50**		**5,000**

N
2-3 Ft: 800 mg/kg Cl
Former
Reserve Pit
Extent of Stressed
Vegetation
Oil Spill near
Well Head
4 Ft: 1,460 mg/kg Cl
Surface
Slope
2-3 Ft: 66 mg/kg Cl
2-3 Ft: 469 mg/kg Cl
Proposed Soil Boring
Scale - Feet
0
45
90
0
15
30
Scale - Meters
Plate 2D
Initial Investigation
Chloride Results
Marks and Garner
Cave State No. 4
Oil Well Head Spill
T-17-S, R-29-E, Sec 4
Eddy County, New Mexico

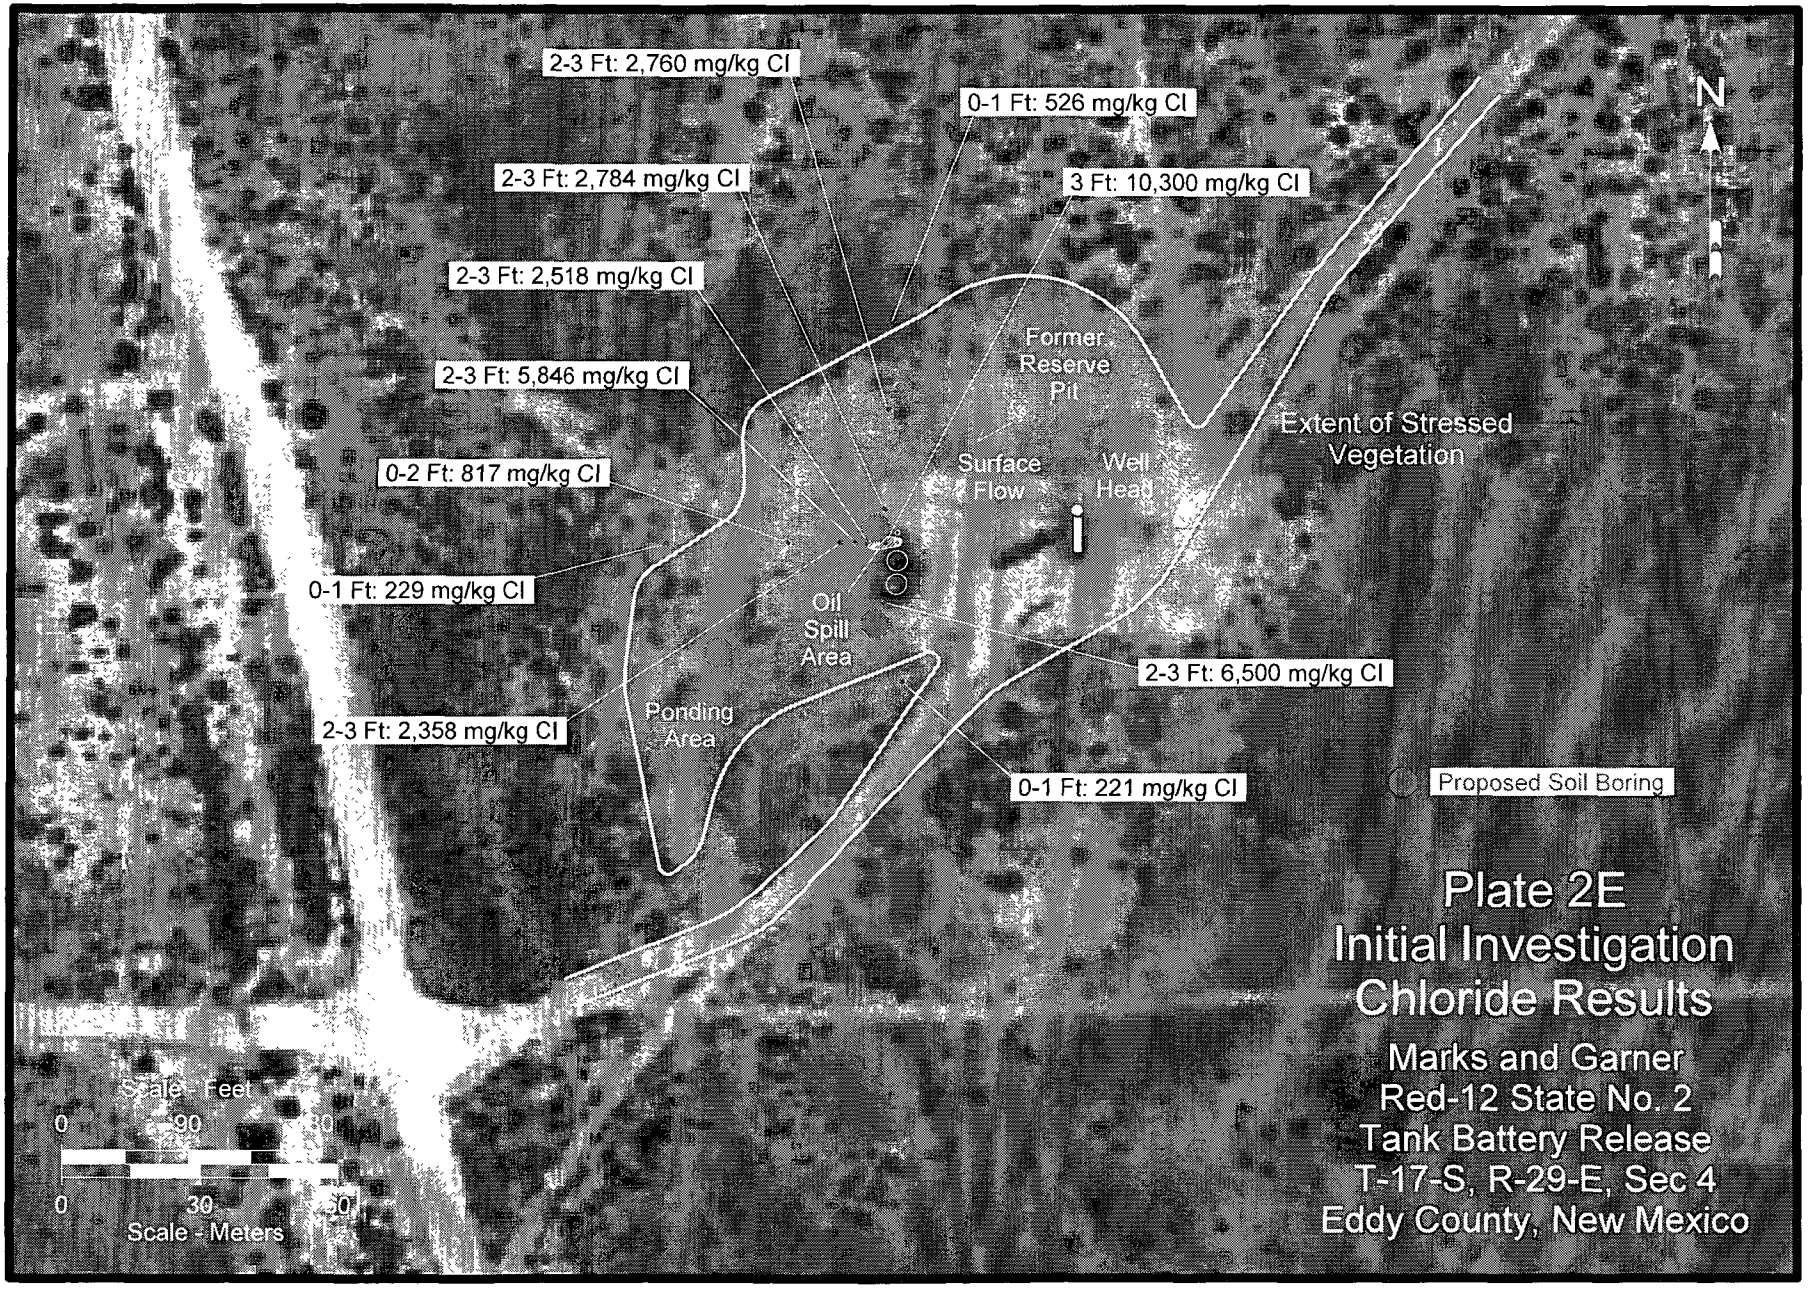
Sample Location	Depth (feet)	Sample Date	Field Cl (mg/kg)	Lab Cl (mg/kg)	PID (ppm)	Benzene (mg/kg)	Toluene (mg/kg)	Ethylbenzene (mg/kg)	Xylenes (mg/kg)	BTEX (mg/kg)	C_{6-12} (mg/kg)	C_{12-28} (mg/kg)	C_{28-35} (mg/kg)
Center Oil Spill	0 5	6/23/09	--	--	10	<0 0011	<0 0023	0 0099	0 0186	0 032	340	**20,500**	1,360
	1 0	6/23/09	--	--	6	--	--	--	--	--	--	--	--
	3 0	6/23/09	--	10,300	0	<0 0011	<0 0022	<0 0011	<0 0011	<0 006	<16 2	58 6	<16 2
10-Ft West	2-3	8/27/09	**2,518**	--	0	--	--	--	--	--	--	--	--
20-Ft West	2-3	8/27/09	**5,846**		0	--	--	--	--	--	--	--	--
30-FT West	2-3	8/27/09	**2,358**	--	0	--	--	--	--	--	--	--	--
20-Ft North	2-3	8/27/09	**2,784**	--	0	--	--	--	--	--	--	--	--
40-Ft South	2-3	8/27/09	**6,500**	--	0	--	--	--	--	--	--	--	--
100-Ft South	0-1	8/28/09	221	--	0	--	--	--	--	--	--	--	--
100-Ft North	2-3	8/28/09	**2,760**		0	--	--	--	--	--	--	--	--
160-Ft North	0-1	8/28/09	**526**	--	0	--	--	--	--	--	--	--	--

70-Ft West	0-2	8/28/09	**817**		0	--	--	--	--	--	--	--	--
160-Ft West	0-1	8/28/09	229	--	0	--	--	--	--	--	--	--	--
NMOCD 1993 Guideline RRALs			**250***		--	**10**	--	--	--	**50**		**5,000**

2-3 Ft: 2,760 mg/kg Cl
0-1 Ft: 526 mg/kg Cl
2-3 Ft: 2,784 mg/kg Cl
3 Ft: 10,300 mg/kg Cl
2-3 Ft: 2,518 mg/kg Cl
Former Reserve Pit
2-3 Ft: 5,846 mg/kg Cl
Extent of Stressed Vegetation
0-2 Ft: 817 mg/kg Cl
Surface Flow
Well Head
0-1 Ft: 229 mg/kg Cl
Oil Spill Area
2-3 Ft: 6,500 mg/kg Cl
Ponding Area
2-3 Ft: 2,358 mg/kg Cl
0-1 Ft: 221 mg/kg Cl
Proposed Soil Boring
N
Scale - Feet
0
90
30
0
30
Scale - Meters
Plate 2E
Initial Investigation
Chloride Results
Marks and Garner
Red-12 State No. 2
Tank Battery Release
T-17-S, R-29-E, Sec 4
Eddy County, New Mexico

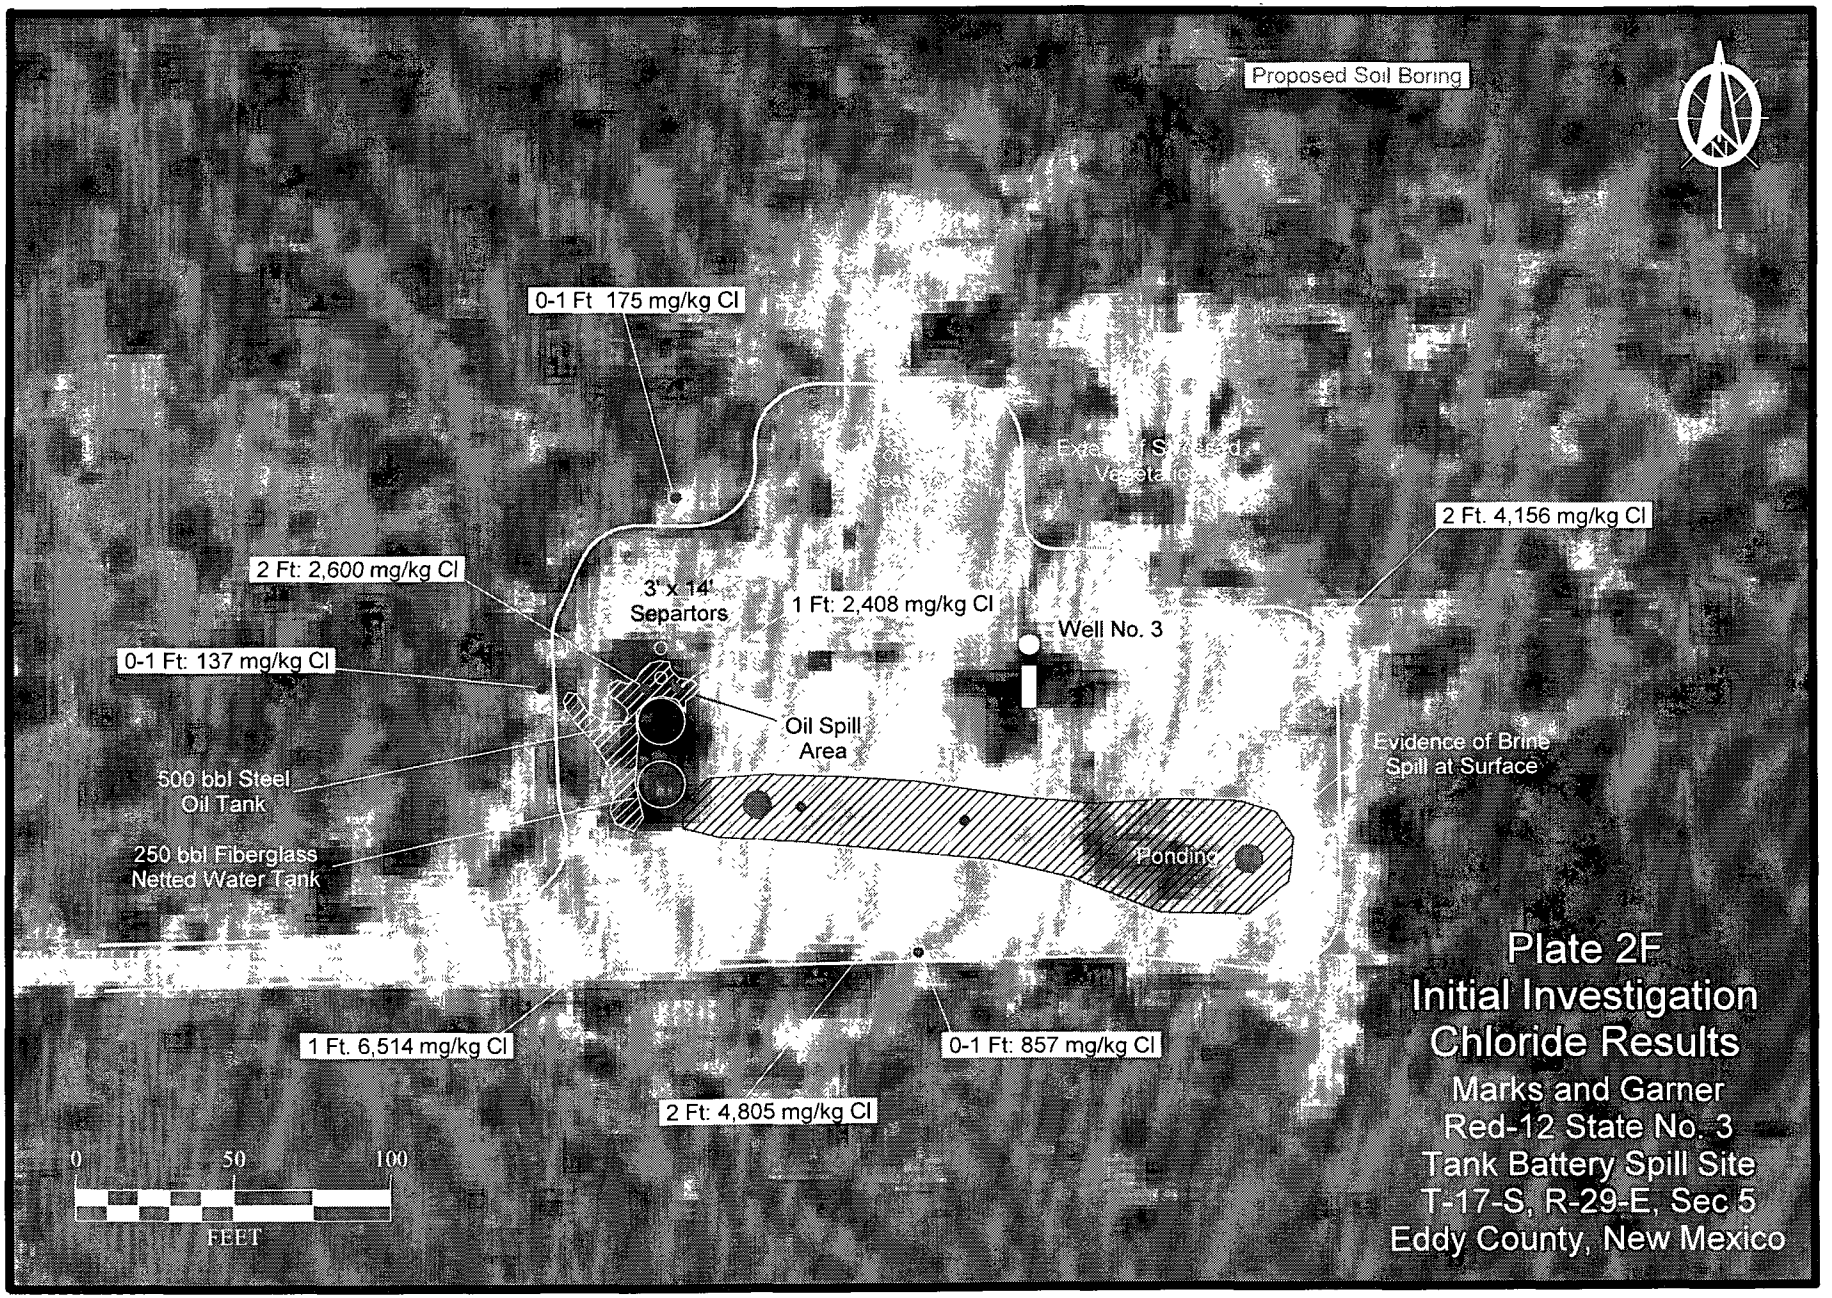
Sample Location	Depth (feet)	Sample Date	Field Cl (mg/kg)	Lab Cl (mg/kg)	PID (ppm)	Benzene (mg/kg)	Toluene (mg/kg)	Ethylbenzene (mg/kg)	Xylenes (mg/kg)	BTEX (mg/kg)	C_{6-12} (mg/kg)	C_{12-28} (mg/kg)	C_{28-35} (mg/kg)
Composite	Surf	6/22/09	**8,068**	--	0	0 0016	<0 0022	0 0015	0 0054	0 011	1,780	**57,000**	**5,510**
Oil Spill West	1 0	6/22/09	**2,408**	--	0	<0 0011	<0 0022	<0 0011	<0 0022	<0 007	<16 7	24 7	<16 7
Oil Spill East	2 0	6/22/09	**2,887**	2,600	0	<0 0011	<0 0023	<0 0011	<0 0011	<0 006	<16 9	35 8	<16 9
Cl Spill East	2 0	8/27/09	**4,156**	--	0	--	--	--	--	--	--	--	--
Cl Spill Center	2 0	8/27/09	**4,805**	--	0	--	--	--	--	--	--	--	--
Cl Spill West	1 0	8/27/09	**6,514**	--	0	--	--	--	--	--	--	--	--
60-Ft North	0-1	8/28/09	175	--	0	--	--	--	--	--	--	--	--
35-Ft West	0-1	8/28/09	137	--	0	--	--	--	--	--	--	--	--
100-Ft Southeast	0-1	8/28/09	**857**	--	0	--	--	--	--	--	--	--	--
NMOCD 1993 Guideline RRALs			**250***		--	**10**	--	--	--	**50**		**5,000**

Proposed Soil Boring
0-1 Ft 175 mg/kg Cl
2 Ft. 4,156 mg/kg Cl
2 Ft: 2,600 mg/kg Cl
3' x 14'
Separtors
1 Ft: 2,408 mg/kg Cl
Well No. 3
0-1 Ft: 137 mg/kg Cl
Oil Spill
Area
Evidence of Brine
Spill at Surface
500 bbl Steel
Oil Tank
250 bbl Fiberglass
Netted Water Tank
Ponding
1 Ft. 6,514 mg/kg Cl
0-1 Ft: 857 mg/kg Cl
2 Ft: 4,805 mg/kg Cl
0
50
100
FEET
Plate 2F
Initial Investigation
Chloride Results
Marks and Garner
Red-12 State No. 3
Tank Battery Spill Site
T-17-S, R-29-E, Sec 5
Eddy County, New Mexico

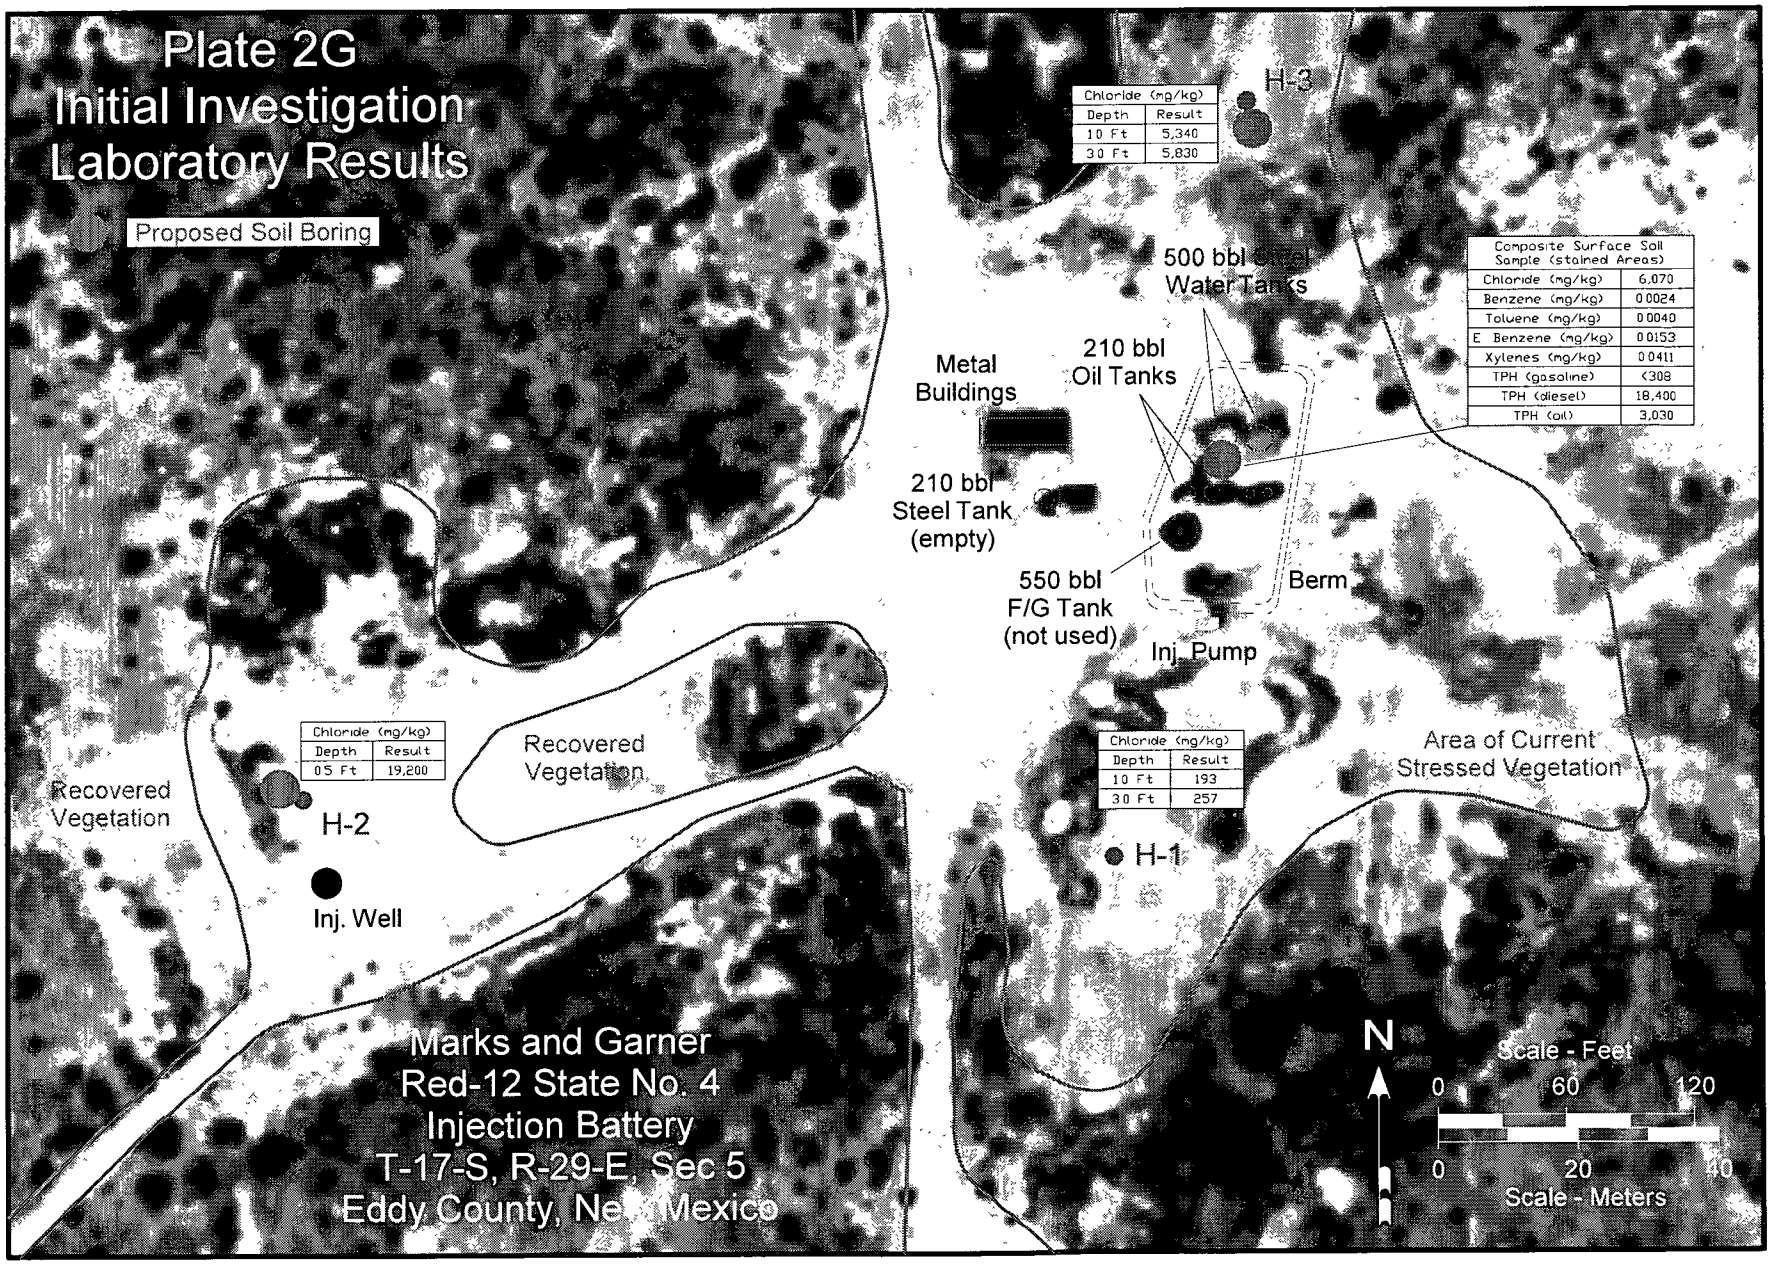
Sample Location	Depth (feet)	Sample Date	Field Cl (mg/kg)	Lab Cl (mg/kg)	PID (ppm)	Benzene (mg/kg)	Toluene (mg/kg)	Ethylbenzene (mg/kg)	Xylenes (mg/kg)	BTEX (mg/kg)	C_{6-12} (mg/kg)	C_{12-28} (mg/kg)	C_{28-35} (mg/kg)
Composite	Surf	6/22/09	**8,068**	--	10	0 0024	0 0040	0 0153	0 0411	0 060	<308	**18,400**	3,030
180-Ft South	1 0	6/22/09	--	193	0	--	--	--	--	--	--	--	--
	3 0	6/22/09	--	**257**	0	--	--	--	--	--	--	--	--
440-Ft Southwest	0 5	6/22/09	--	**19,200**	0	--	--	--	--	--	--	--	--
180-Ft North	1 0	6/22/09	**6,085**	**5,340**	0	--	--	--	--	--	--	--	--
	3	6/22/09	**6,227**	**5,830**	0	--	--	--	--	--	--	--	--
NMOCD 1993 Guideline RRALs			**250***		--	**10**	--	--	--	**50**		**5,000**

Plate 2G
Initial Investigation
Laboratory Results
Proposed Soil Boring
Chloride (mg/kg)
Depth | Result
10 Ft | 5,340
30 Ft | 5,830
H-3
500 bbl Steel Water Tanks
Composite Surface Soil Sample (stained Areas)
Chloride (mg/kg) | 6,070
Benzene (mg/kg) | 0.0024
Toluene (mg/kg) | 0.0040
E. Benzene (mg/kg) | 0.0153
Xylenes (mg/kg) | 0.0411
TPH (gasoline) | <308
TPH (diesel) | 18,400
TPH (oil) | 3,030
Metal Buildings
210 bbl Oil Tanks
210 bbl Steel Tank (empty)
550 bbl F/G Tank (not used)
Berm
Inj. Pump
Chloride (mg/kg)
Depth | Result
05 Ft | 19,200
Recovered Vegetation
Recovered Vegetation
H-2
Inj. Well
Chloride (mg/kg)
Depth | Result
10 Ft | 193
30 Ft | 257
H-1
Area of Current Stressed Vegetation
Marks and Garner
Red-12 State No. 4
Injection Battery
T-17-S, R-29-E, Sec 5
Eddy County, New Mexico
N
Scale - Feet
0
60
120
0
20
40
Scale - Meters
