R. T. HICKS CONSULTANTS, LTD.

September 10, 2009

RE: Seven Produced Fluid Releases at sites operated by Marks and Garner Production Ltd, Company in Eddy County, NM as follows:

R.T. Hicks Consultants is pleased to submit this response to your August 19, 2009 directive letter concerning the characterization activities on the behalf of Marks and Garner Production Ltd. Because this letter proposes collection of additional data, we request that NMOCD consider this letter an interim response. Plate 1a shows the location of the sites.

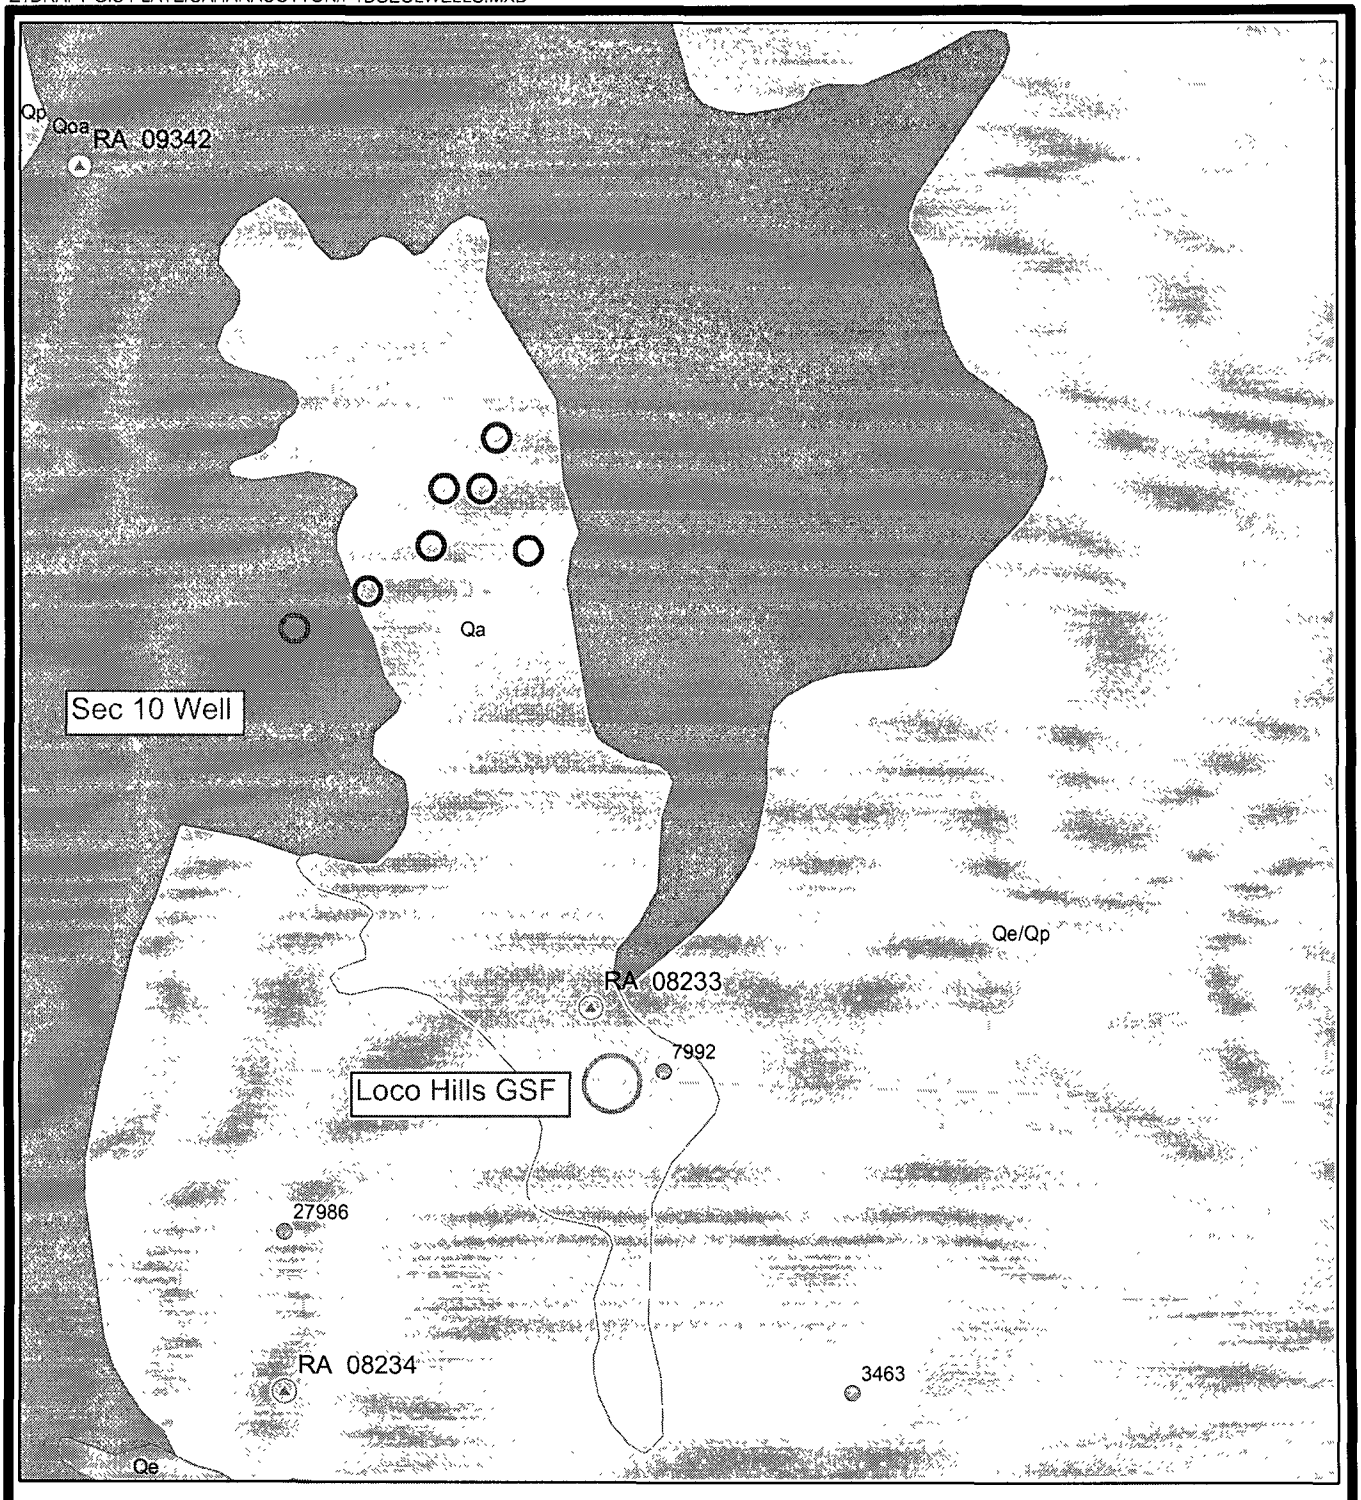
R.T. Hicks Consultants, Ltd 901 Rio Grande Blvd NW Suite F-142 Albuquerque, NM 87104 Ph: 505.266.5004	Geologic Map Showing Nearby Wells	Plate 1b
	Marks and Garner	Sept 2009

Depth to Ground Water and Ground Water Quality
Plate 1b shows the location of the Marks & Garner sites (red circles) that are the subject of investigations in support of gaining compliance with Part 29 of the NMOCD Rules. Also shown on Plate 1b are:

The geologic map shows that Quaternary Alluvium fills the valley of Bear Grass Draw. Quaternary eolian and pediment deposits dominate the southern portion of the area shown in Plate 1b and Quaternary Older Alluvium comprises the majority of the northern portion.

Plate 1b shows two other wells from the PTTC database south of the Loco Hills Gas Storage Facility. According to the PTTC database, both of these wells are screened below the alluvial cover in the Triassic Dockham group or the Rustler. These two aquifers are confined in this area.

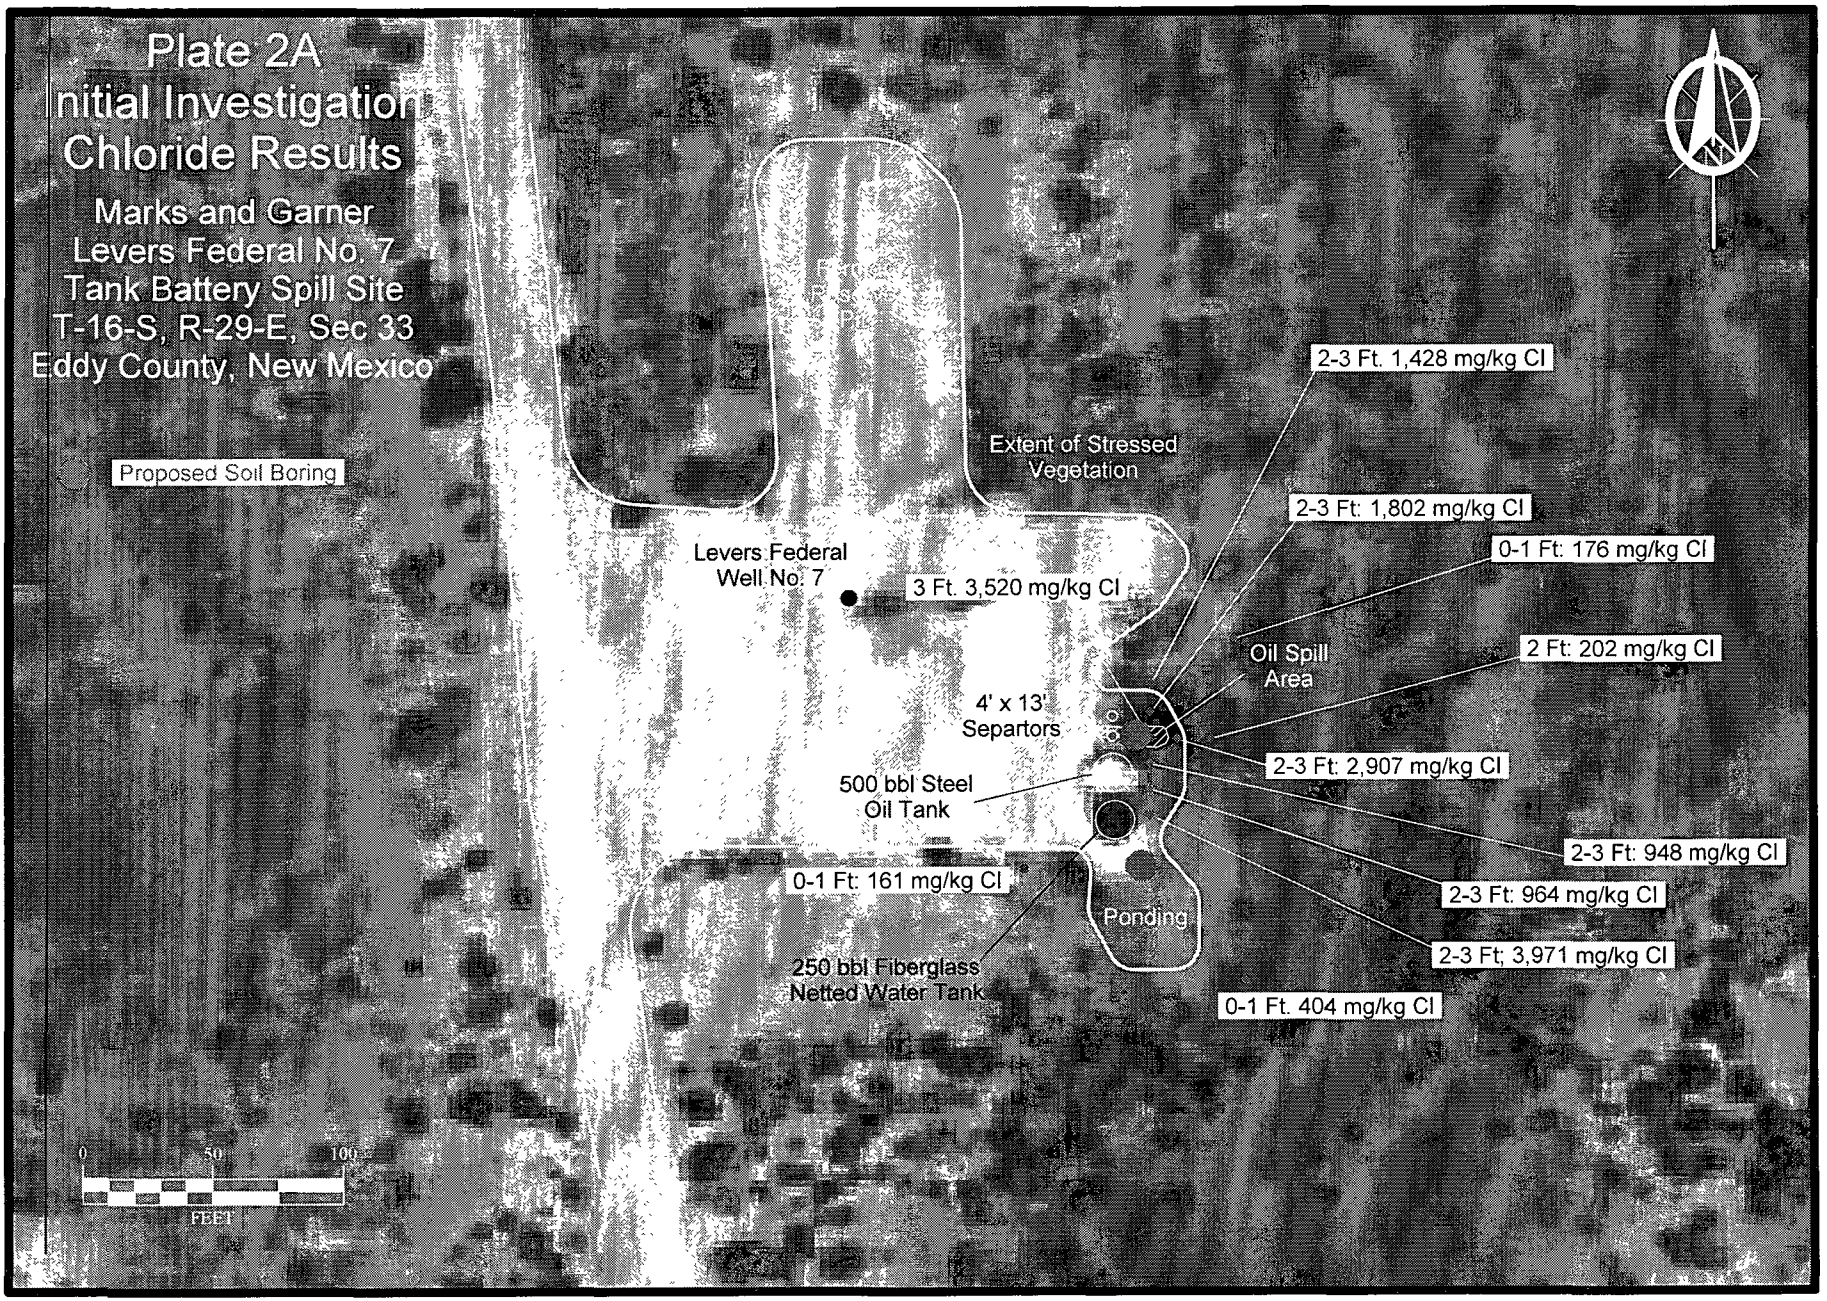
Marks & Garner - Levers Federal No. 7 Site
Field and Laboratory Data - Soil Samples

Plate 2A
nitial Investigation
Chloride Results
Marks and Garner
Levers Federal No. 7
Tank Battery Spill Site
T-16-S, R-29-E, Sec 33
Eddy County, New Mexico
Proposed Soil Boring
Extent of Stressed Vegetation
Levers Federal Well No. 7
3 Ft. 3,520 mg/kg Cl
2-3 Ft. 1,428 mg/kg Cl
2-3 Ft: 1,802 mg/kg Cl
0-1 Ft: 176 mg/kg Cl
2 Ft: 202 mg/kg Cl
Oil Spill Area
4' x 13' Separtors
2-3 Ft: 2,907 mg/kg Cl
500 bbl Steel Oil Tank
2-3 Ft: 948 mg/kg Cl
2-3 Ft: 964 mg/kg Cl
0-1 Ft: 161 mg/kg Cl
Ponding
2-3 Ft; 3,971 mg/kg Cl
250 bbl Fiberglass Netted Water Tank
0-1 Ft. 404 mg/kg Cl
0
50
100
FEET

Hicks Consultants recommends that a hollow-stem auger be used to complete the vertical delineation of hydrocarbon- and chloride-impacted soil at each site according to the attached plates. We anticipate that a drilling rig will be available in mid to late October 2009 and a final report for each site, including recommendations for remedial actions, will be submitted to the NMOCD by the end of 2009. In the final report we will provide remediation action levels for soil and underlying sediment based upon criteria in NMOCD Rules, science-based evaluation of the sampling data and physical setting.

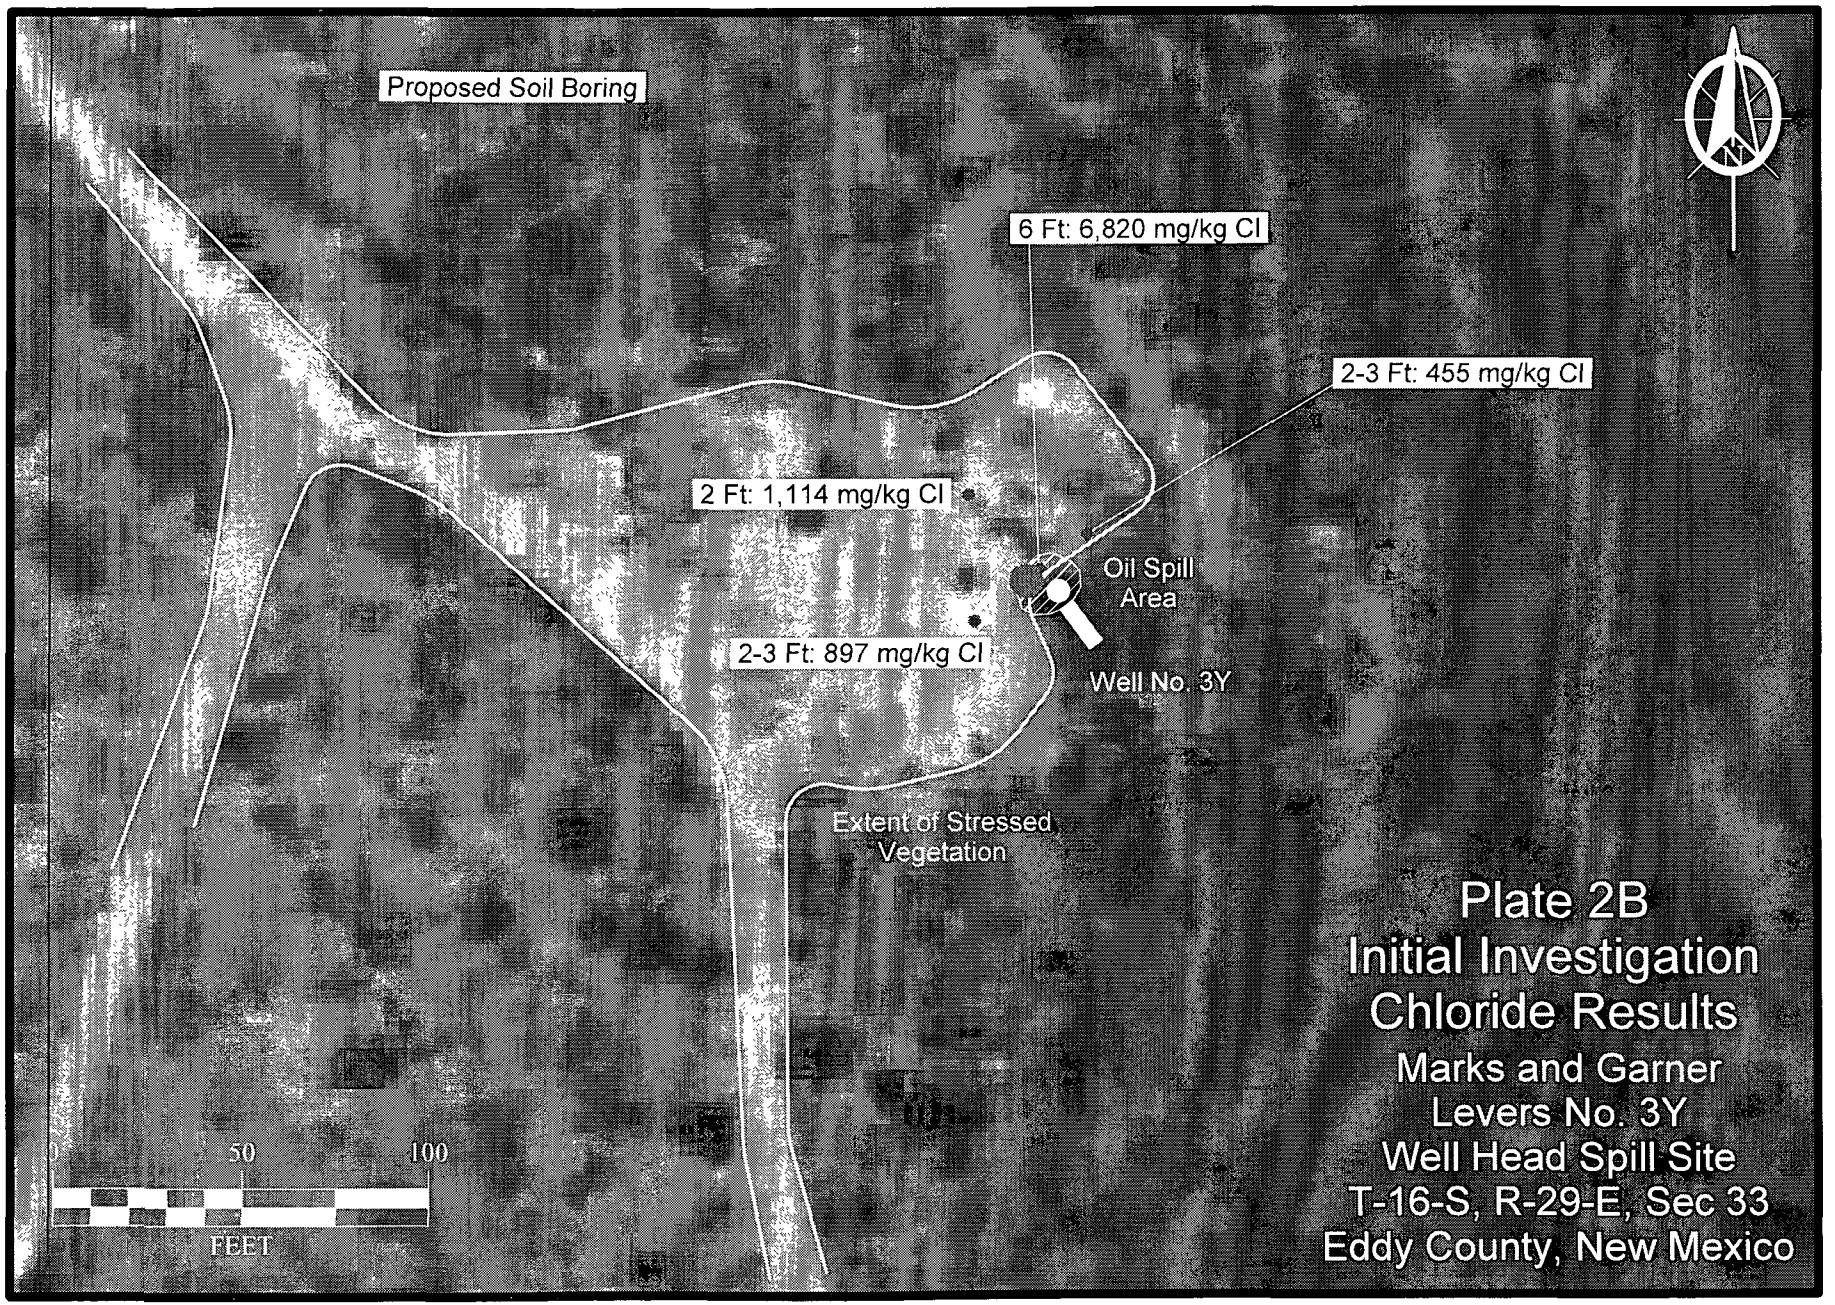
Marks & Garner - Levers No. 3Y Site
Field and Laboratory Data - Soil Samples

Proposed Soil Boring
6 Ft: 6,820 mg/kg Cl
2-3 Ft: 455 mg/kg Cl
2 Ft: 1,114 mg/kg Cl
Oil Spill Area
2-3 Ft: 897 mg/kg Cl
Well No. 3Y
Extent of Stressed Vegetation
0
50
100
FEET
Plate 2B
Initial Investigation
Chloride Results
Marks and Garner
Levers No. 3Y
Well Head Spill Site
T-16-S, R-29-E, Sec 33
Eddy County, New Mexico

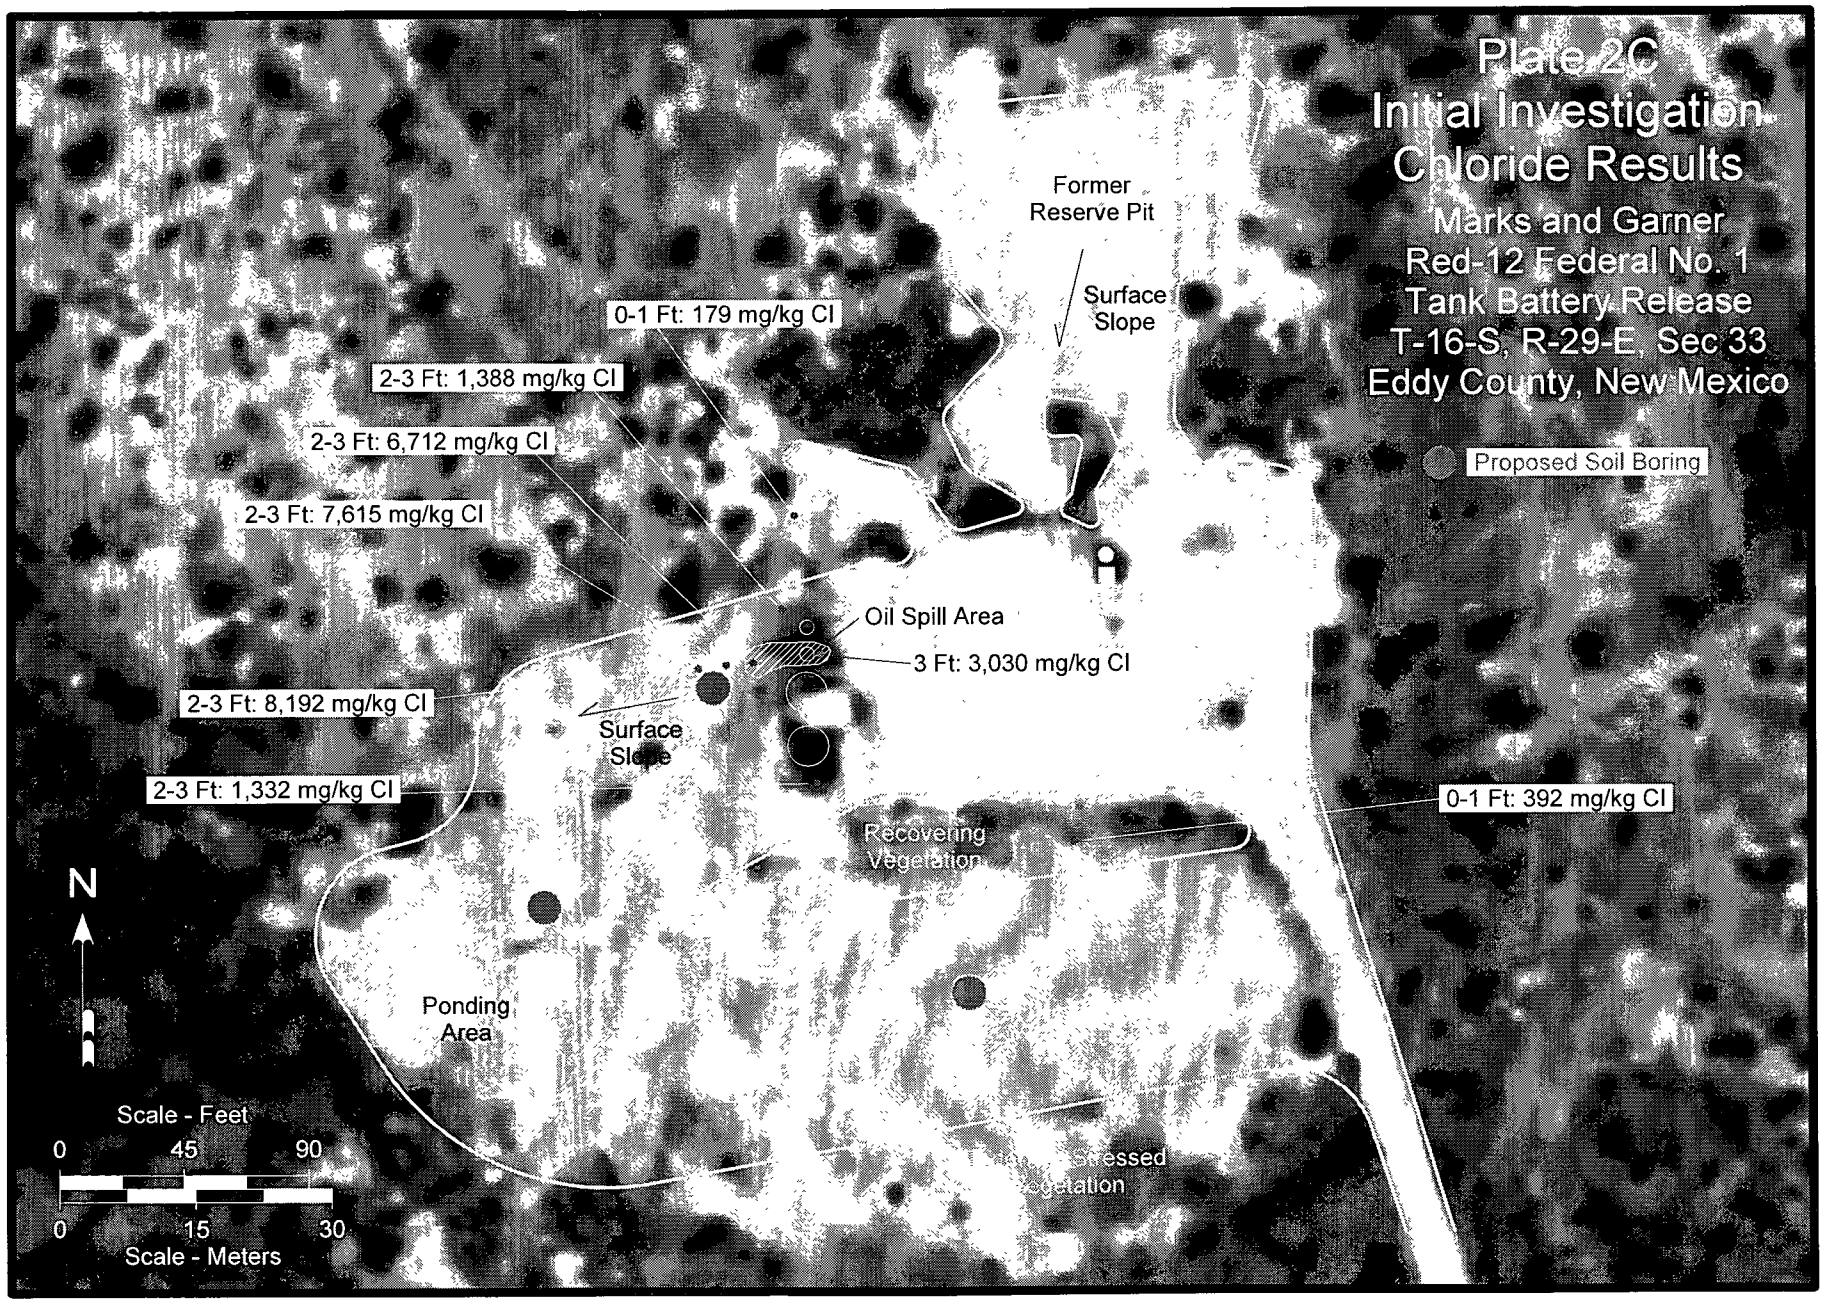
Marks & Garner - Red-12 Federal No. 1 Site
Field and Laboratory Data - Soil Samples

Plate 2C
Initial Investigation
Chloride Results
Marks and Garner
Red-12 Federal No. 1
Tank Battery Release
T-16-S, R-29-E, Sec 33
Eddy County, New Mexico
Proposed Soil Boring
Former
Reserve Pit
Surface
Slope
0-1 Ft: 179 mg/kg Cl
2-3 Ft: 1,388 mg/kg Cl
2-3 Ft: 6,712 mg/kg Cl
2-3 Ft: 7,615 mg/kg Cl
Oil Spill Area
3 Ft: 3,030 mg/kg Cl
2-3 Ft: 8,192 mg/kg Cl
Surface
Slope
2-3 Ft: 1,332 mg/kg Cl
0-1 Ft: 392 mg/kg Cl
Recovering
Vegetation
N
Ponding
Area
Scale - Feet
0
45
90
0
15
30
Scale - Meters

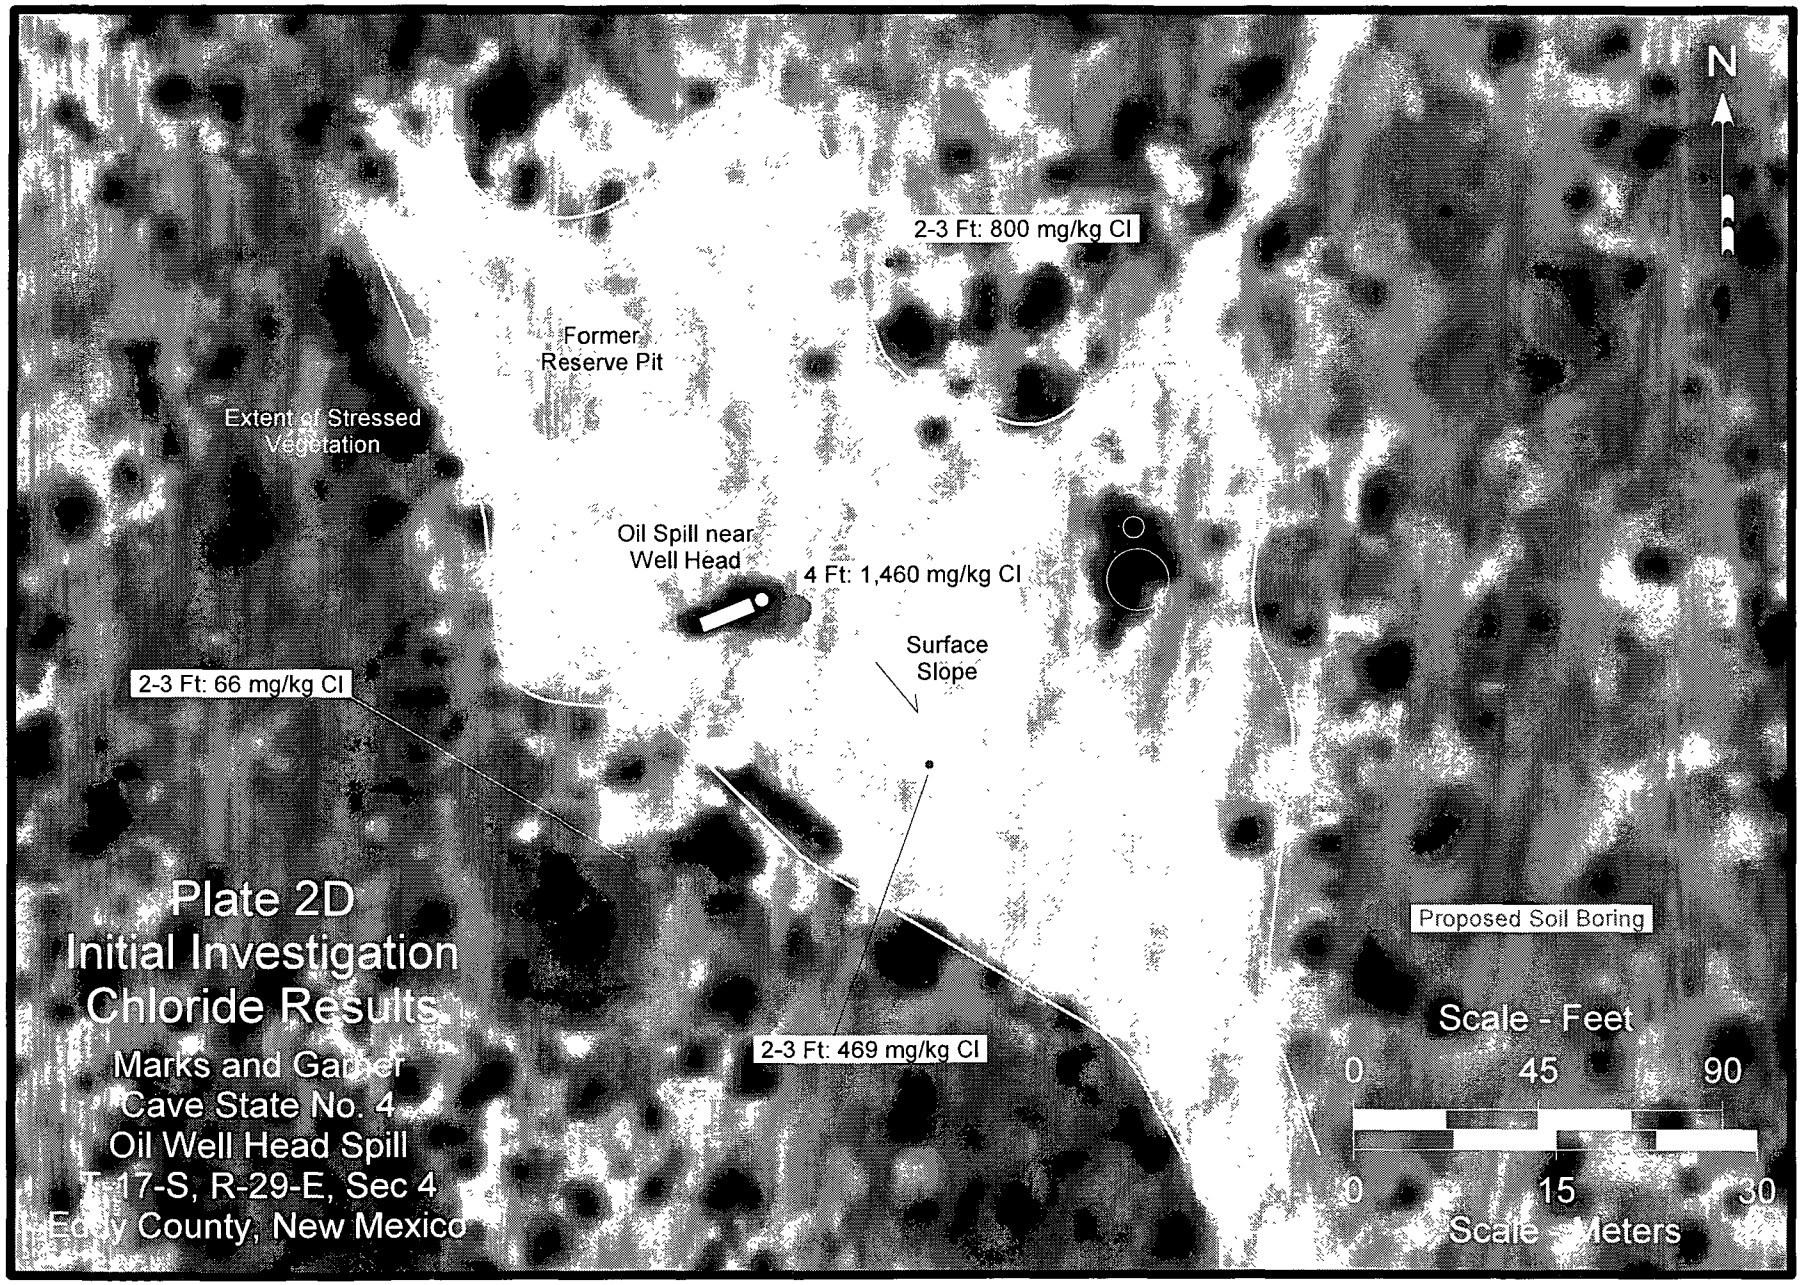
N
2-3 Ft: 800 mg/kg Cl
Former
Reserve Pit
Extent of Stressed
Vegetation
Oil Spill near
Well Head
4 Ft: 1,460 mg/kg Cl
Surface
Slope
2-3 Ft: 66 mg/kg Cl
Plate 2D
Initial Investigation
Chloride Results
Marks and Garber
Cave State No. 4
Oil Well Head Spill
T-17-S, R-29-E, Sec 4
Eddy County, New Mexico
2-3 Ft: 469 mg/kg Cl
Proposed Soil Boring
Scale - Feet
0
45
90
0
15
30
Scale - Meters

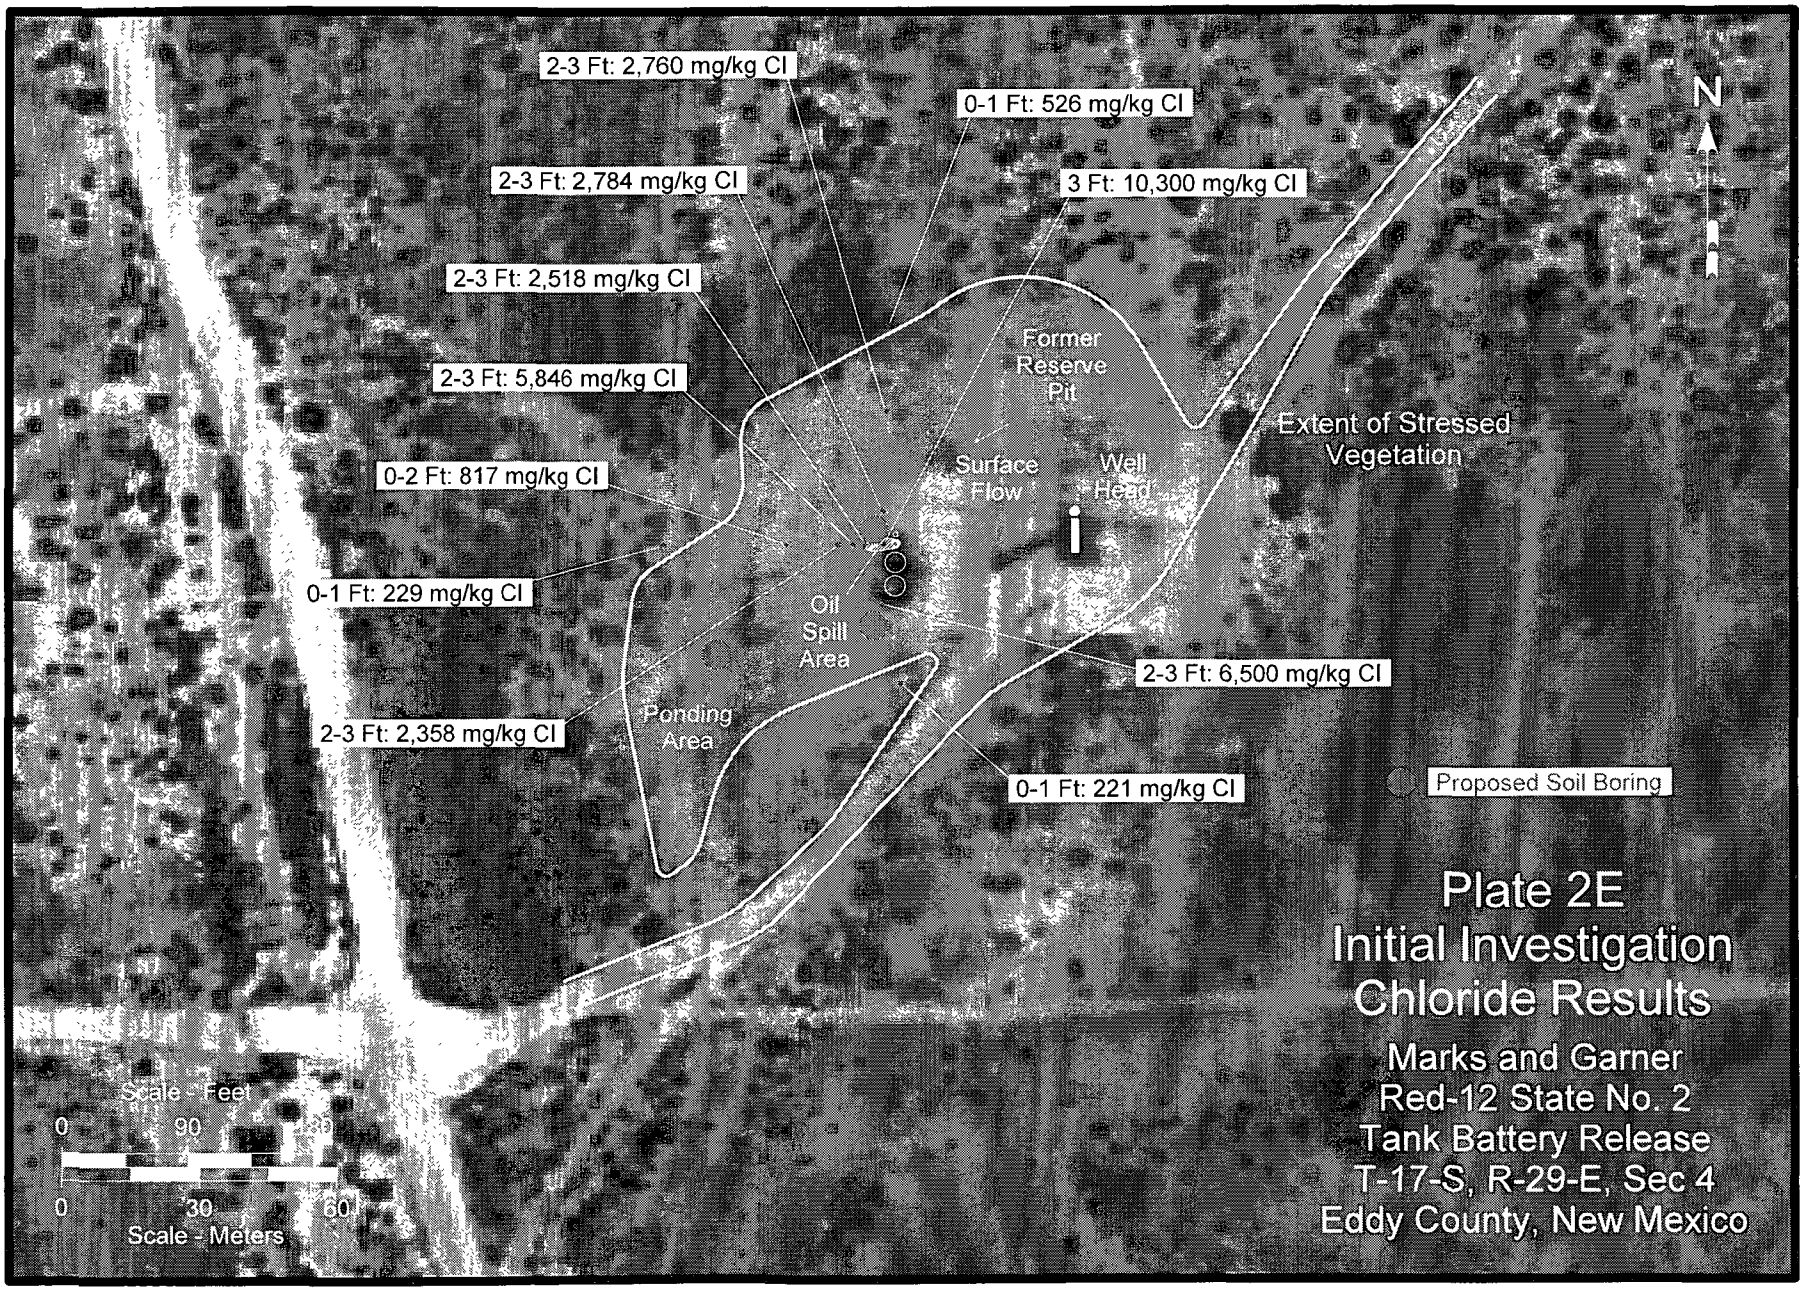
2-3 Ft: 2,760 mg/kg Cl
0-1 Ft: 526 mg/kg Cl
2-3 Ft: 2,784 mg/kg Cl
3 Ft: 10,300 mg/kg Cl
2-3 Ft: 2,518 mg/kg Cl
Former Reserve Pit
2-3 Ft: 5,846 mg/kg Cl
Extent of Stressed Vegetation
Surface Flow
Well Head
0-2 Ft: 817 mg/kg Cl
0-1 Ft: 229 mg/kg Cl
Oil Spill Area
2-3 Ft: 6,500 mg/kg Cl
Ponding Area
2-3 Ft: 2,358 mg/kg Cl
0-1 Ft: 221 mg/kg Cl
Proposed Soil Boring
N
Scale - Feet
0
90
180
0
30
60
Scale - Meters
Plate 2E
Initial Investigation
Chloride Results
Marks and Garner
Red-12 State No. 2
Tank Battery Release
T-17-S, R-29-E, Sec 4
Eddy County, New Mexico

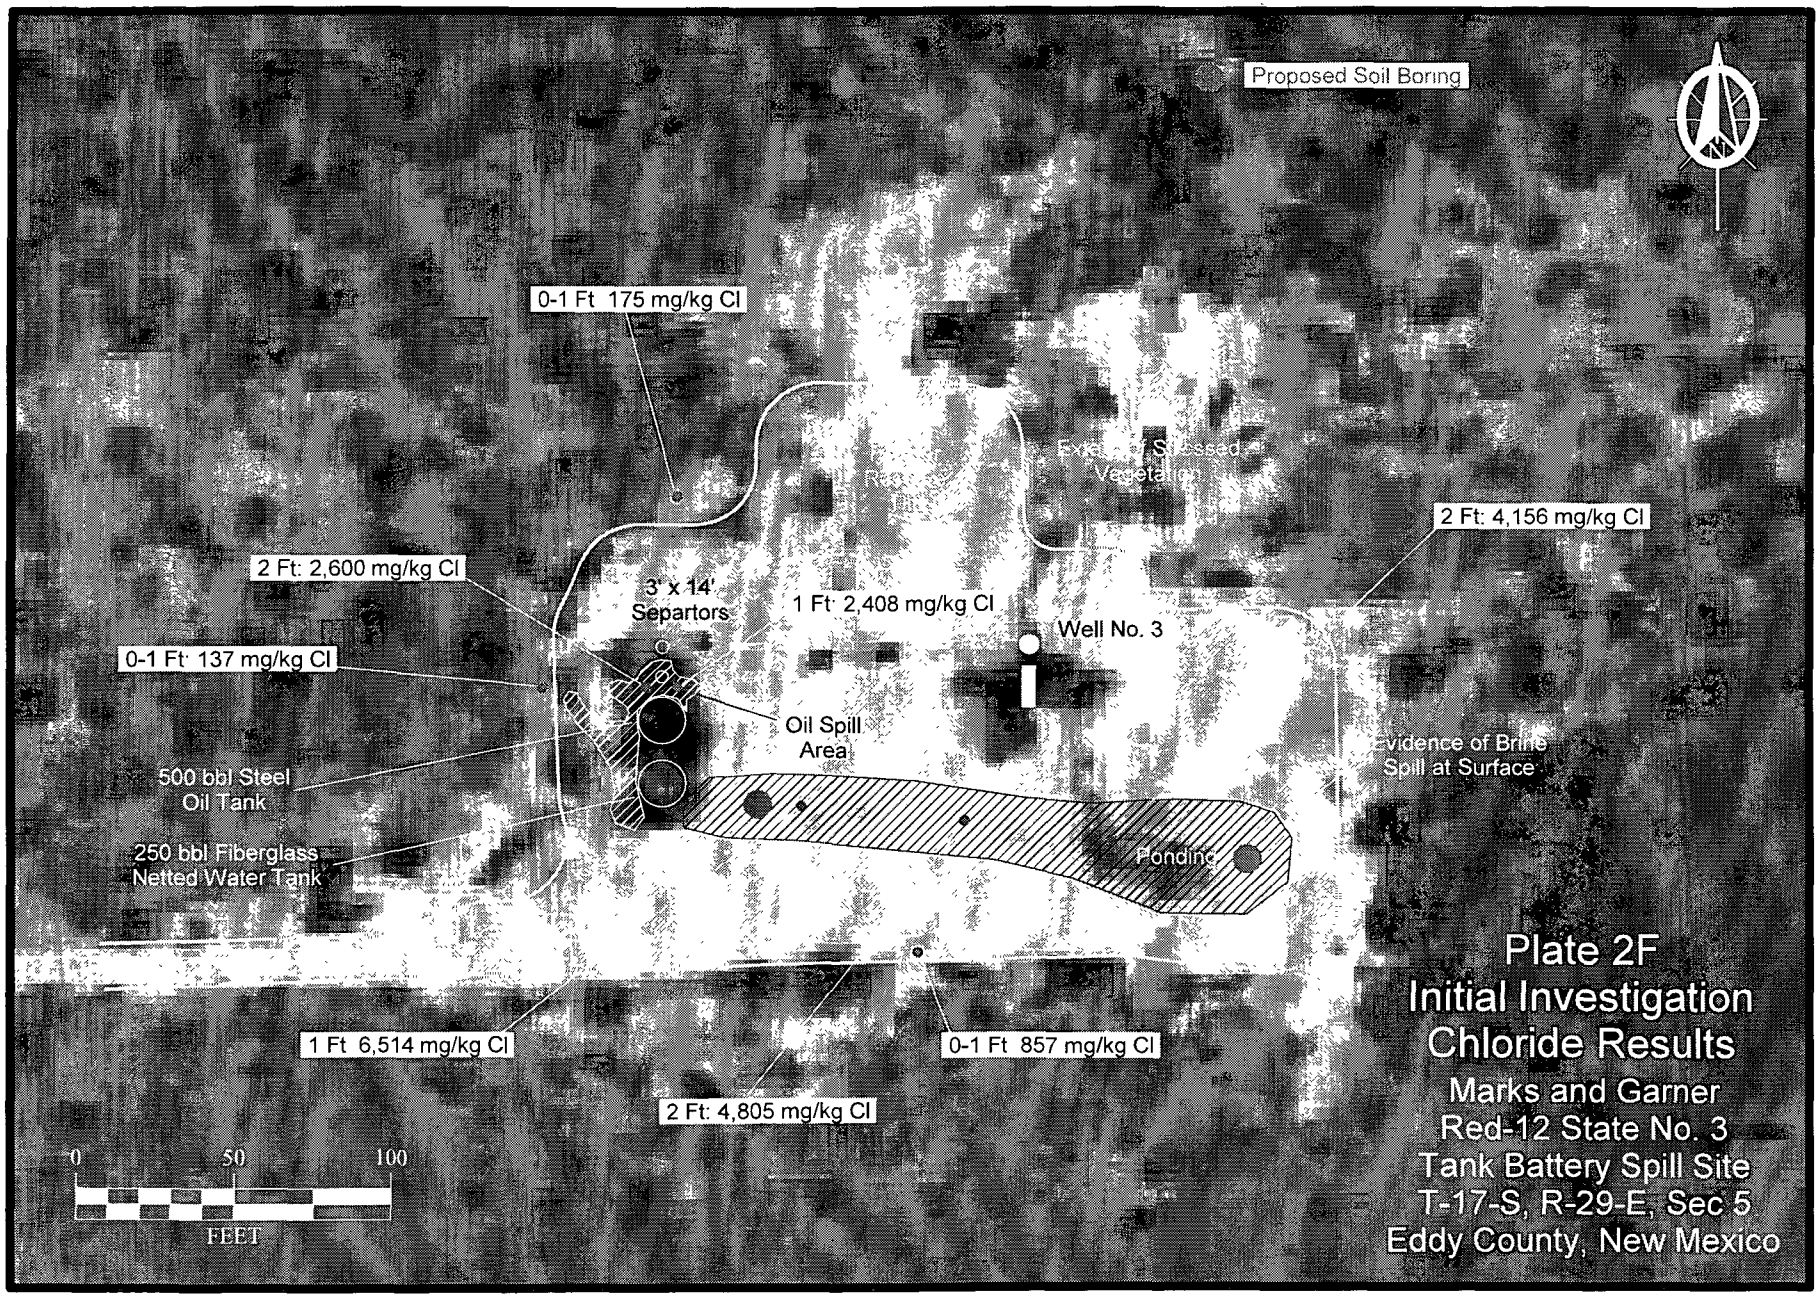
Proposed Soil Boring
0-1 Ft 175 mg/kg Cl
Extent of Stressed Vegetation
2 Ft: 4,156 mg/kg Cl
2 Ft: 2,600 mg/kg Cl
3' x 14' Separtors
1 Ft 2,408 mg/kg Cl
Well No. 3
0-1 Ft 137 mg/kg Cl
Oil Spill Area
Evidence of Brine Spill at Surface
500 bbl Steel Oil Tank
250 bbl Fiberglass Netted Water Tank
Ponding
1 Ft 6,514 mg/kg Cl
0-1 Ft 857 mg/kg Cl
2 Ft: 4,805 mg/kg Cl
0
50
100
FEET
Plate 2F
Initial Investigation
Chloride Results
Marks and Garner
Red-12 State No. 3
Tank Battery Spill Site
T-17-S, R-29-E, Sec 5
Eddy County, New Mexico

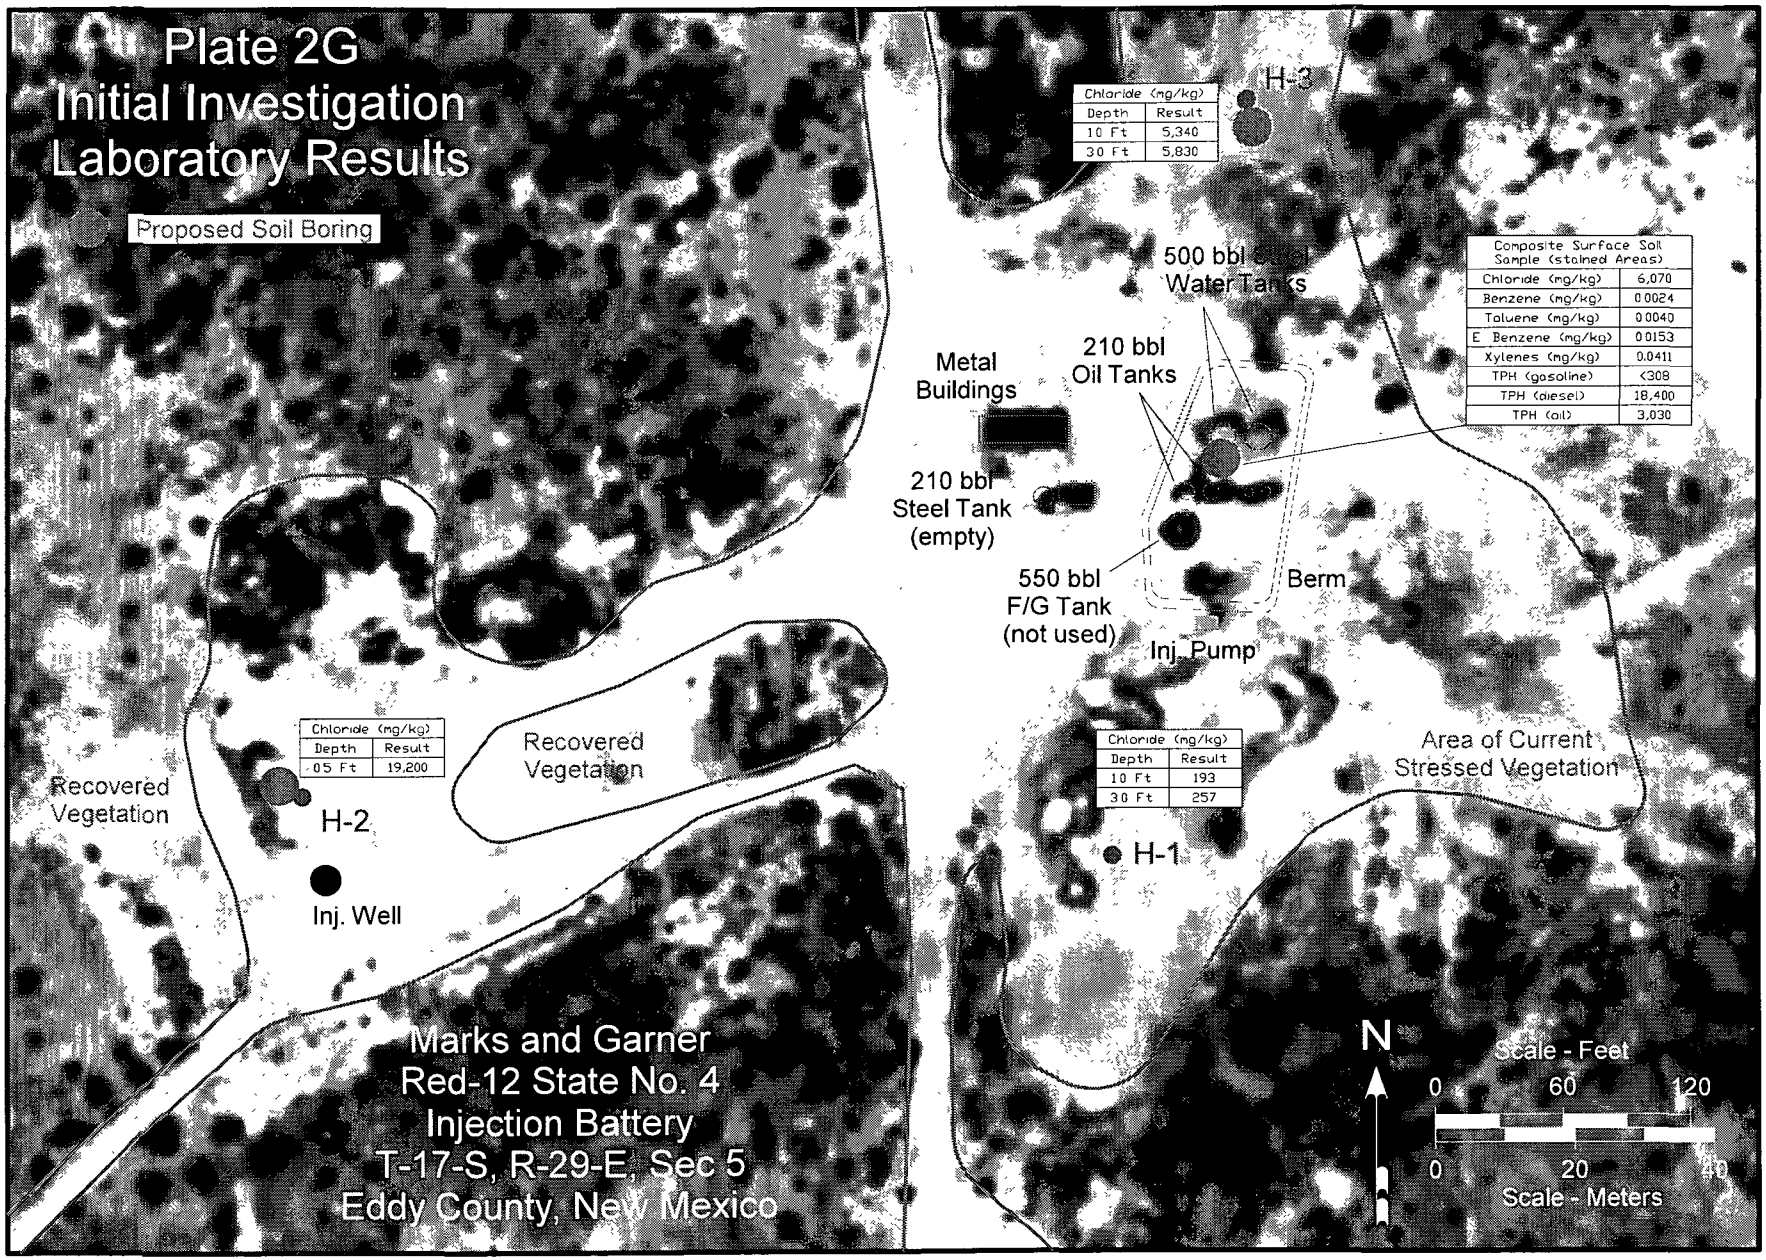
Plate 2G
Initial Investigation
Laboratory Results
Proposed Soil Boring
Chloride (mg/kg)
Depth | Result
10 Ft | 5,340
30 Ft | 5,830
H-3
Composite Surface Soil Sample (stained Areas)
Chloride (mg/kg) | 6,070
Benzene (mg/kg) | 0.0024
Toluene (mg/kg) | 0.0040
E. Benzene (mg/kg) | 0.0153
Xylenes (mg/kg) | 0.0411
TPH (gasoline) | <308
TPH (diesel) | 18,400
TPH (oil) | 3,030
500 bbl Steel Water Tanks
210 bbl Oil Tanks
Metal Buildings
210 bbl Steel Tank (empty)
550 bbl F/G Tank (not used)
Berm
Inj. Pump
Chloride (mg/kg)
Depth | Result
.05 Ft | 19,200
Recovered Vegetation
Recovered Vegetation
H-2
Inj. Well
Chloride (mg/kg)
Depth | Result
10 Ft | 193
30 Ft | 257
H-1
Area of Current Stressed Vegetation
Marks and Garner
Red-12 State No. 4
Injection Battery
T-17-S, R-29-E, Sec 5
Eddy County, New Mexico
N
Scale - Feet
0
60
120
0
20
40
Scale - Meters
