ANNUAL MONITORING REPORT

GROUNDWATER REMEDIATION REPORT

GCU #170
(K) SECTION 35, T29N, R12W, NMPM
SAN JUAN COUNTY, NEW MEXICO

APRIL 2009

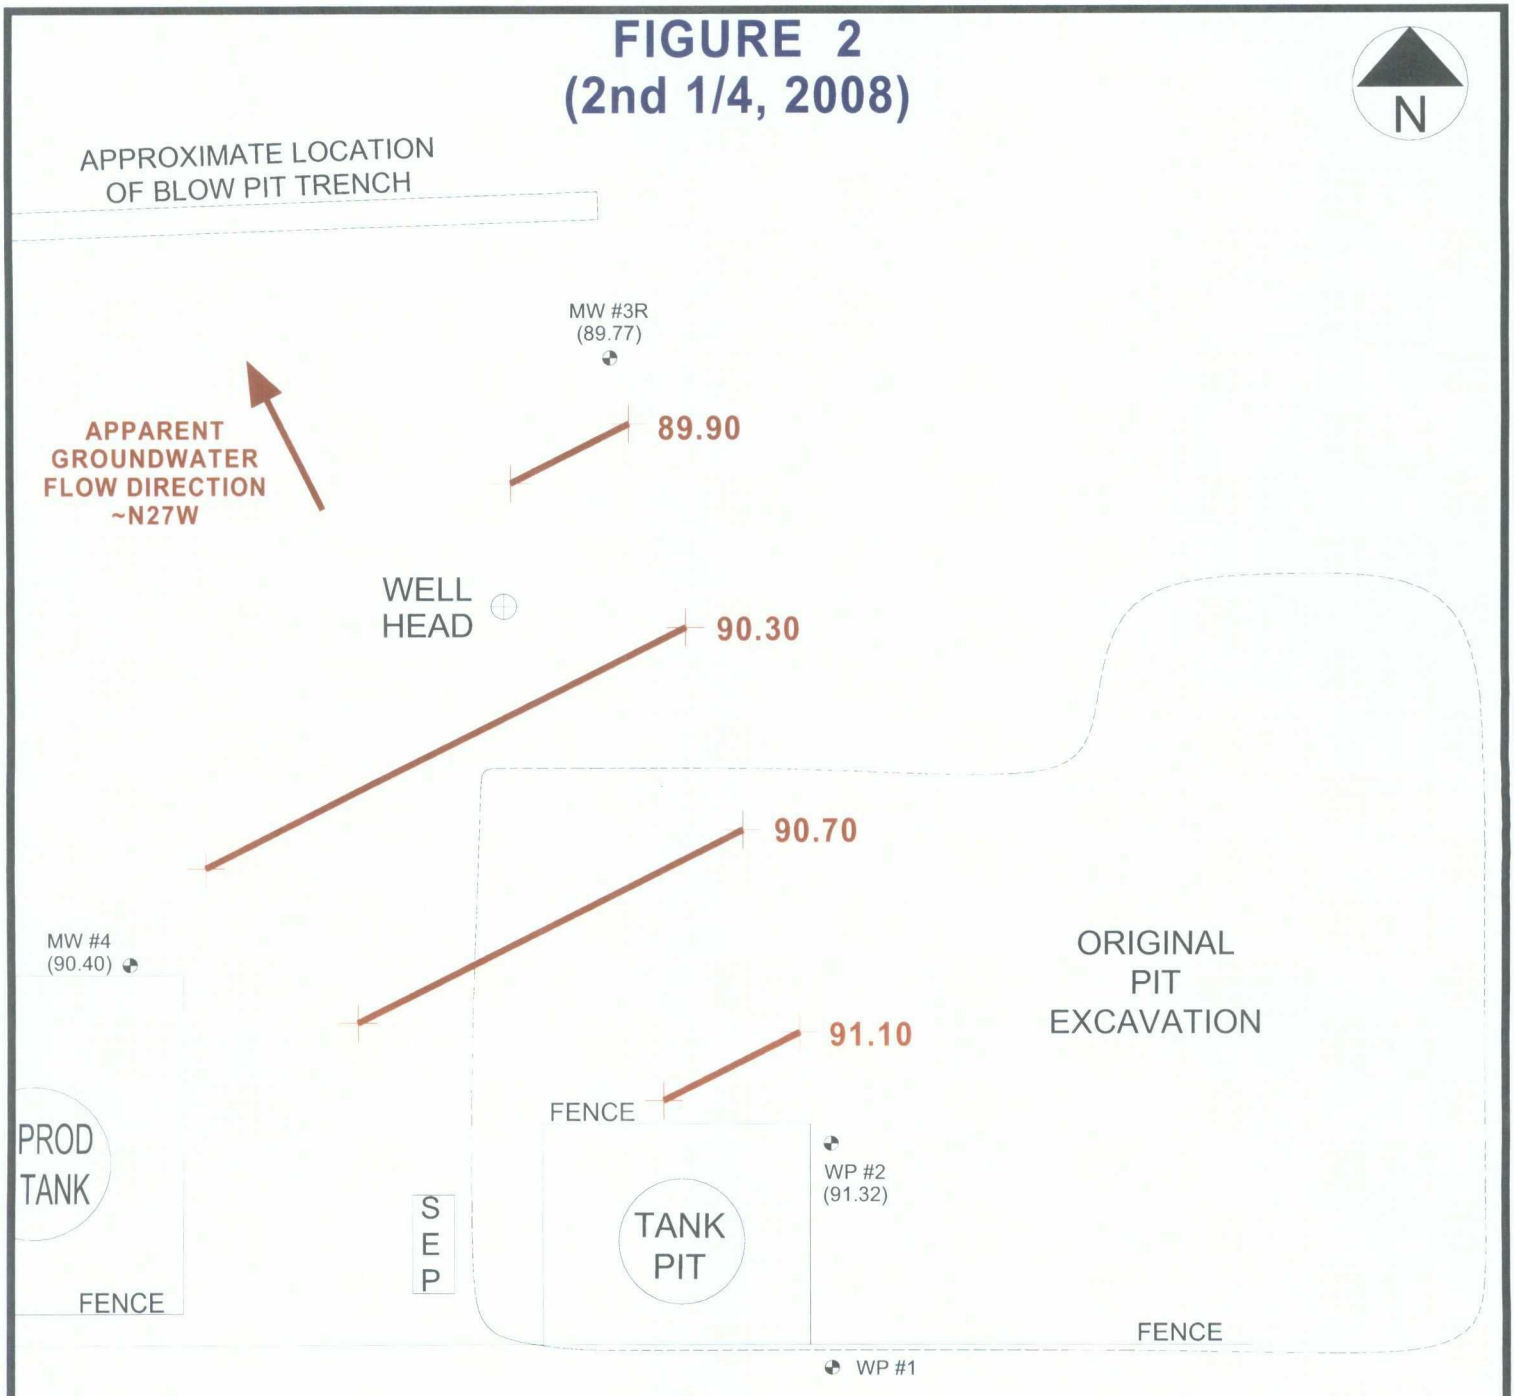
FIGURE 2
(2nd 1/4, 2008)

Top of Well Elevation
WP #2	(100.80)
MW #3R	(99.59)
MW #4	(101.14)
MW #4 (90.40)	Groundwater Elevation as of 6/9/08.

GROUNDWATER CONTOUR MAP
06/08

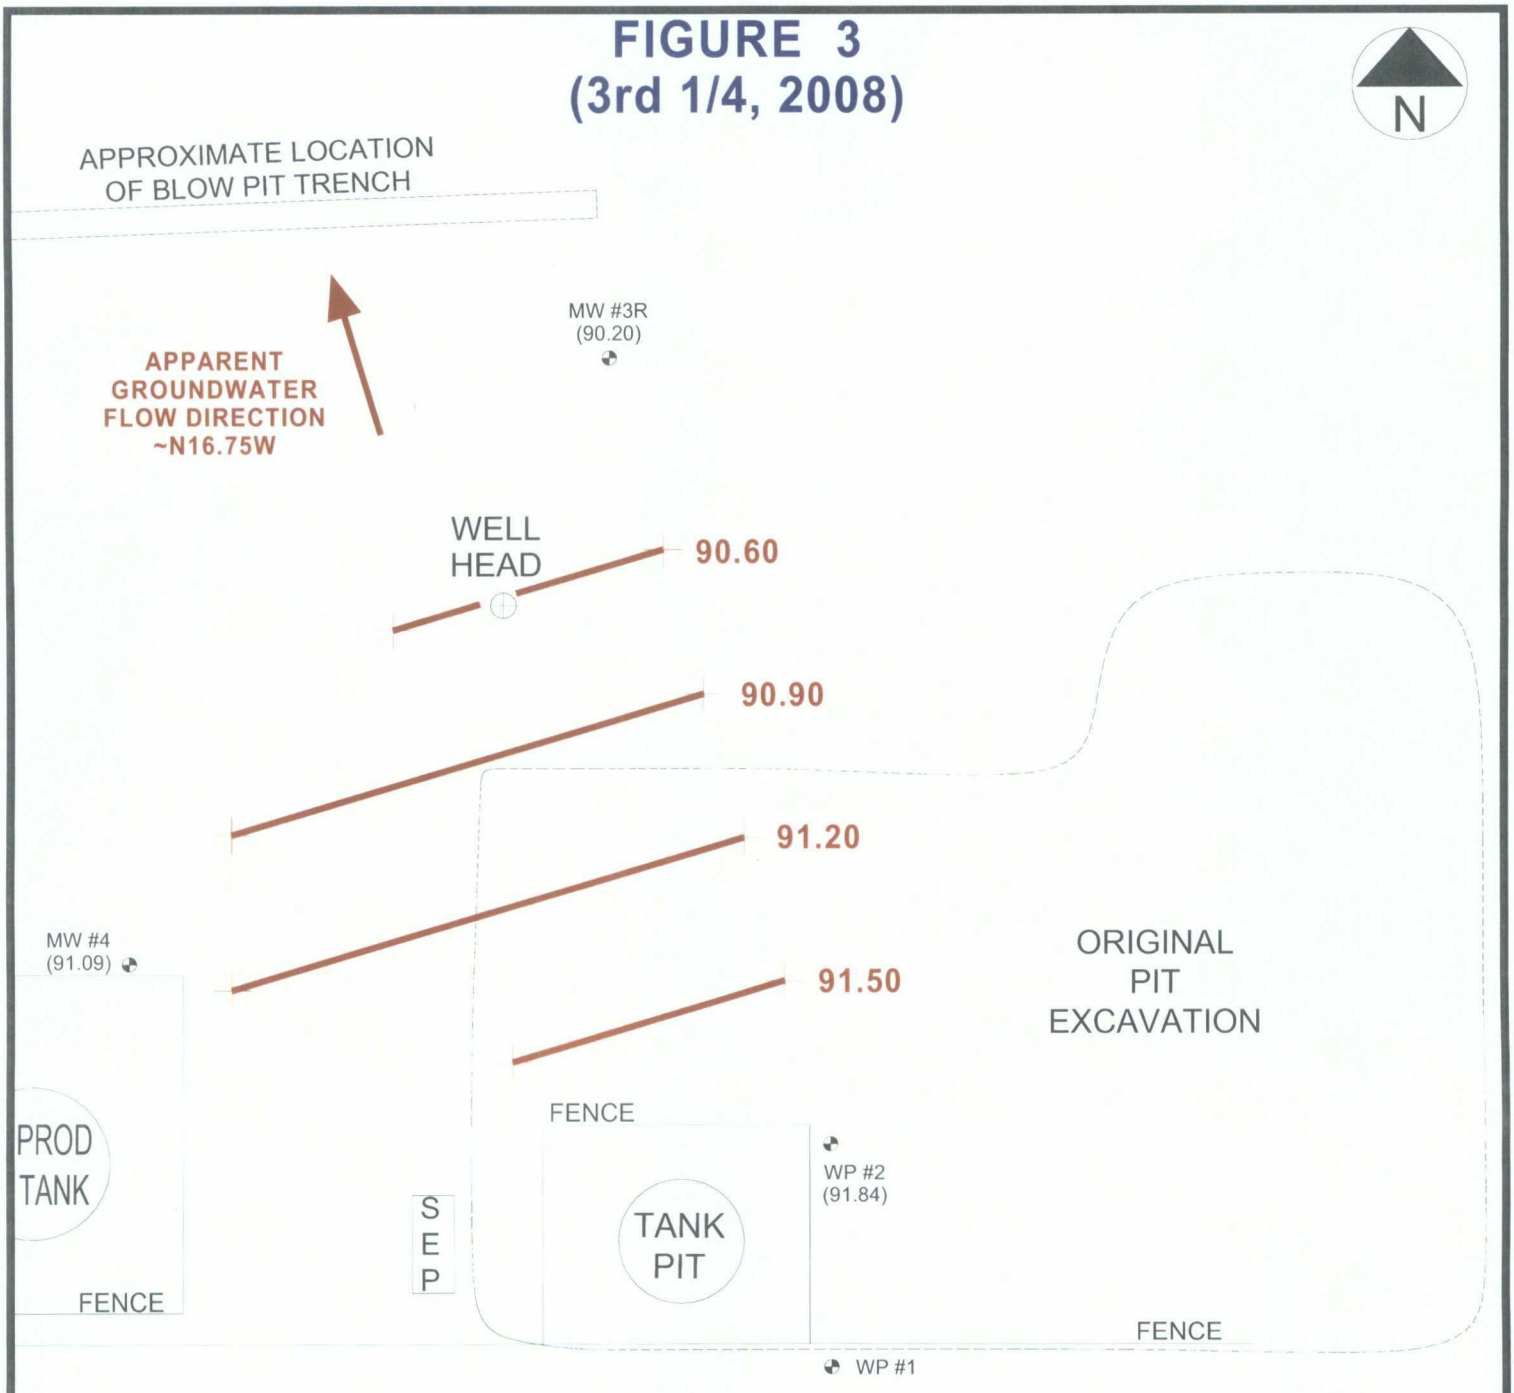
FIGURE 3
(3rd 1/4, 2008)

Top of Well Elevation
WP #2	(100.80)
MW #3R	(99.59)
MW #4	(101.14)
MW #4 (91.09)	Groundwater Elevation as of 8/27/08.

GROUNDWATER CONTOUR MAP
06/08
