INVESTIGATION & CHARACTERIZATION WORK PLAN FOR RICE OPERATING COMPANY EME JCT. C-8 VENT

LOCATED AT UNIT "C", SEC. 8, T20S, R37E LEA COUNTY, NEW MEXICO

Tetra Tech Project No. 114-6400253
October 1, 2009

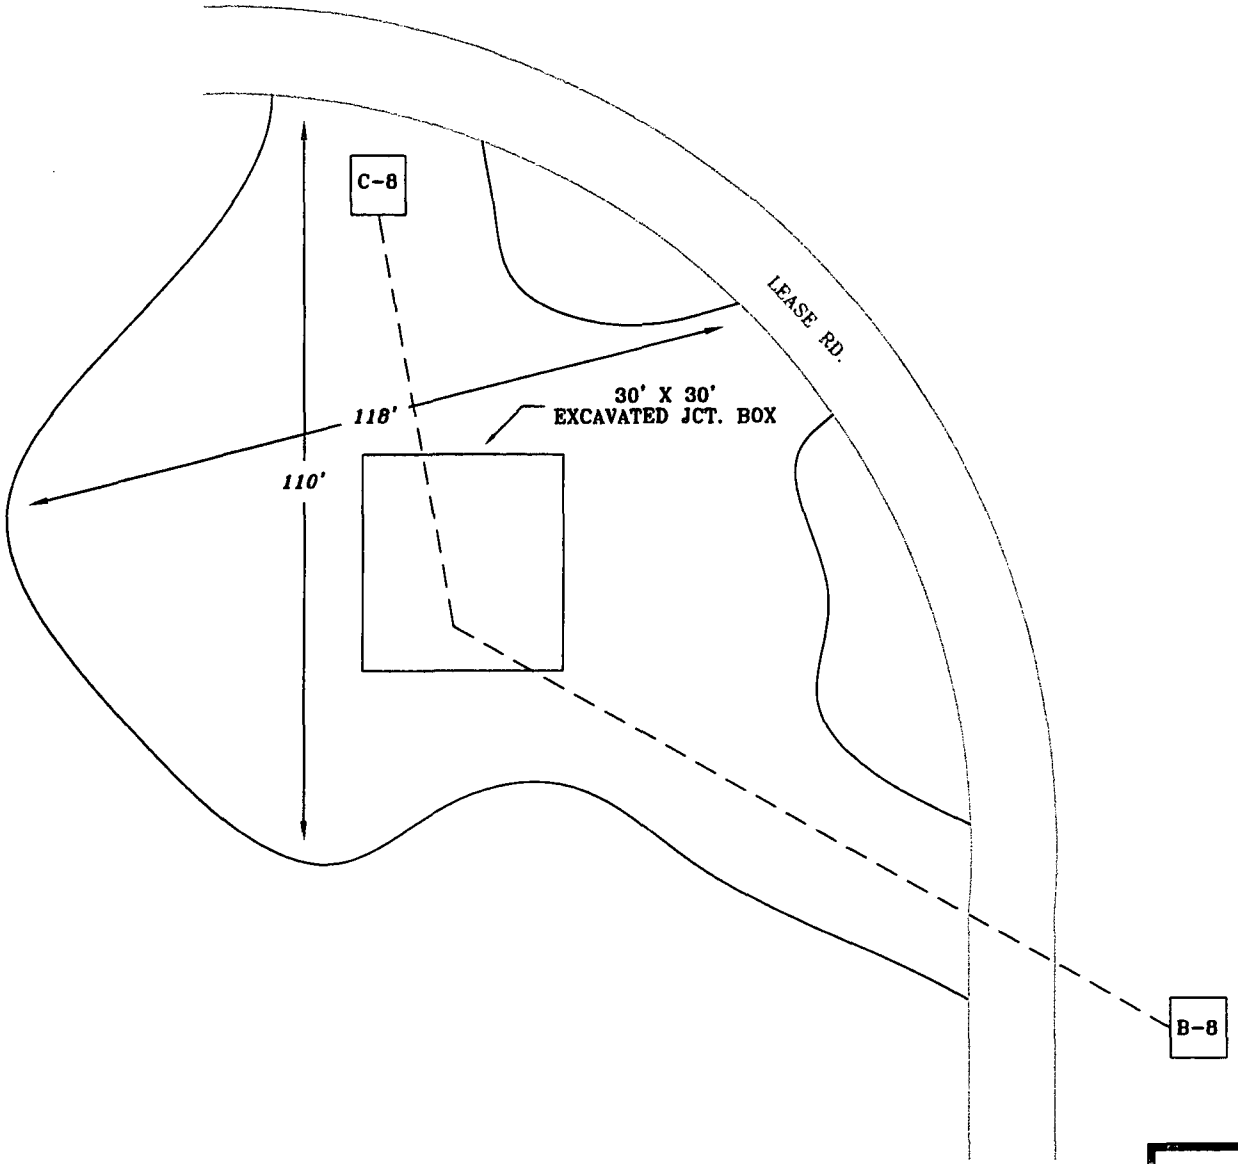
FIGURE NO. 3

RICE OPERATING COMPANY
EME C-8 VENT
SITE MAP

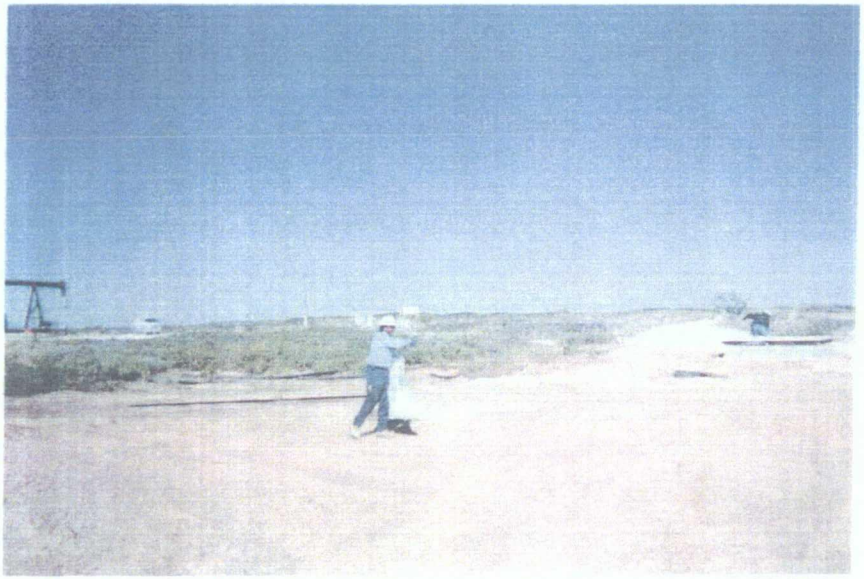
seeding backfilled site 10 25/2006

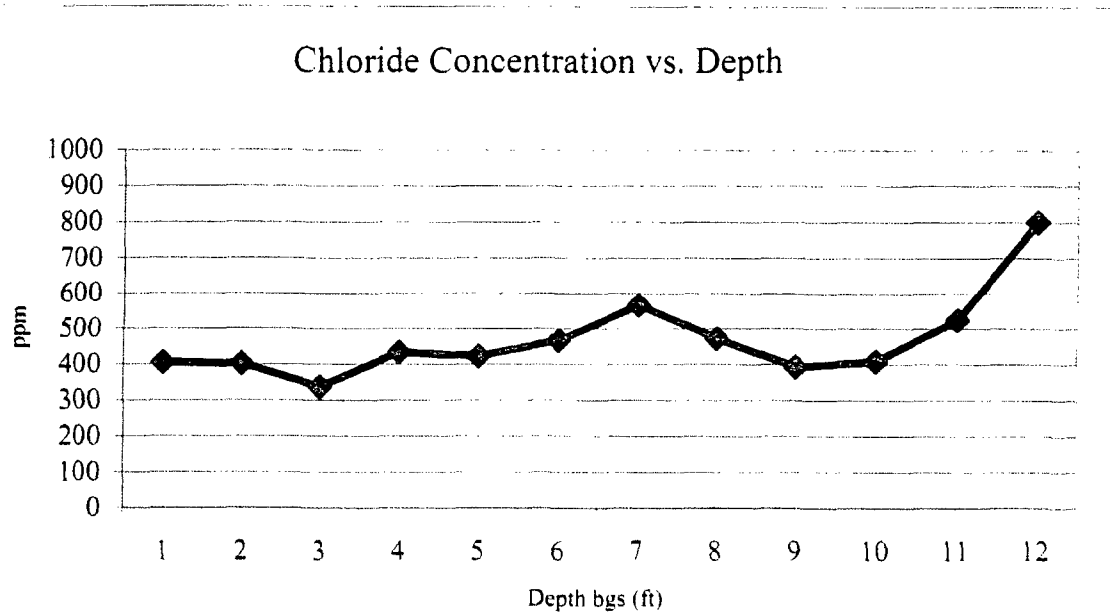
Backhoe samples at 15 ft south of the junction (source)

Depth bgs (ft)	[Cl⁻] ppm
1	404
2	401
3	336
4	433
5	422
6	466
7	566
8	472
9	392
10	407
11	523
12	800

Groundwater = 40 ft
