From: Victor Ayala [vayala@dh-enviro.com]
Sent: Tuesday, July 13, 2010 8:42 AM
To: Bratcher, Mike, EMNRD
Cc: lfric@CLTHOMAS.com
Subject: RE: Soil Samples - Murchison Oil Lease
Attachments: Field Sketch with FID Readings.pdf

PROJECT: Murchison Artesia
PROJECT #:
TASK:

PROJECT: Murchison Artesia
PROJECT #:
TASK: Headspace Readings FID

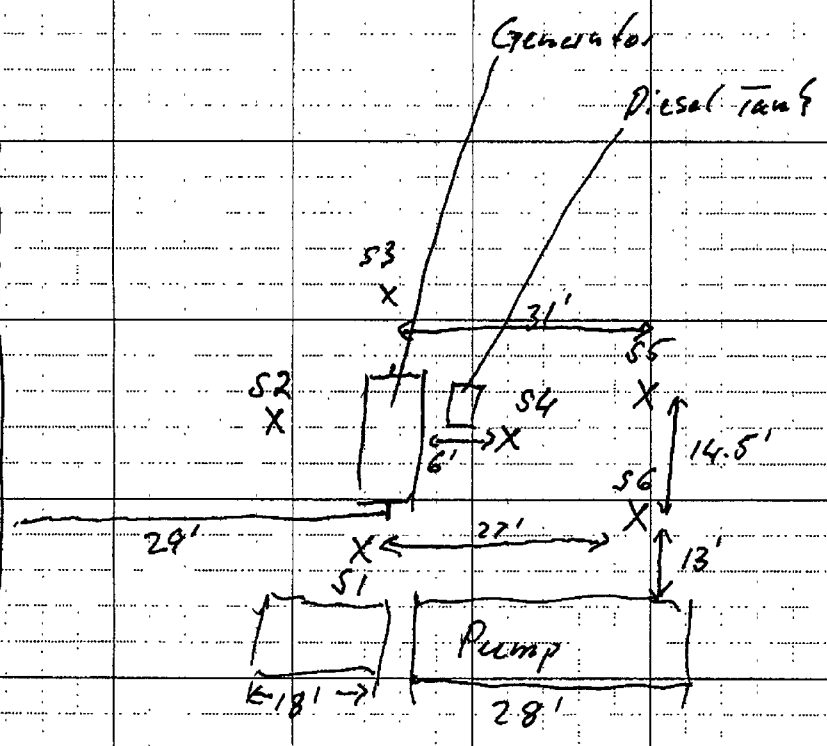
Per our phone conversation, I am submitting the Flame Ionization Detector readings on headspace samples collected at the referenced site. These readings were pulled on a different set of samples collected at the same locations as those collected for laboratory analysis. The FID readings are all below 100 ppm and most were below 25 ppm. As discussed, we will analyze the samples collected at 6 inches for both TPH and BTEX.

Surface		6"		
S1		38.5		78.3		
S2		5.3		1.5		
S3		0.0		0.0		
S4		27.3		53.4		
S5		22.1		1.6		
S6		0.0		0.0
