Abatement Plan

RE: Stage 2 Abatement Plan (AP-78)
South Four Lakes #15 Site
T12S-R34E-Section 2, Unit Letter G
Lea County, New Mexico

STAGE 2 ABATEMENT PLAN (AP-78)
SOUTH FOUR LAKES #15 SITE
TOWNSHIP 12 SOUTH, RANGE 34 EAST, SECTION 2, UNIT G
LEA COUNTY, NEW MEXICO

OCTOBER 1, 2008

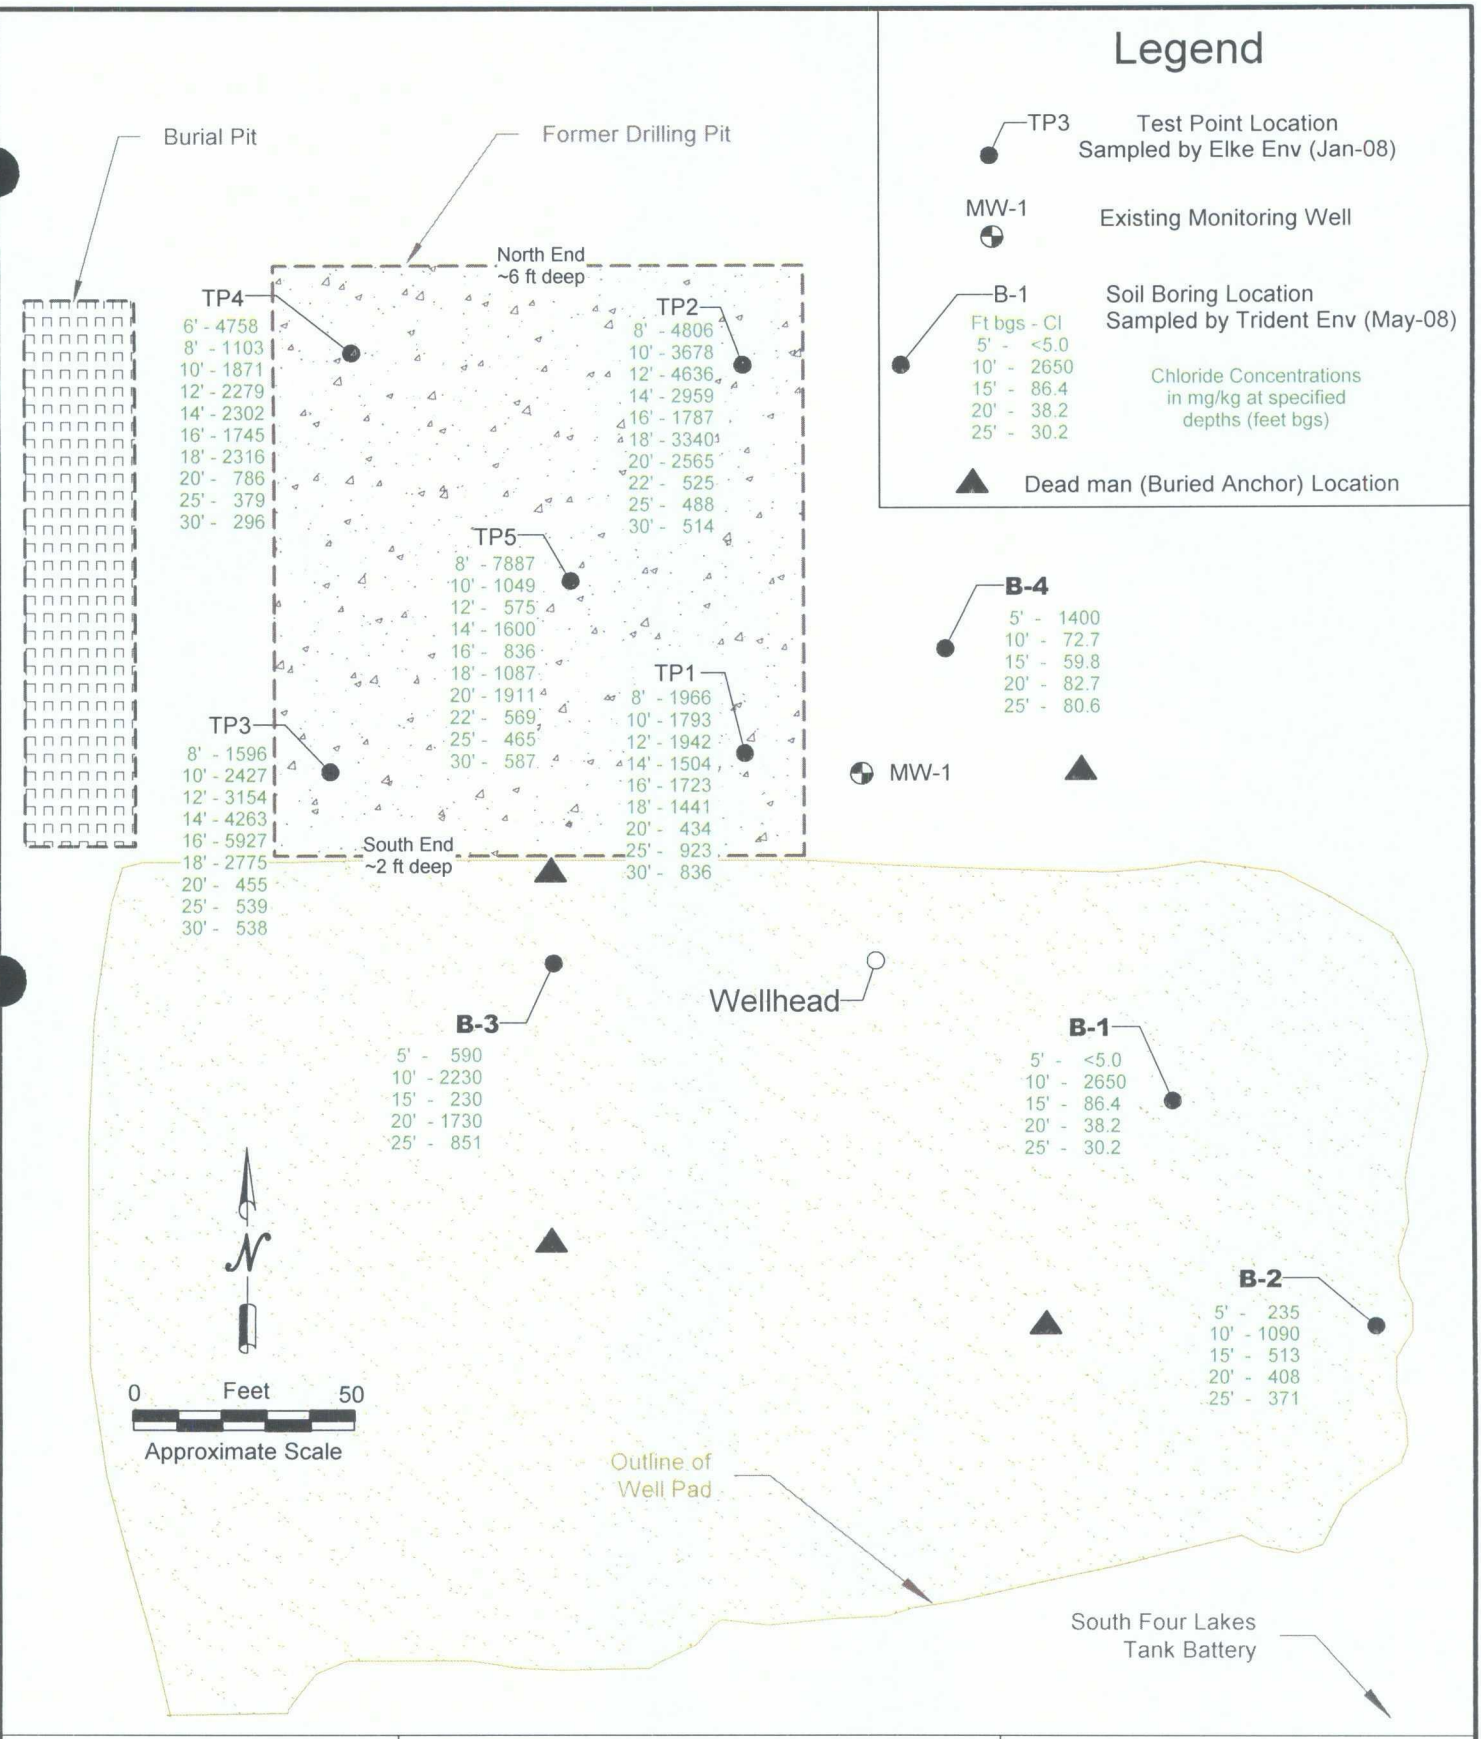
Figure 3
Choride Concentrations in Vadose Zone

The first boring (B-1) was completed approximately 100 feet downgradient of existing monitoring well MW-1, which is located near the southeast corner of the former drilling pit. Since depth discrete groundwater specific conductivity (SC) readings from this boring suggested readings above background conditions, a second boring (B-2) was installed another 75 feet downgradient where conductivity readings indicated background levels. A third (B-3) and fourth (B-4) soil boring were installed approximately 25 feet south and 25 feet east, respectively, of the former drilling pit to horizontally delineate conditions closer to the targeted source. The location of each soil boring is shown on Figures 3 and 4.

Generally, the first few feet of subsurface soils consisted of a clayey loam. Below this layer, silty clayey fine sand and fine sands with interbeds of caliche and indurated sands were encountered until a depth of approximately 25 feet where groundwater was reached. Below this depth fine sands continued to a depth of approximately 51 feet where a very hard sandstone/quartzite layer was encountered. Below the approximately 1- to 2-foot thick sandstone/quartzite layer, loose and unconsolidated fine-grained flowing sands were encountered. Groundwater was encountered at approximately 25 feet bgs. A more detailed description of each soil boring is provided on the lithologic logs in Appendix B. Laboratory analysis of chloride concentrations for each soil sample is summarized in Table 2 below, depicted on Figure 2, and shown on the individual lithologic logs in Appendix B. Field and laboratory analysis of groundwater samples from the soil boring program are summarized in Table 3 below and depicted on Figure 3.

Based on the soil boring data obtained by Elke Environmental in January 2008 (TP-1 through TP-5) and Trident Environmental in May 2008 (B-1 through B-4) the chloride impact to the vadose zone is limited to within the perimeter of the former drilling pit. The greatest chloride mass was observed at the TP-2 (northeast corner) and TP-3 (southwest corner) of the pit.

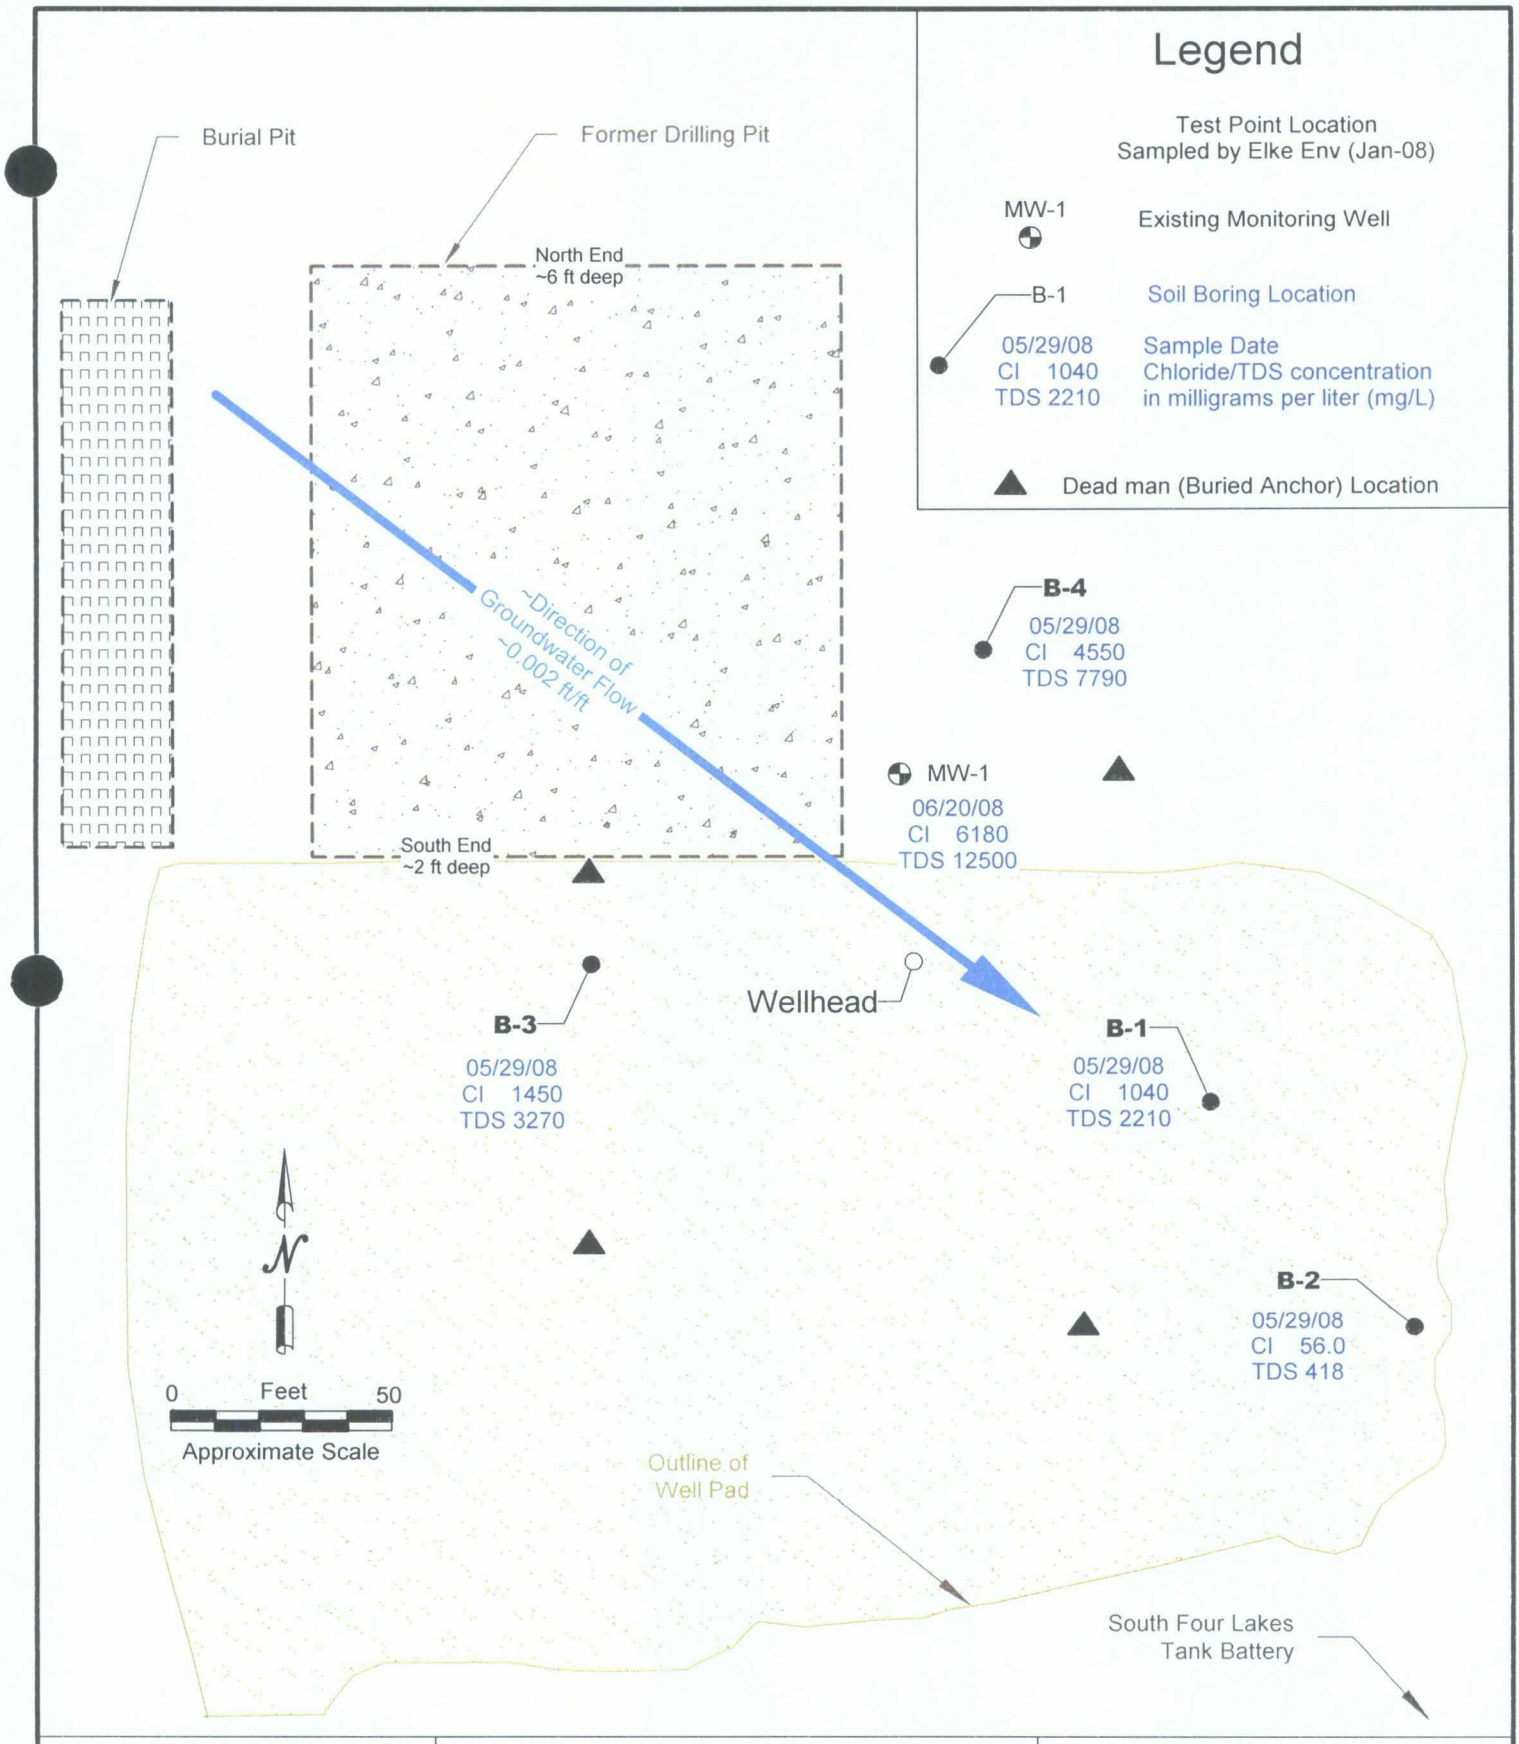
Figure 4
Choride and TDS
Concentrations
in Groundwater

Chloride and TDS concentrations in groundwater at monitoring well MW-1, and soil borings B-1, B-3, and B-4 exceeded WQCC standards. The highest chloride (6,180 mg/L) and TDS (12,500 mg/L) levels were at MW-1 which is expected due to it's immediately downgradient location with respect to the former drilling pit. Horizontal dispersion of the chloride and TDS in groundwater does not exceed beyond approximately 150 feet downgradient (southeast) of the southeast corner of the pit as evidenced by the results of boring B-2 where background chloride and TDS levels were observed in groundwater.

3. After NMOCD approval of the Stage 1 and 2 Abatement Plan:
   a. Use mud rotary drilling and install RW-1 approximately 20 feet south of MW-1 (outside of the deadman zone) to further define the vertical magnitude of groundwater impairment and to serve as a supply well for the proposed pump-and-use remedy. The depth of this well will not go beyond 100 ft bgs (expected base of Ogallala Fm.) and will terminate when field conditions (specific conductivity readings) indicate declining chloride levels with depth.
