QTR Groundwater Report

RE: ConocoPhillips Company Randleman #1 - Groundwater Monitoring Report, Aztec, New Mexico

QUARTERLY GROUNDWATER MONITORING REPORT

CONOCOPHILLIPS COMPANY
RANDLEMAN No.1
PRODUCTION FACILITY
SAN JUAN COUNTY, NEW MEXICO

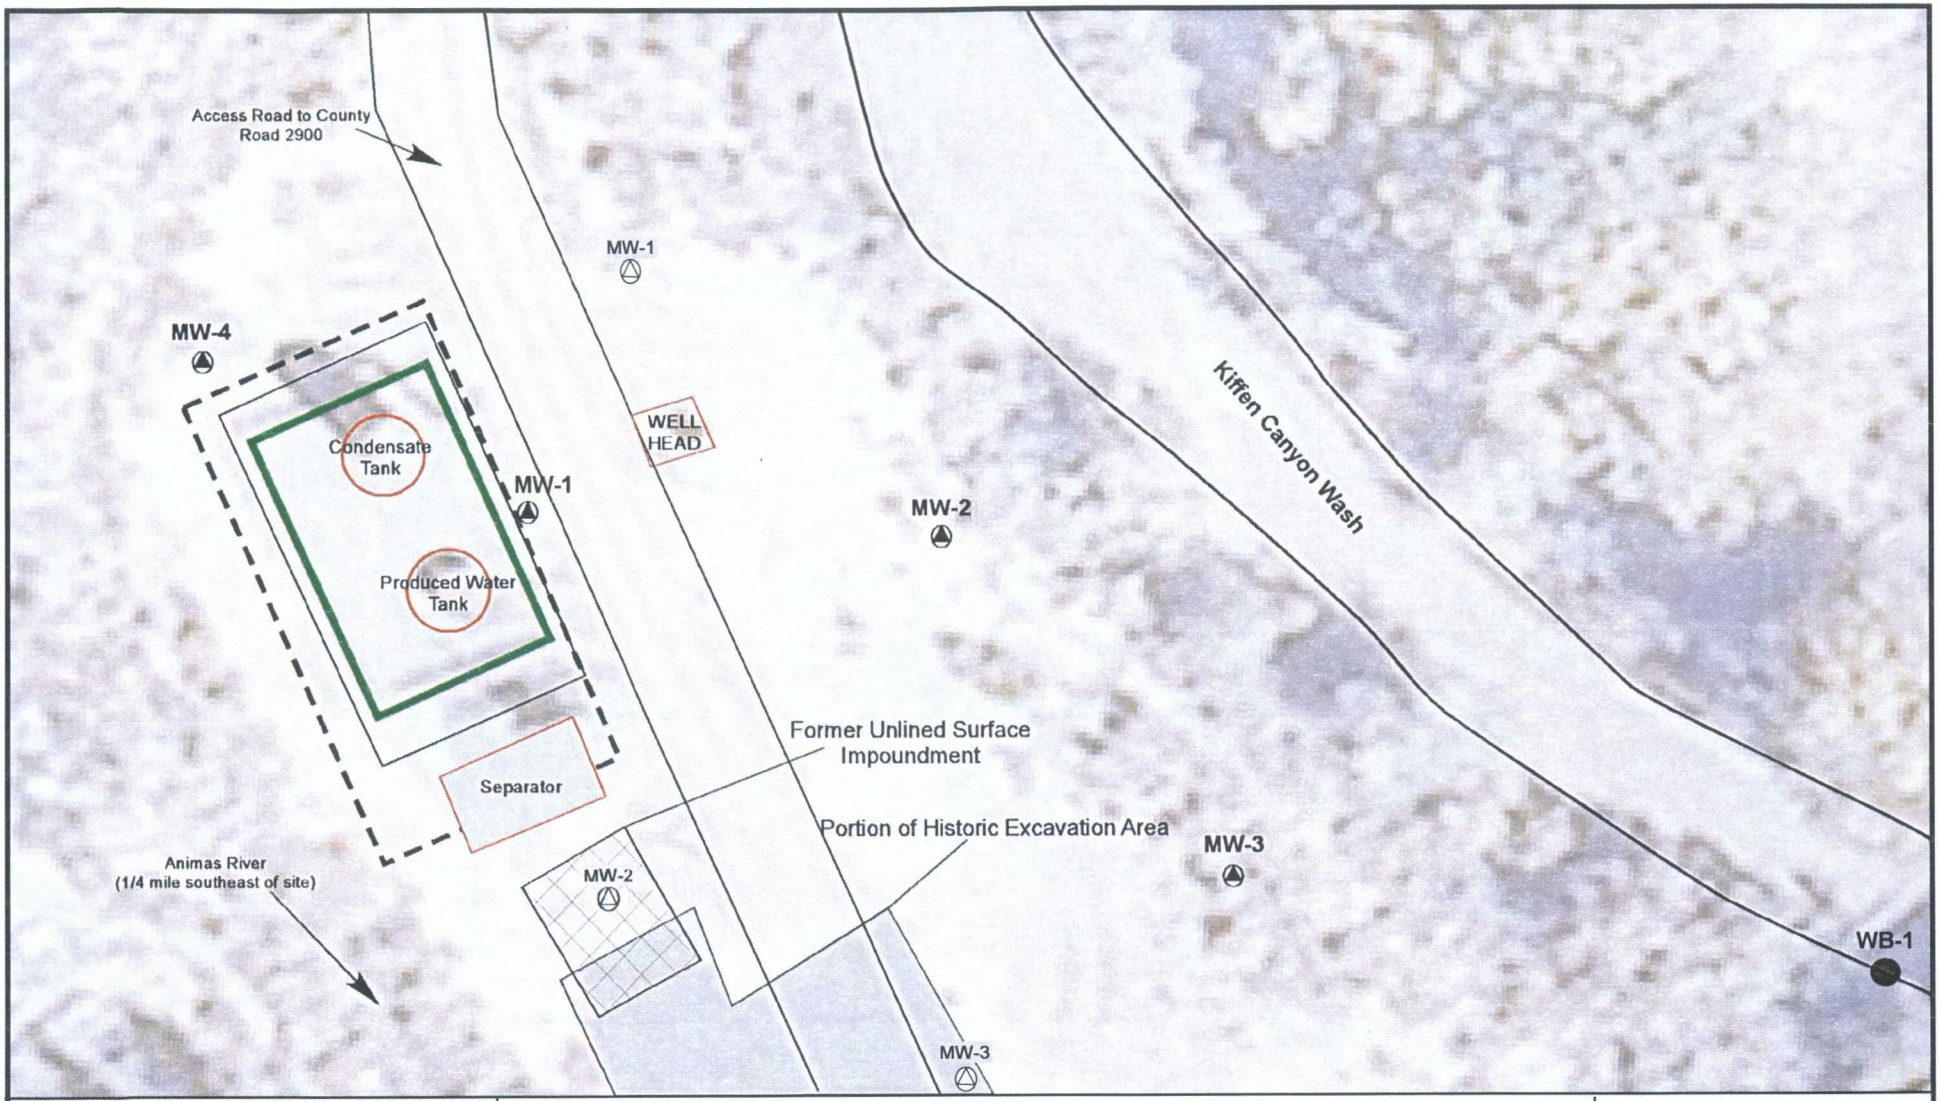
FIGURE 2:
SITE DETAIL MAP
CONOCOPHILLIPS COMPANY
RANDLEMAN #1
GAS PRODUCTION WELL
Sec 13, T31N, R11W
Aztec, New Mexico

In April 1997, an unlined surface impoundment (**Figure 2**) was discovered to have been impacted by petroleum hydrocarbons. On April 29, 1997, excavation of the soil beneath the impoundment began; once complete, a total of 613 cubic yards of hydrocarbon impacted soil were removed and landfarmed at the nearby Randleman No. 3 site (Williams 2002). Three monitor wells were installed at the Site on May 14, 1997, and quarterly groundwater monitoring was conducted through March 1998. Evaluation of groundwater monitoring results initiated another excavation in April 1998 of 2,220 cubic yards of hydrocarbon impacted soil "to address residual soil contamination extending to the south of the original excavated area" (Williams, 2002). Quarterly groundwater monitoring was continued through September 2000, and after 4 consecutive quarters of groundwater monitoring results below New Mexico Water Quality Control Commission (NMWQCC) groundwater quality standards for benzene, toluene, ethylbenzene, and total xylenes (BTEX), Williams Environmental Services (Williams) requested that the New Mexico Oil Conservation Division (OCD) grant closure status to the Site. In June 2002, OCD granted closure for the Site, provided that Williams plug and abandon all Site groundwater monitor wells according to OCD standards (NMEMNRD, 2002). The historical excavation area and historical groundwater monitor wells are displayed in **Figure 2**.

On February 23, 2009, a release of approximately 60 barrels of condensate occurred as a result of a hole in an on-Site production tank. Envirotech Inc. of Farmington, NM (Envirotech) excavated an area of approximately 42 ft. x 51 ft. x 7 ft. deep on February 26, 2009. Seven composite soil samples were collected during excavation activities and were field analyzed for total petroleum hydrocarbons (TPH) using Environmental Protection Agency (EPA) Method 418.1. Additionally, samples were field analyzed for organic vapors using a photoionization detector (PID) and heated headspace techniques. TPH results ranged from 8 to 1,080 parts per million (ppm) in the walls of the excavation. Organic vapor concentrations ranged from 6.8 ppm to 898 ppm. Due to levels of TPH and organic vapors above OCD action levels, the excavation was continued on February 27, 2009 (Envirotech, 2009). The total area of excavation measured 81 ft x 43 ft x 20 ft. deep. The excavation area is depicted in **Figure 2**.

On March 2, 2009, groundwater was found seeping into the southeast corner of the excavation at a depth of approximately 20 feet bgs. A vacuum truck operated by Rock Springs was contracted by Envirotech to collect groundwater from the excavation; approximately 10 gallons of water were removed. After removal of collected groundwater, Envirotech obtained a soil sample from the southeast corner of the excavation at a depth of 20 feet bgs. TPH and organic vapor results were found to be above OCD action levels. During field analysis of the soil sample, groundwater continued to seep into the excavation. Groundwater was again removed from the excavation, and additional excavation was performed to obtain a soil sample below OCD action levels. A groundwater sample was collected and sent for laboratory analysis of volatile organic compounds by EPA Method 8260. The groundwater sample was found to contain benzene, total xylenes and total naphthalenes above NMWQCC groundwater quality standards. Soon after the groundwater sample was taken, the excavation caved in making further water removal via the vacuum truck impossible (Envirotech, 2009). The excavation area is depicted in **Figure 2**.

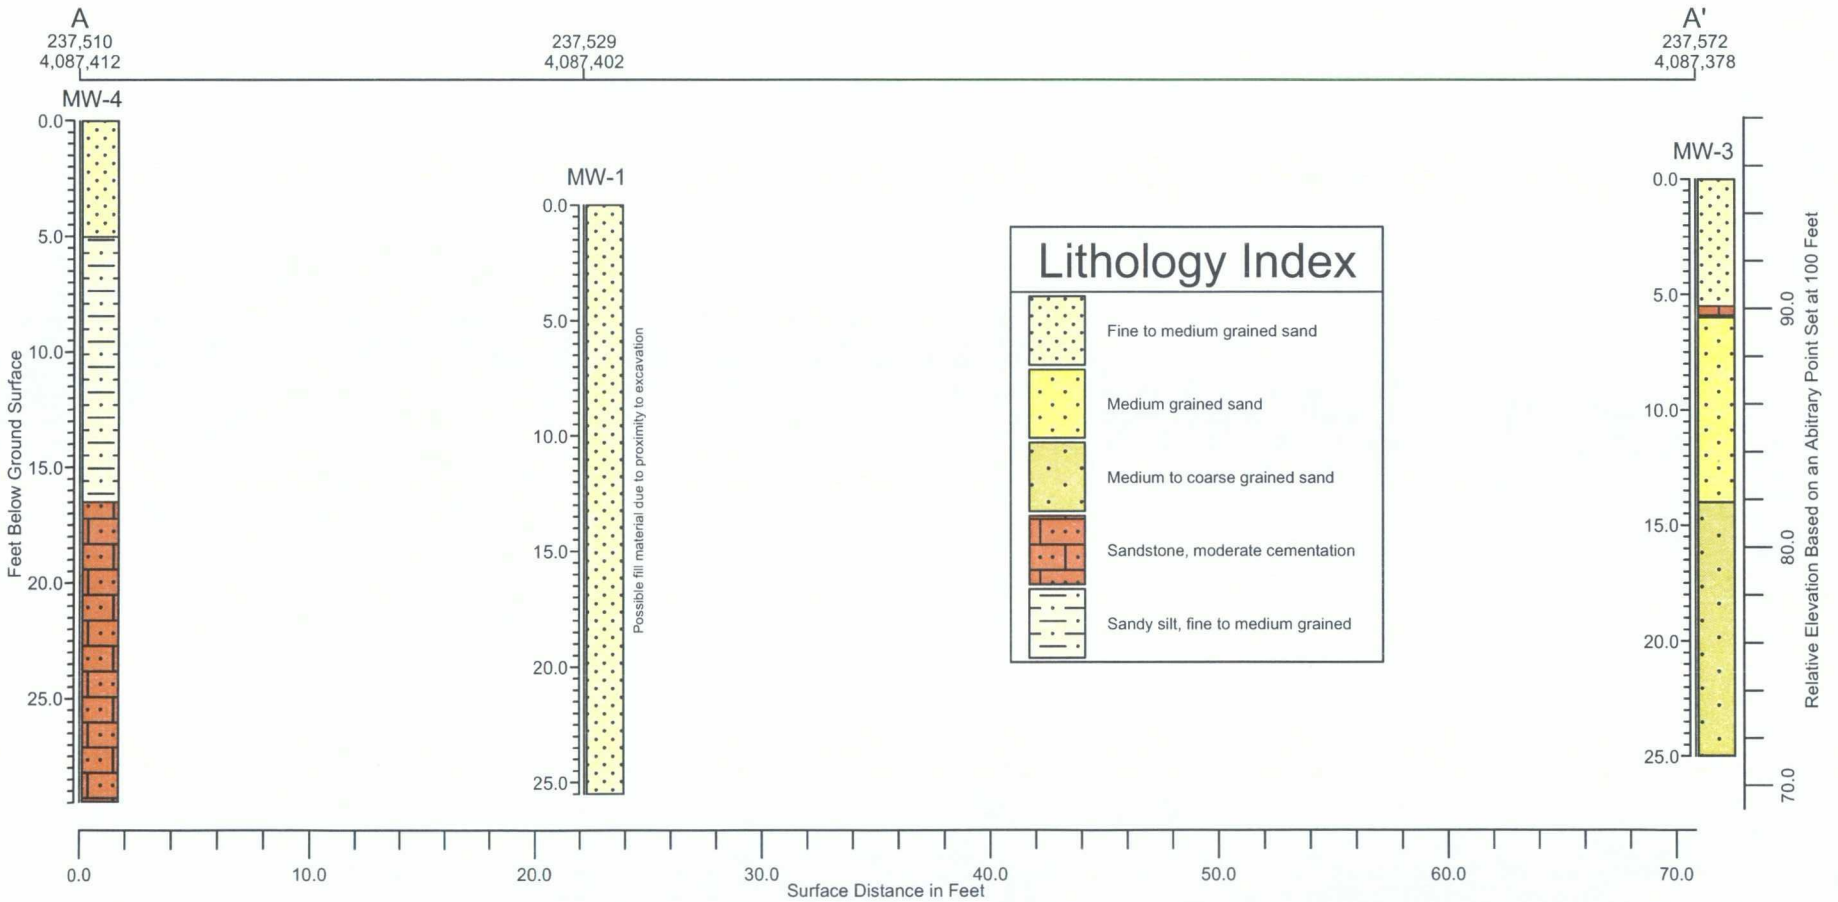
Figure 3. Randleman #1 - Cross-Section A-A'

Tetra Tech installed four groundwater monitor wells at the Site between June 9, 2009 and June 10, 2009. A generalized geologic cross section was produced using soil boring data collected during monitoring well installation (**Figure 3**). Following drilling activities in June 2009, the casings for Site monitor wells were surveyed using an arbitrary reference-elevation of 100 feet above mean sea level (amsl). Data obtained from the Site survey is used in conjunction with quarterly monitoring data to produce groundwater elevation maps for the Site (**Figure 4**). Groundwater flow direction at the Site is to the east/southeast.

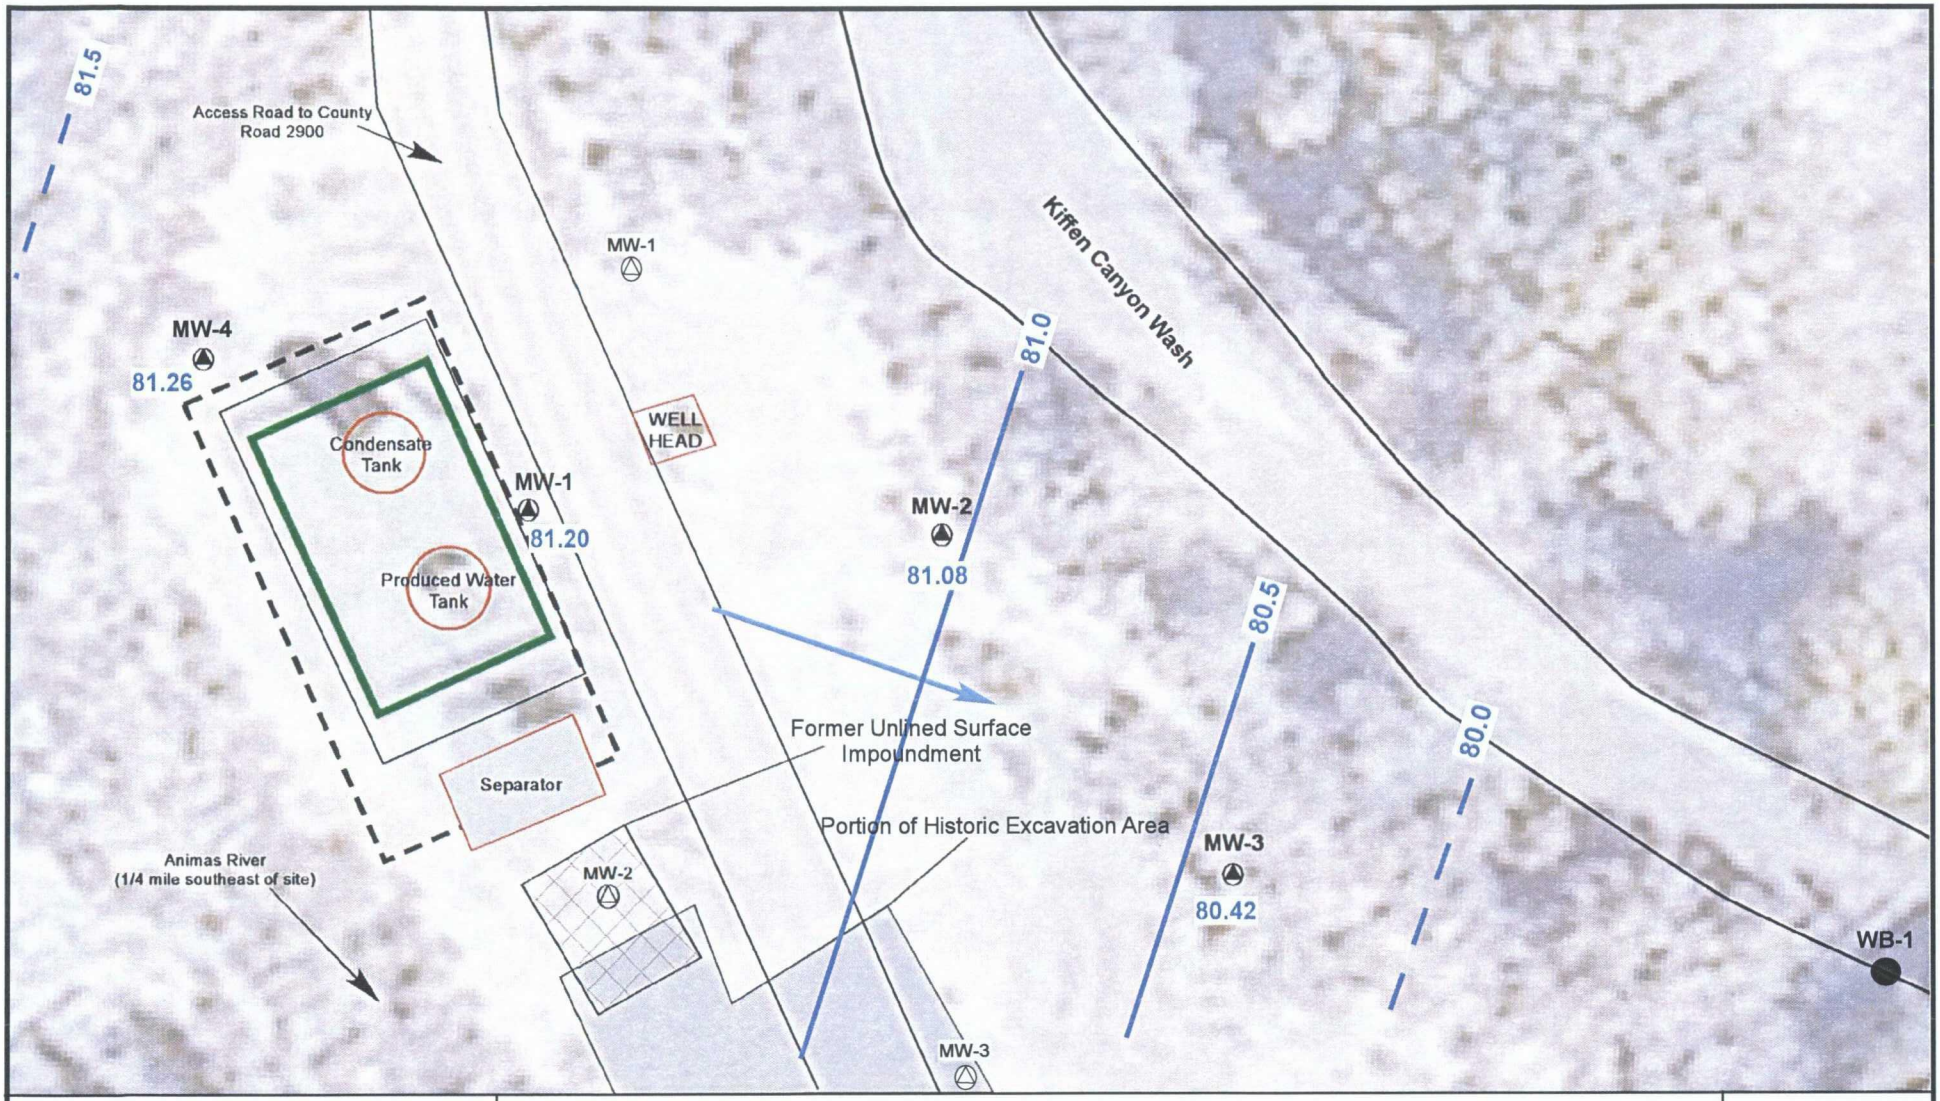
FIGURE 4:
GROUNDWATER ELEVATION MAP - June 2010
CONOCOPHILLIPS COMPANY
RANDLEMAN #1
GAS PRODUCTION WELL
Sec 13, T31N, R11W
Aztec, New Mexico

A groundwater sampling event was conducted at the Site on June 9, 2010. Prior to collection of groundwater samples from Monitor Wells MW-1, MW-2, MW-3 and MW-4, depth to groundwater in each well was measured using a dual interface probe (**Table 2**). A groundwater elevation contour map reflecting June 9, 2010 groundwater elevation is presented as **Figure 4**.

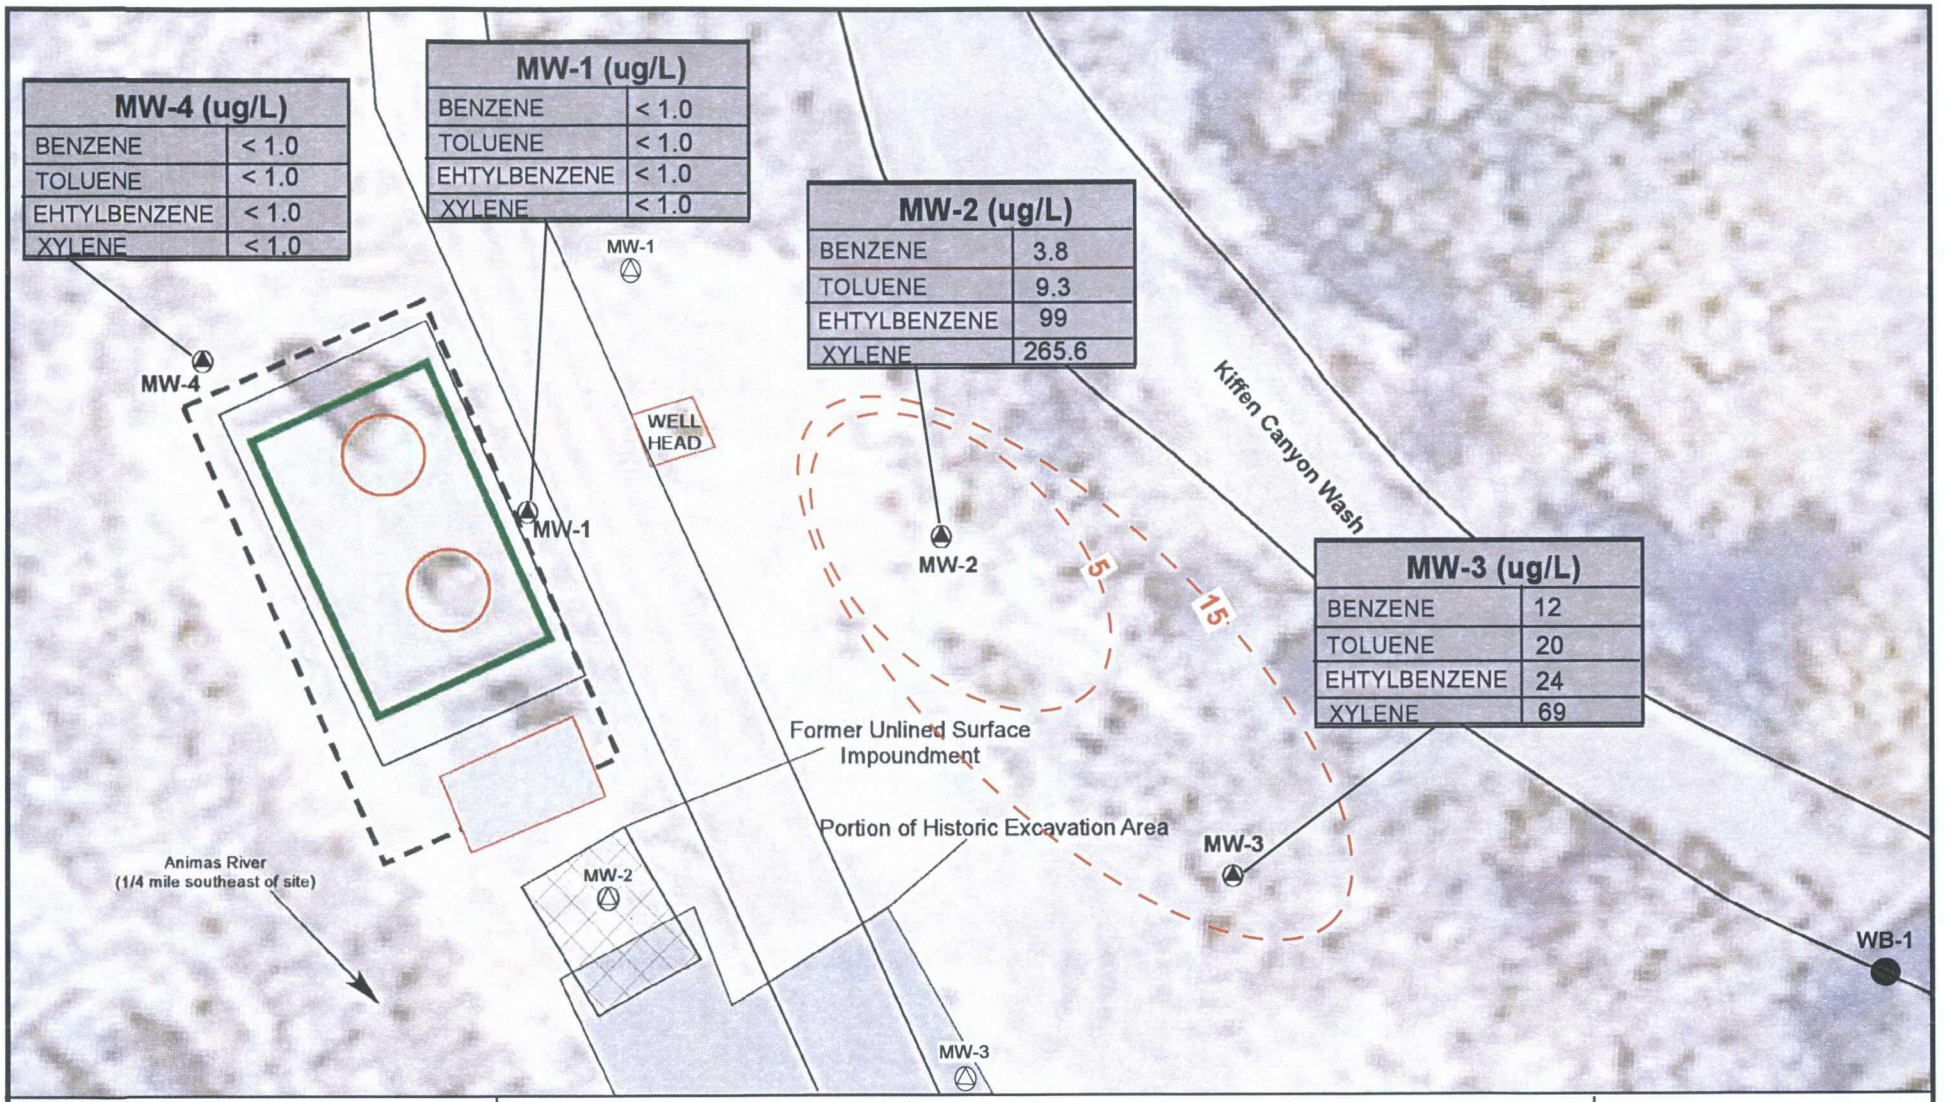
FIGURE 5:
BTEX GROUNDWATER CONCENTRATION MAP
June 2010
CONOCOPHILLIPS COMPANY
RANDLEMAN #1
GAS PRODUCTION WELL
Sec 13, T31N, R11W
Aztec, New Mexico

- **Benzene**
  - The human health NMWQCC groundwater quality standard for benzene is 10 µg/L. Groundwater samples collected from Monitor Well MW-3 was above the standard with a concentration of 12 µg/L.
- **Total Xylenes**
  - The human health NMWQCC groundwater quality standard for total xylenes is 620 µg/L. The groundwater samples collected from all Monitor Wells were below the NMWQCC standard for total xylenes; representing the second quarter of NMWQCC compliance for total xylenes at the Site.
- **Total Dissolved Solids**
  - The human health NMWQCC groundwater quality standard for total dissolved solids is 1,000 mg/L. Groundwater samples collected from Monitor Wells MW-1, MW-2, MW-3 and MW-4 were above the standard with concentrations of 3,340 µg/L; 2,590 µg/L; 2,200 µg/L and 4,720 µg/L, respectively.

The corresponding laboratory analytical report for the June 2010 groundwater sampling event, including quality control summaries, is included in **Appendix B**. A map showing BTEX concentrations in groundwater from Site monitoring wells during the April 2010 groundwater sampling event is included as **Figure 5**.

Tetra Tech recommends continued quarterly groundwater sampling at the Site in order to provide sufficient data for Site closure. Site closure will be requested when groundwater analytical results indicate that all constituents of concern are consistently below NMWQCC groundwater quality standards. Please contact Kelly Blanchard at 505-237-8440 or kelly.blanchard@tetratech.com if you have any questions or require additional information.
