1R - 427-07

RE: **ICP Report and Termination Request**
Rice Operating Company – EME SWD System
EME Jct. O-24 (1R427-07): UL/O sec. 24 T20S R36E

EME jct. O-24

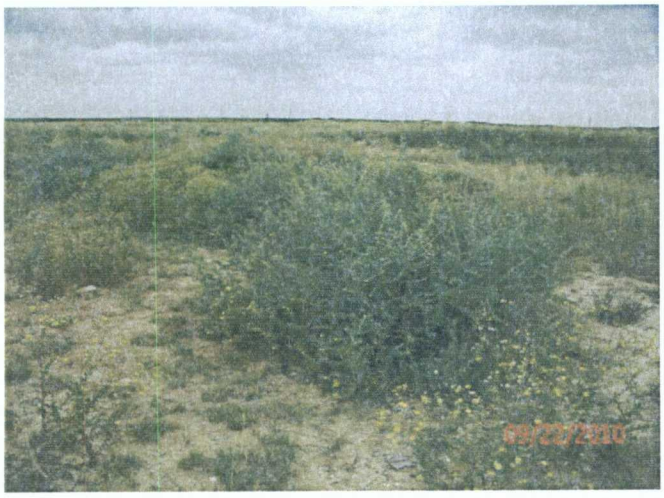
Facing east

Based on the fact that there is no groundwater below the former O-24 junction box, the site will in no way contribute to groundwater impairment. In addition, the vegetation has returned (see Appendix D) and will provide an evapo-transpiration layer at the site further inhibiting the downward movement of the chlorides. Plants capture water through their roots and so reduce the amount of water infiltrating below the root zone and transporting residual chloride to groundwater. Because there is no groundwater below the site and vegetation has returned, RECS requests Termination status for this site.
