RE: 2013 Annual Report Submittals
San Juan River Basin Program - Pit Sites

2013 ANNUAL GROUNDWATER REPORT

K-27 Line Drip
Meter Code: LD072
T25N, R6W, Sec4, Unit E

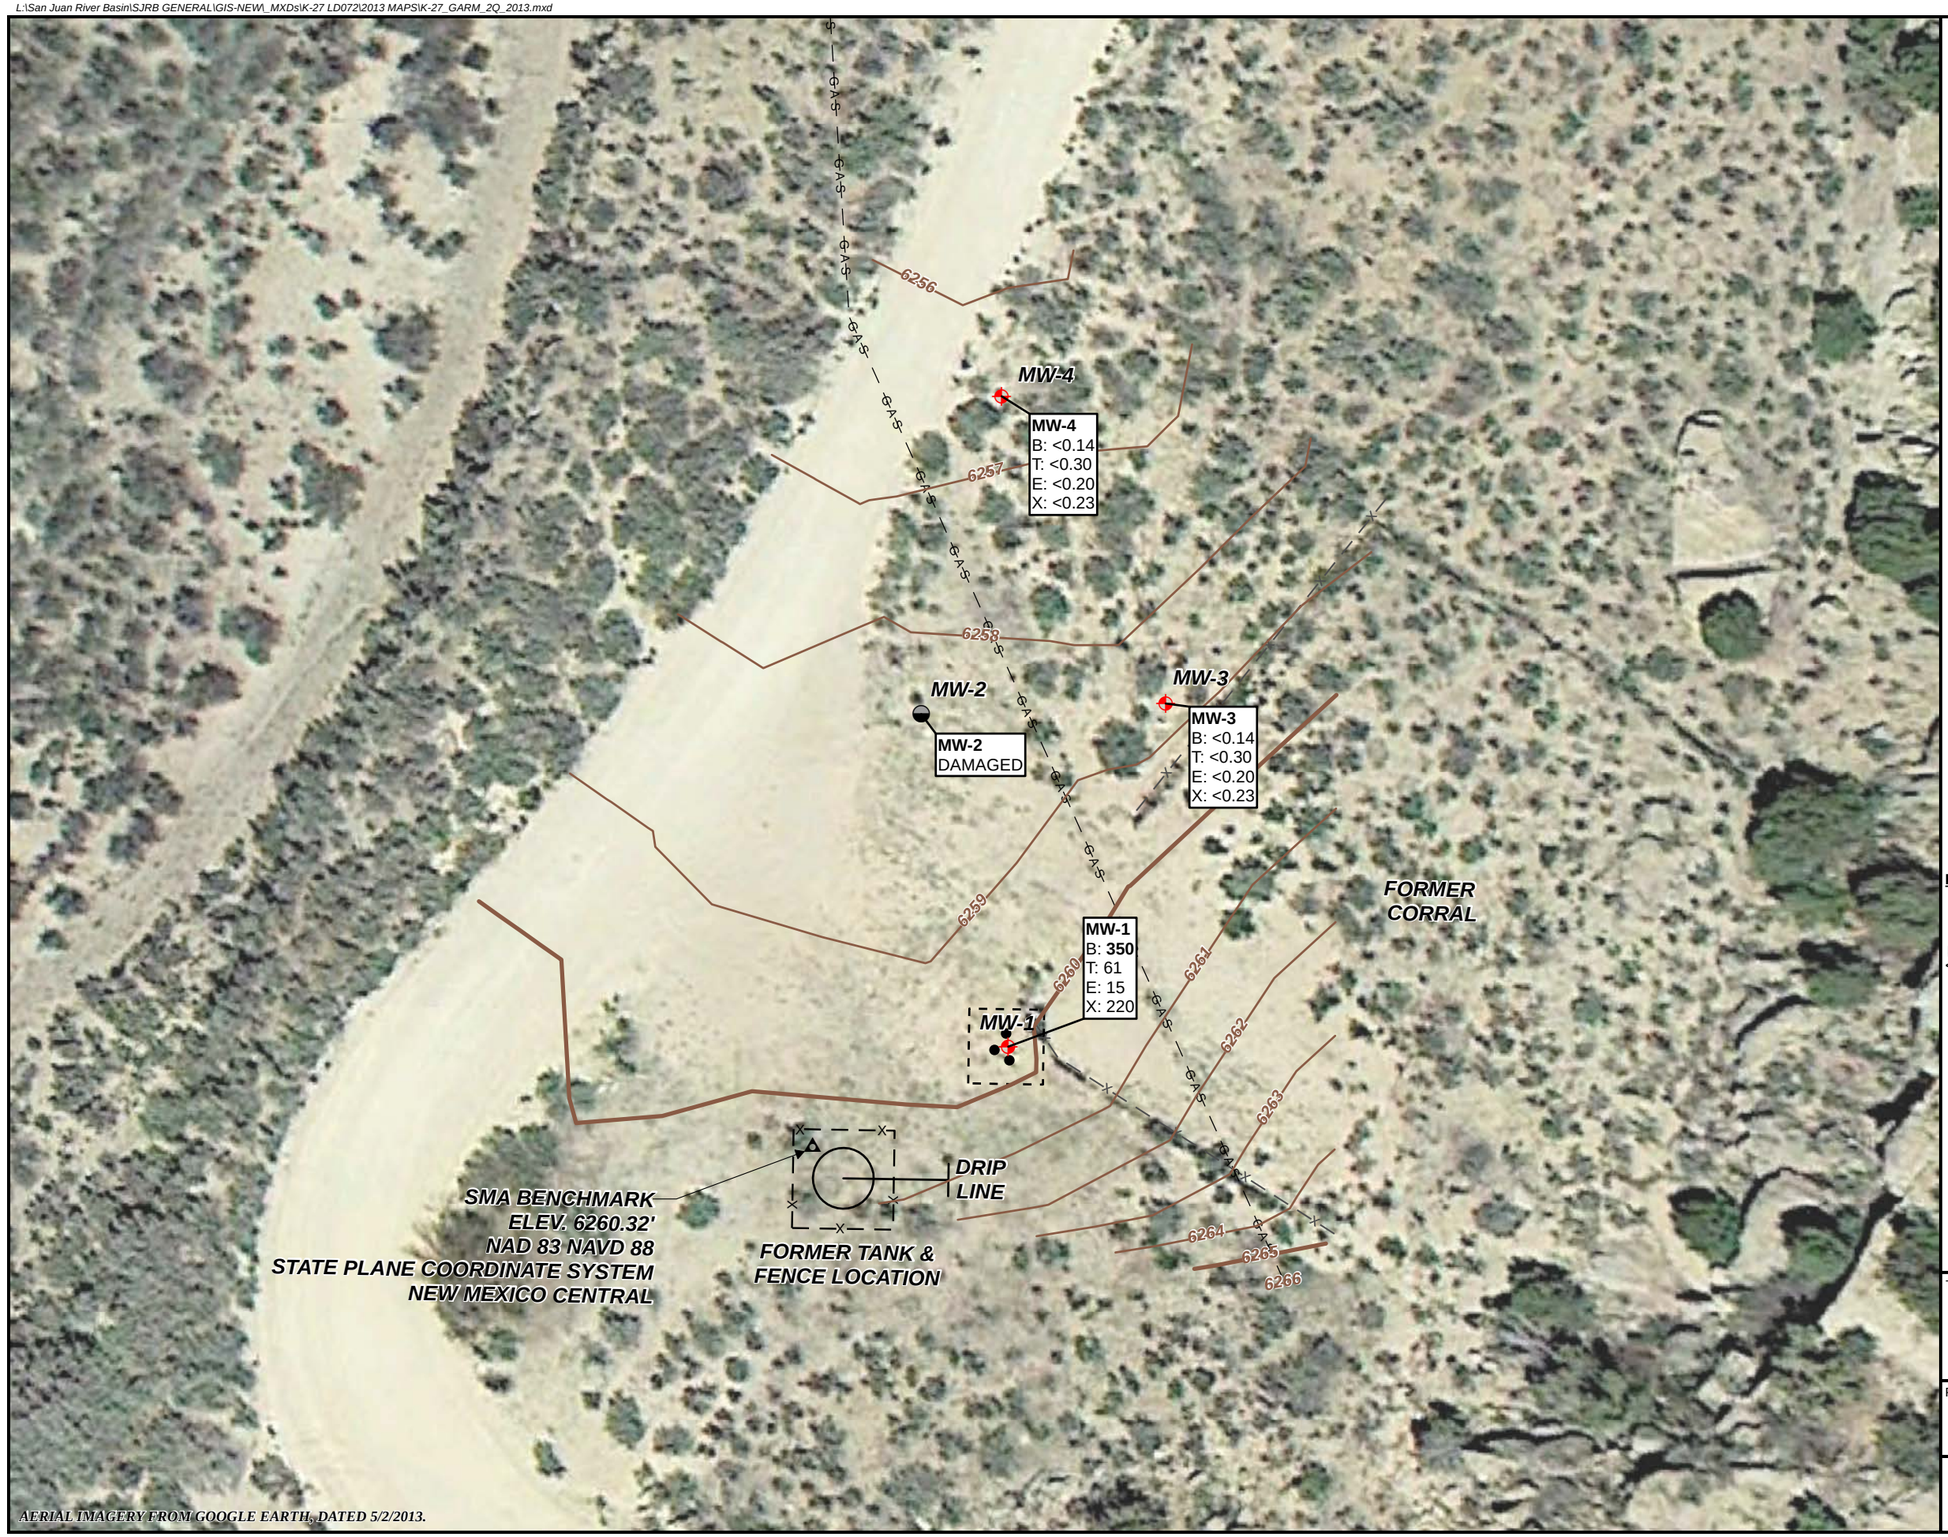
Figure No.: 1

- Concentrations of benzene in groundwater collected from MW-1 remained above the New Mexico Water Quality Control Commission (NMWQCC) standard for each of the three 2013 quarterly sampling events. Toluene, ethylbenzene, and total xylenes concentrations were below NMWQCC standards at MW-1 for each sampling events.

- Monitoring well MW-2 is damaged and cannot be sampled or gauged.

TITLE:
K27 LD072
GROUNDWATER ANALYTICAL RESULTS
SAMPLED JUNE 5, 2013

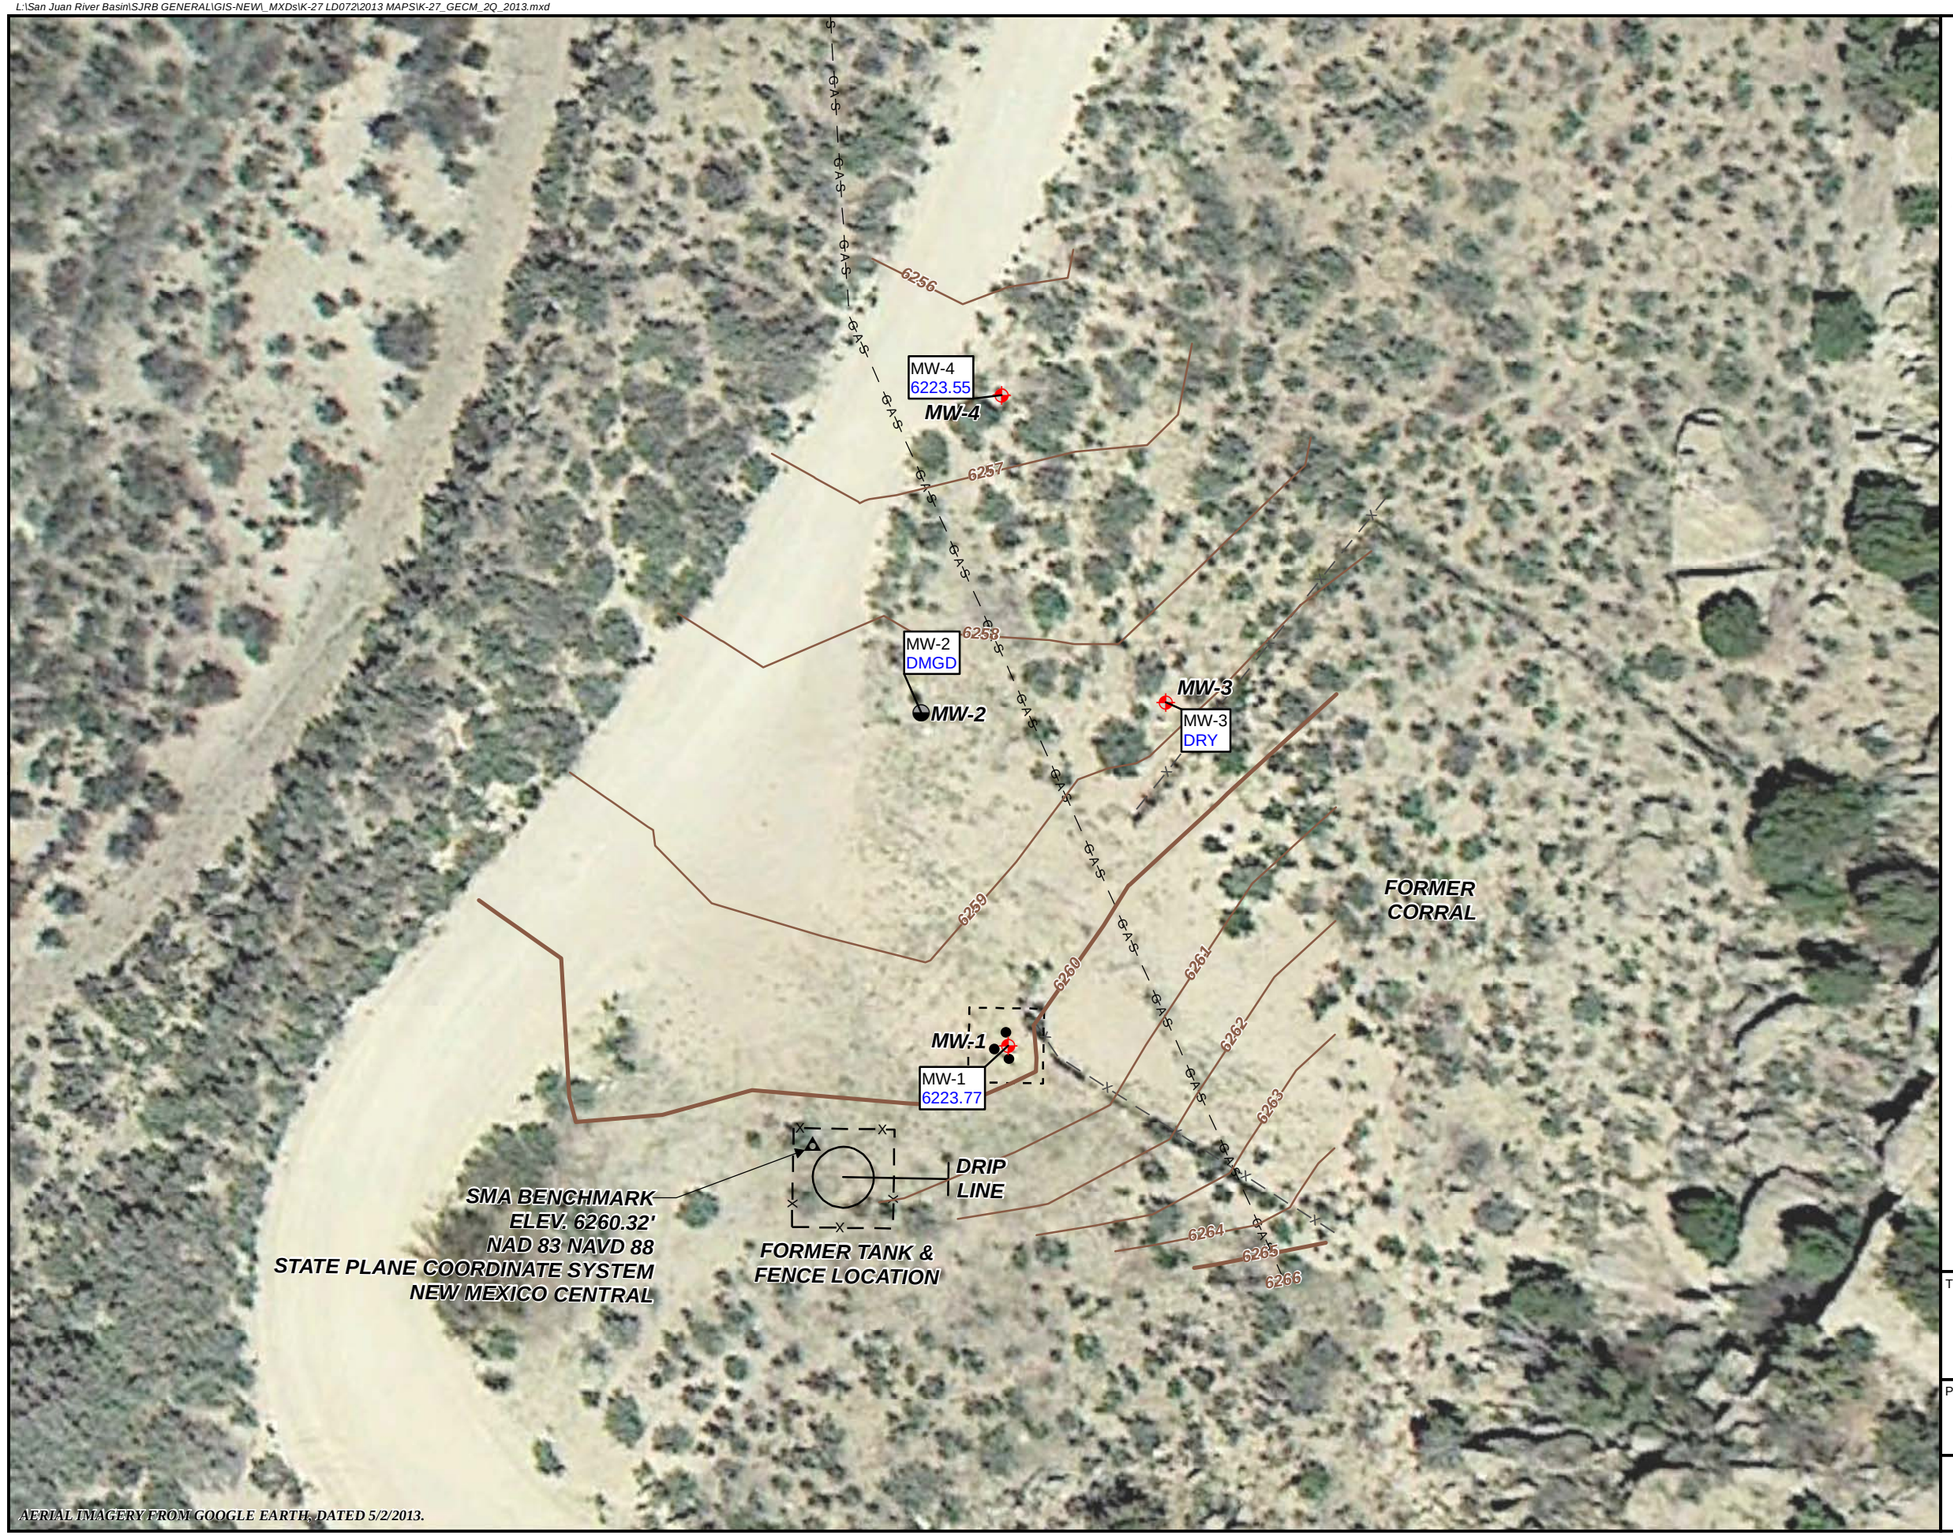
Figure No.: 2

- The groundwater flow direction has historically been to the northeast at the Site; however, since only two wells had groundwater measurements, no groundwater contour or flow direction is shown on the Groundwater Elevation figures (see Figures 2, 4, and 6). Water measured in monitoring well MW-3 during the June sampling event appears to be condensation or groundwater accumulated in the sump at the bottom of the monitoring well, and not groundwater representative of the water bearing formation.

TITLE:
K27 LD072
GROUNDWATER ELEVATION MAP
GAUGED JUNE 5, 2013

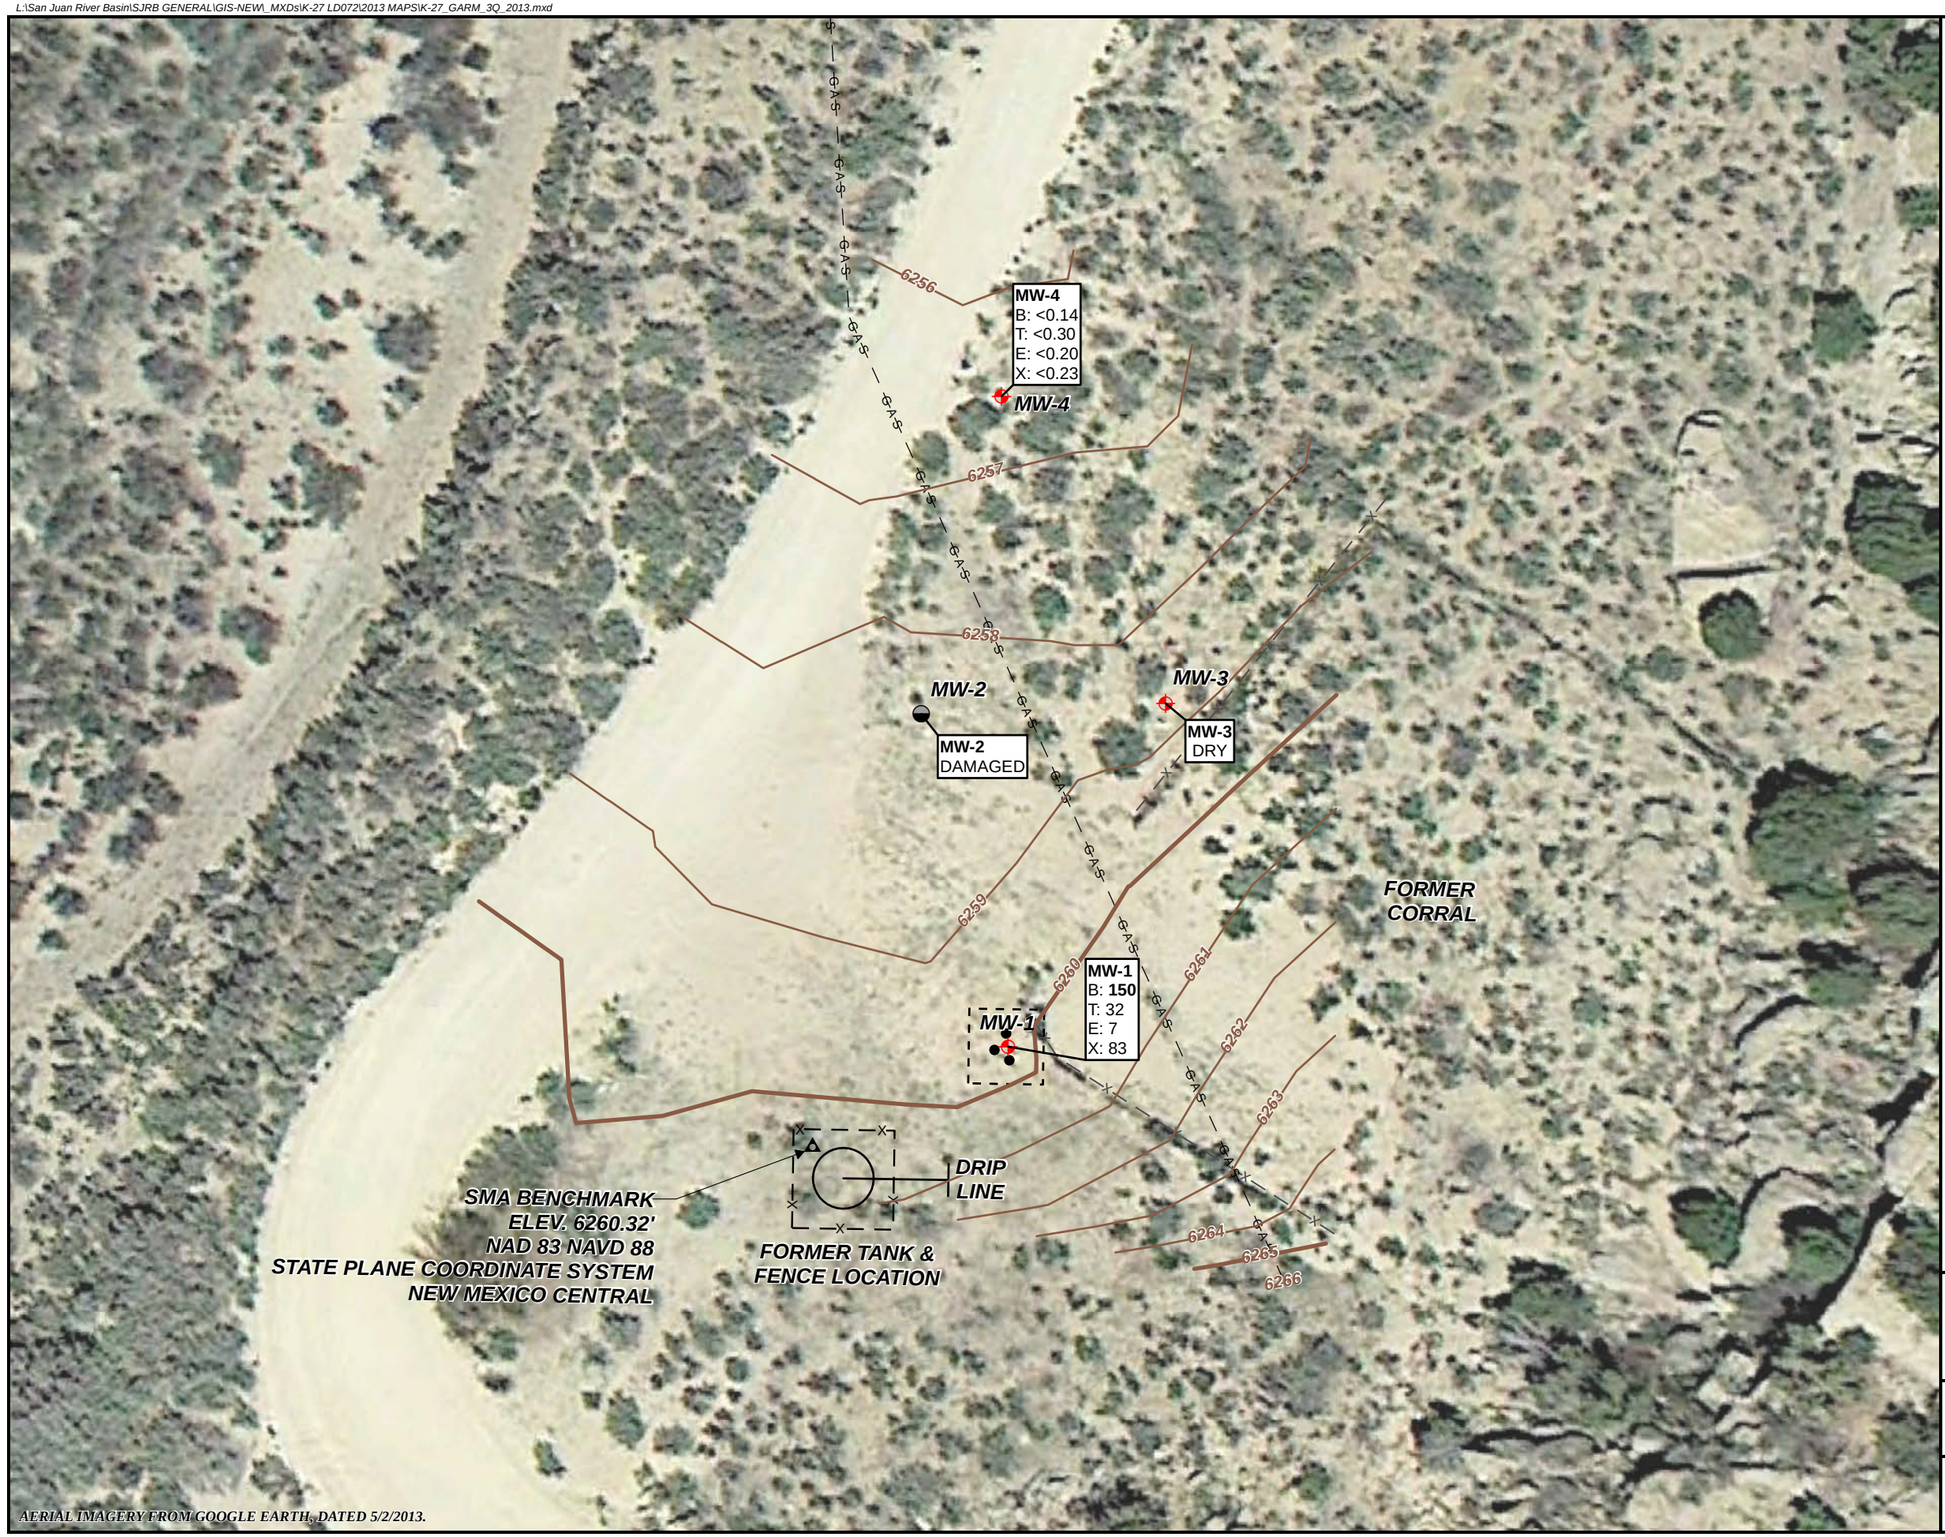
Figure No.: 3

TITLE:
K27 LD072
GROUNDWATER ANALYTICAL RESULTS
SAMPLED SEPTEMBER 10, 2013

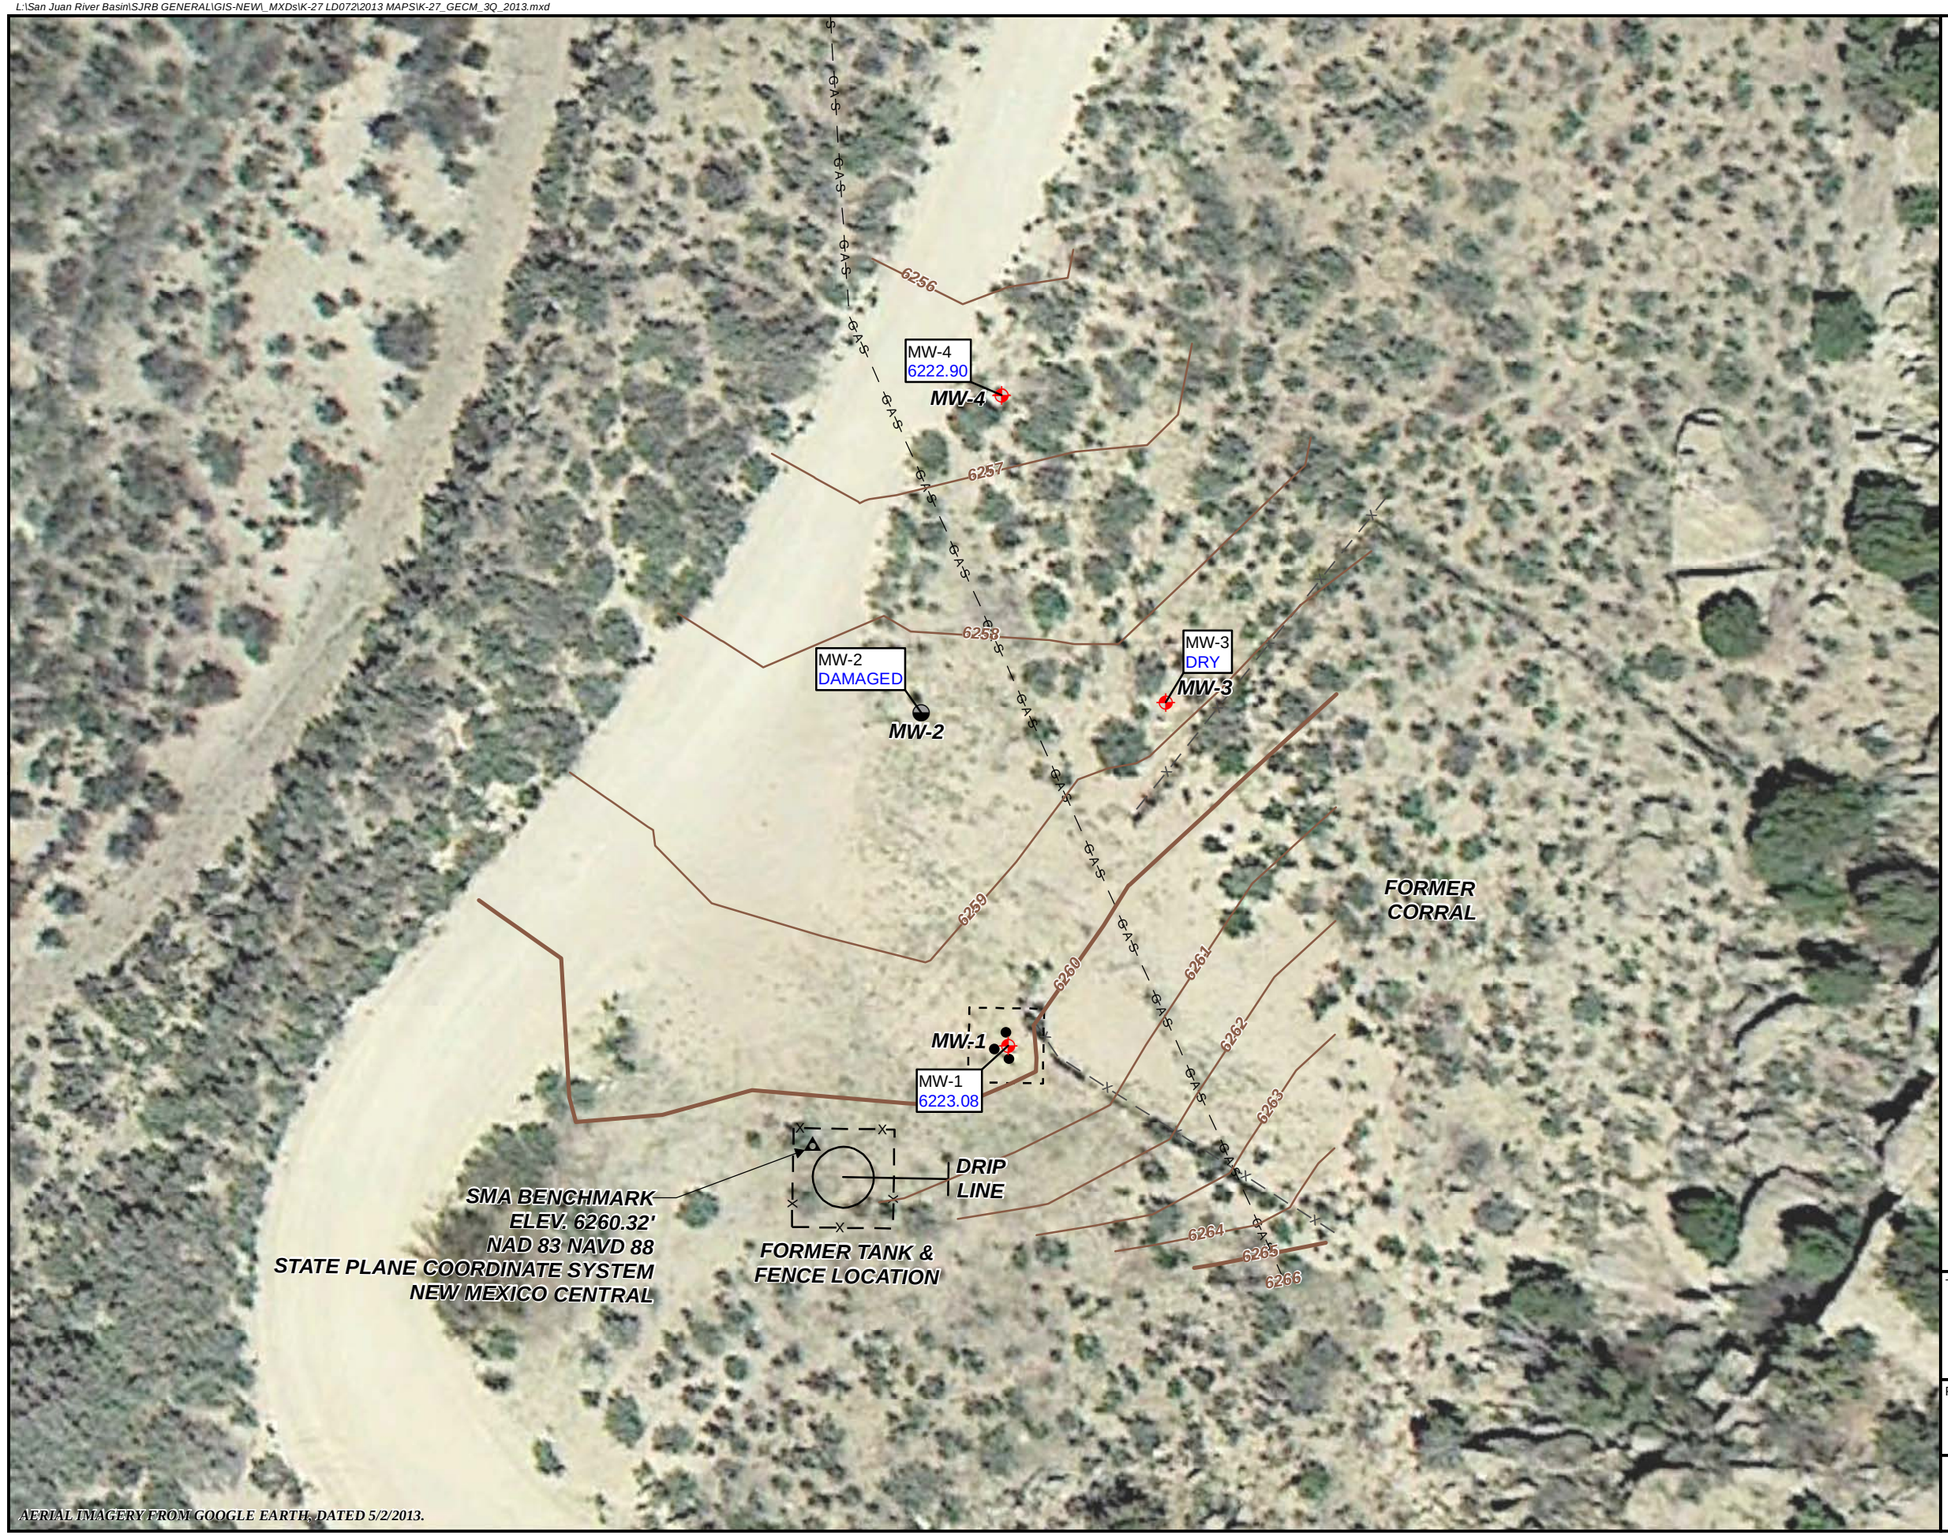
Figure No.: **4**

K27 LD072
GROUNDWATER ELEVATION MAP
GAUGED SEPTEMBER 9, 2013

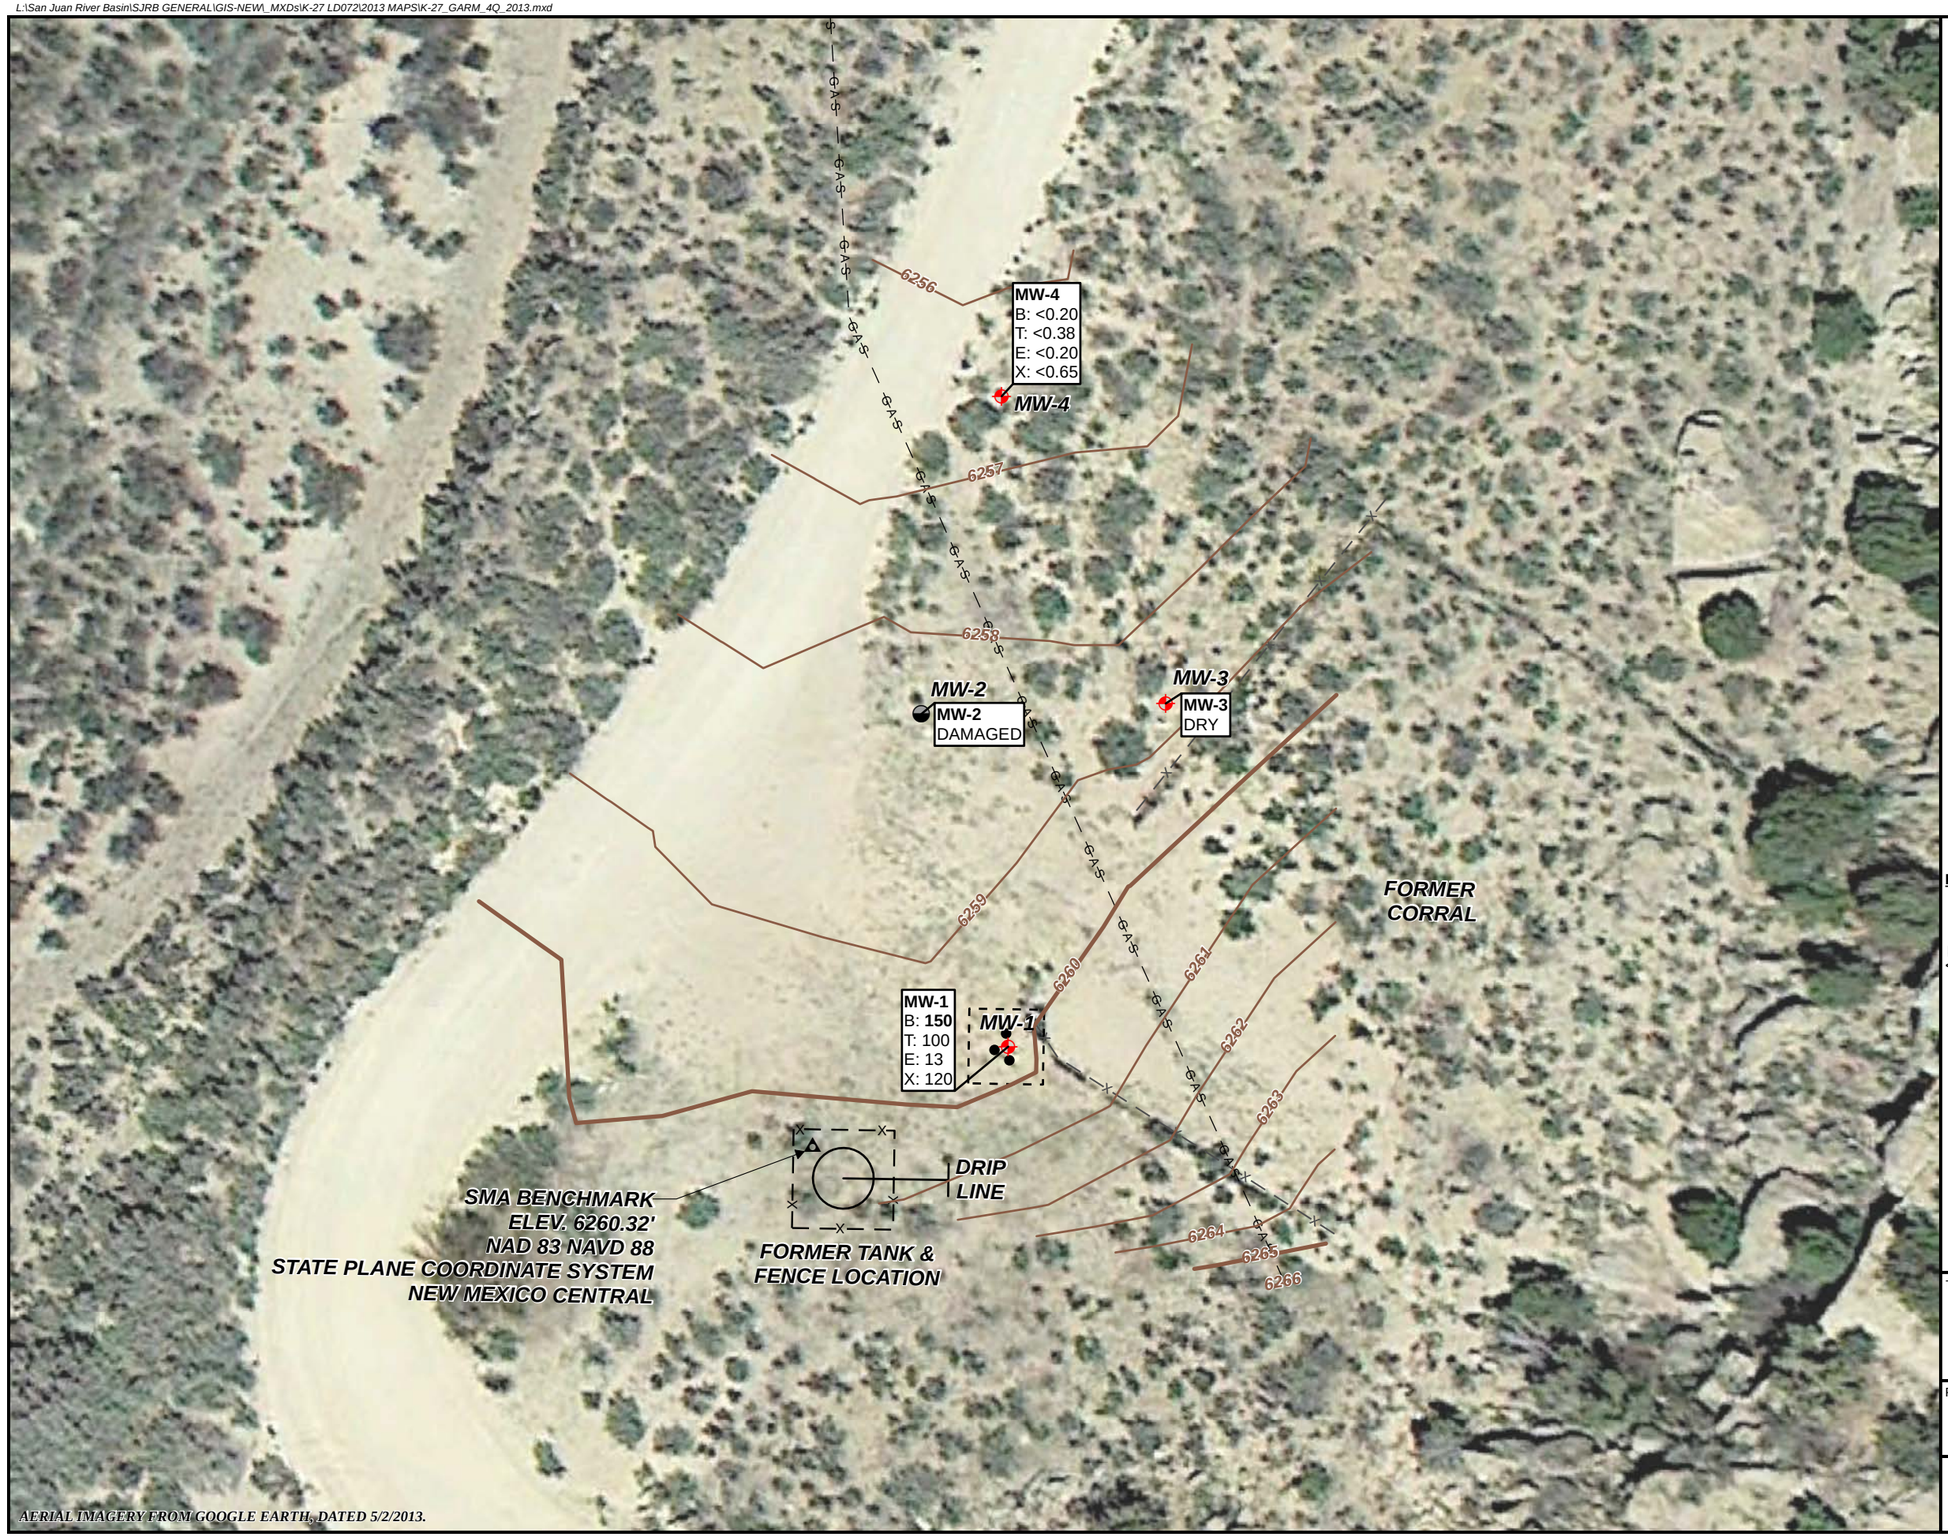
Figure No.: 5

TITLE:
K27 LD072
GROUNDWATER ANALYTICAL RESULTS
SAMPLED DECEMBER 11, 2013

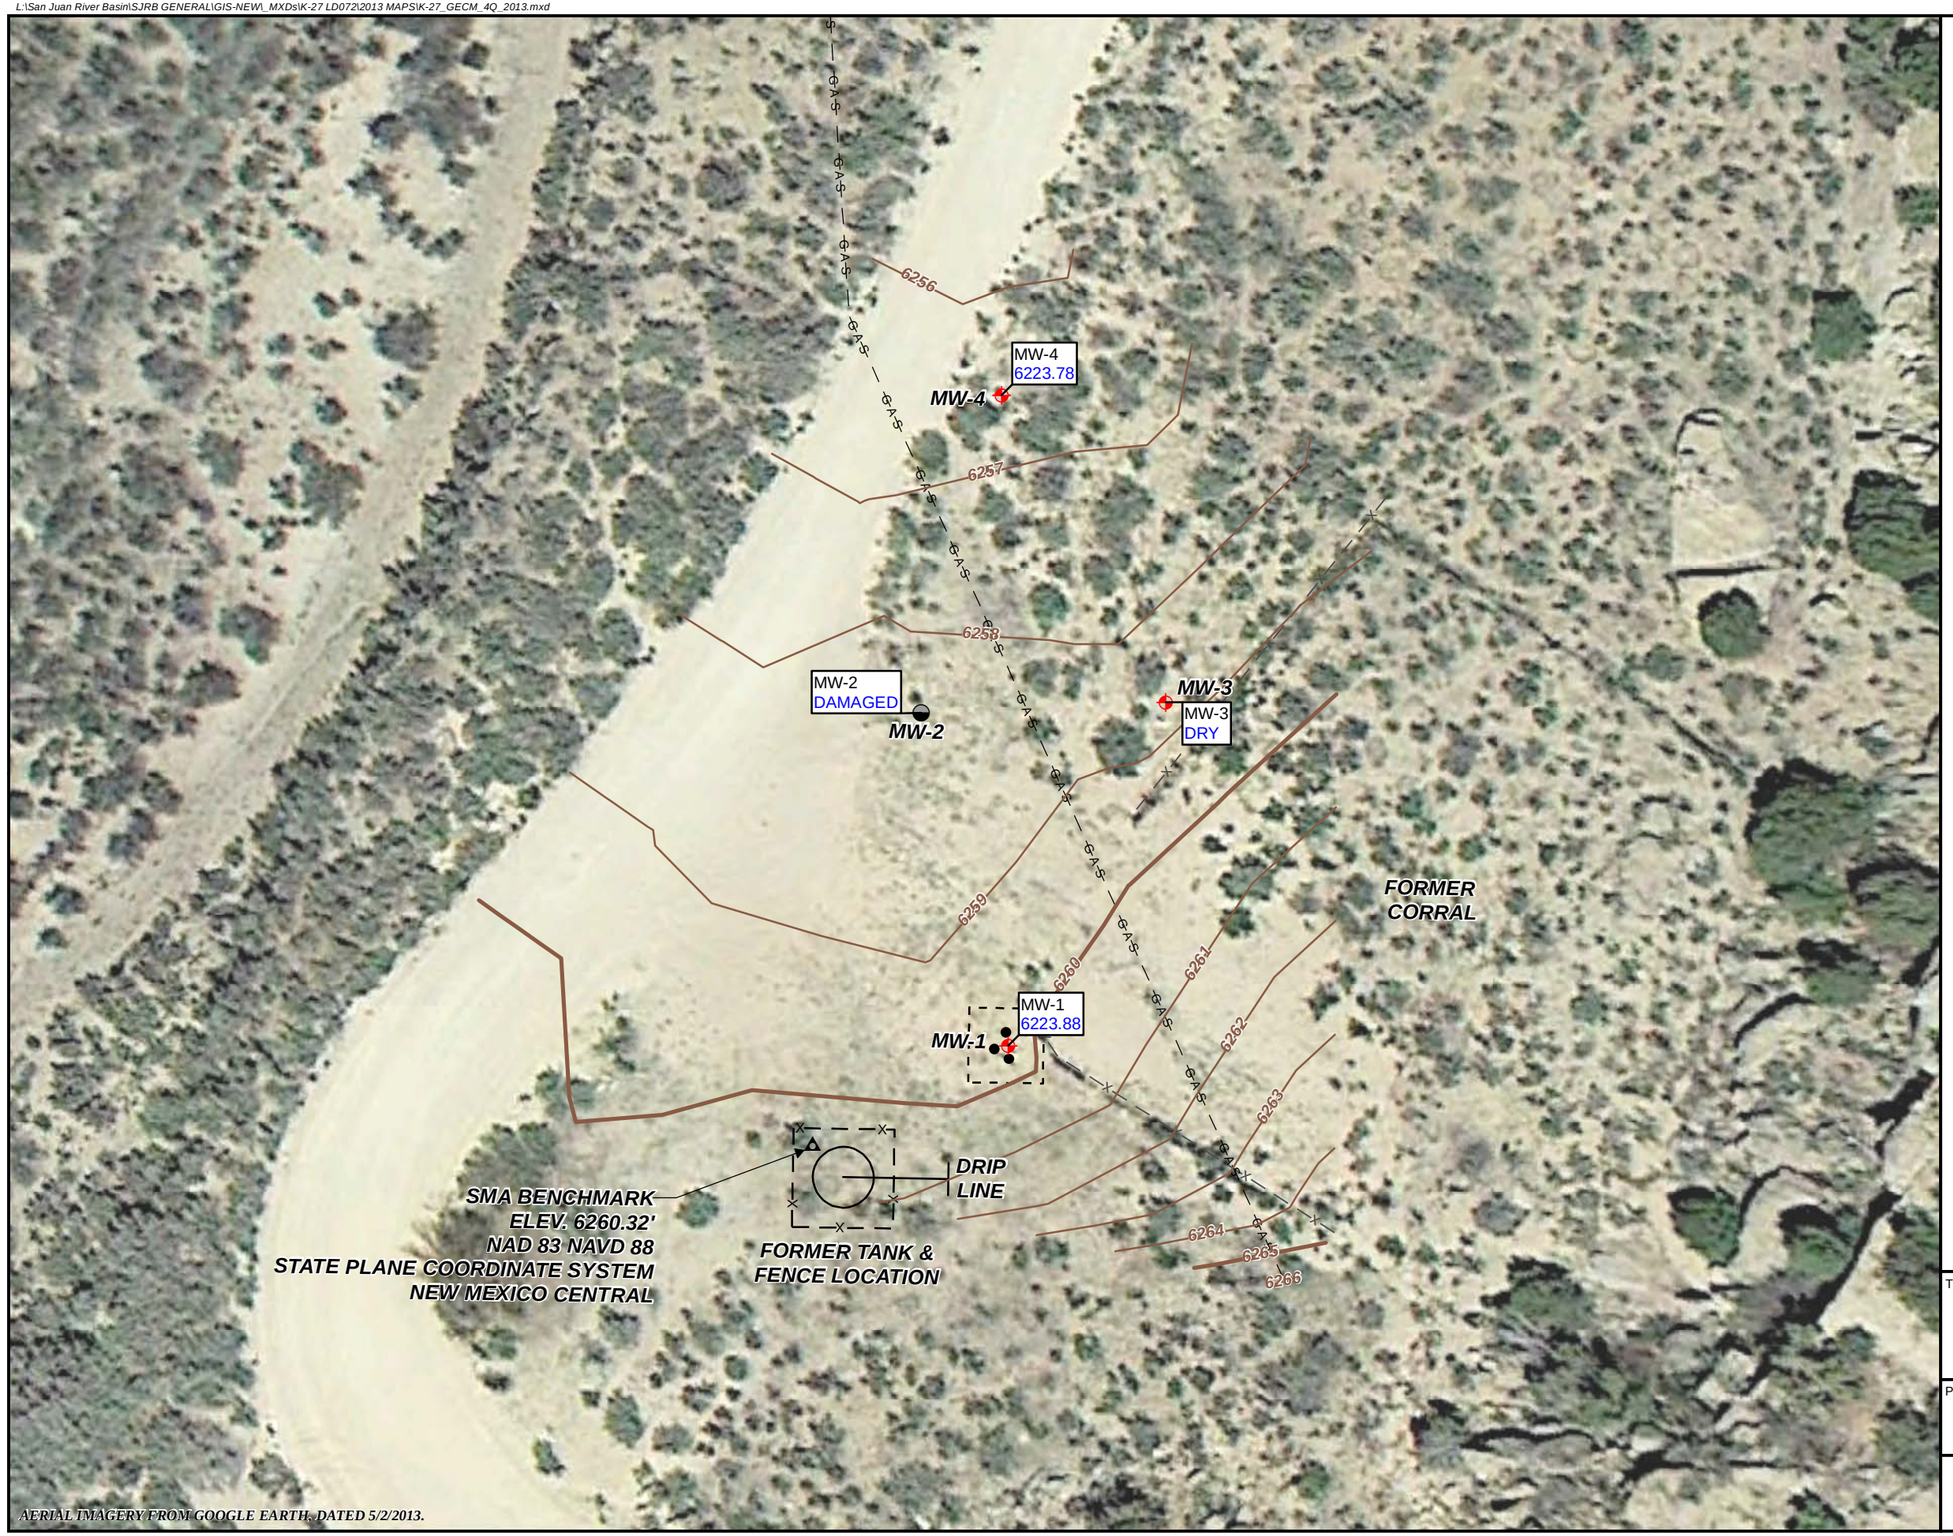
Figure No.: 6

K27 LD072
GROUNDWATER ELEVATION MAP
GAUGED DECEMBER 12, 2013
