Re: Mark Owen #9 Reserve Pit (AP #57)
2013 Annual Groundwater Monitoring and Site Assessment Report

2013 Annual Groundwater Monitoring and Site Assessment Report

Mark Owen No. 9
NMOCD AP No. 57

January 2015 • 046121 • Report No. 10

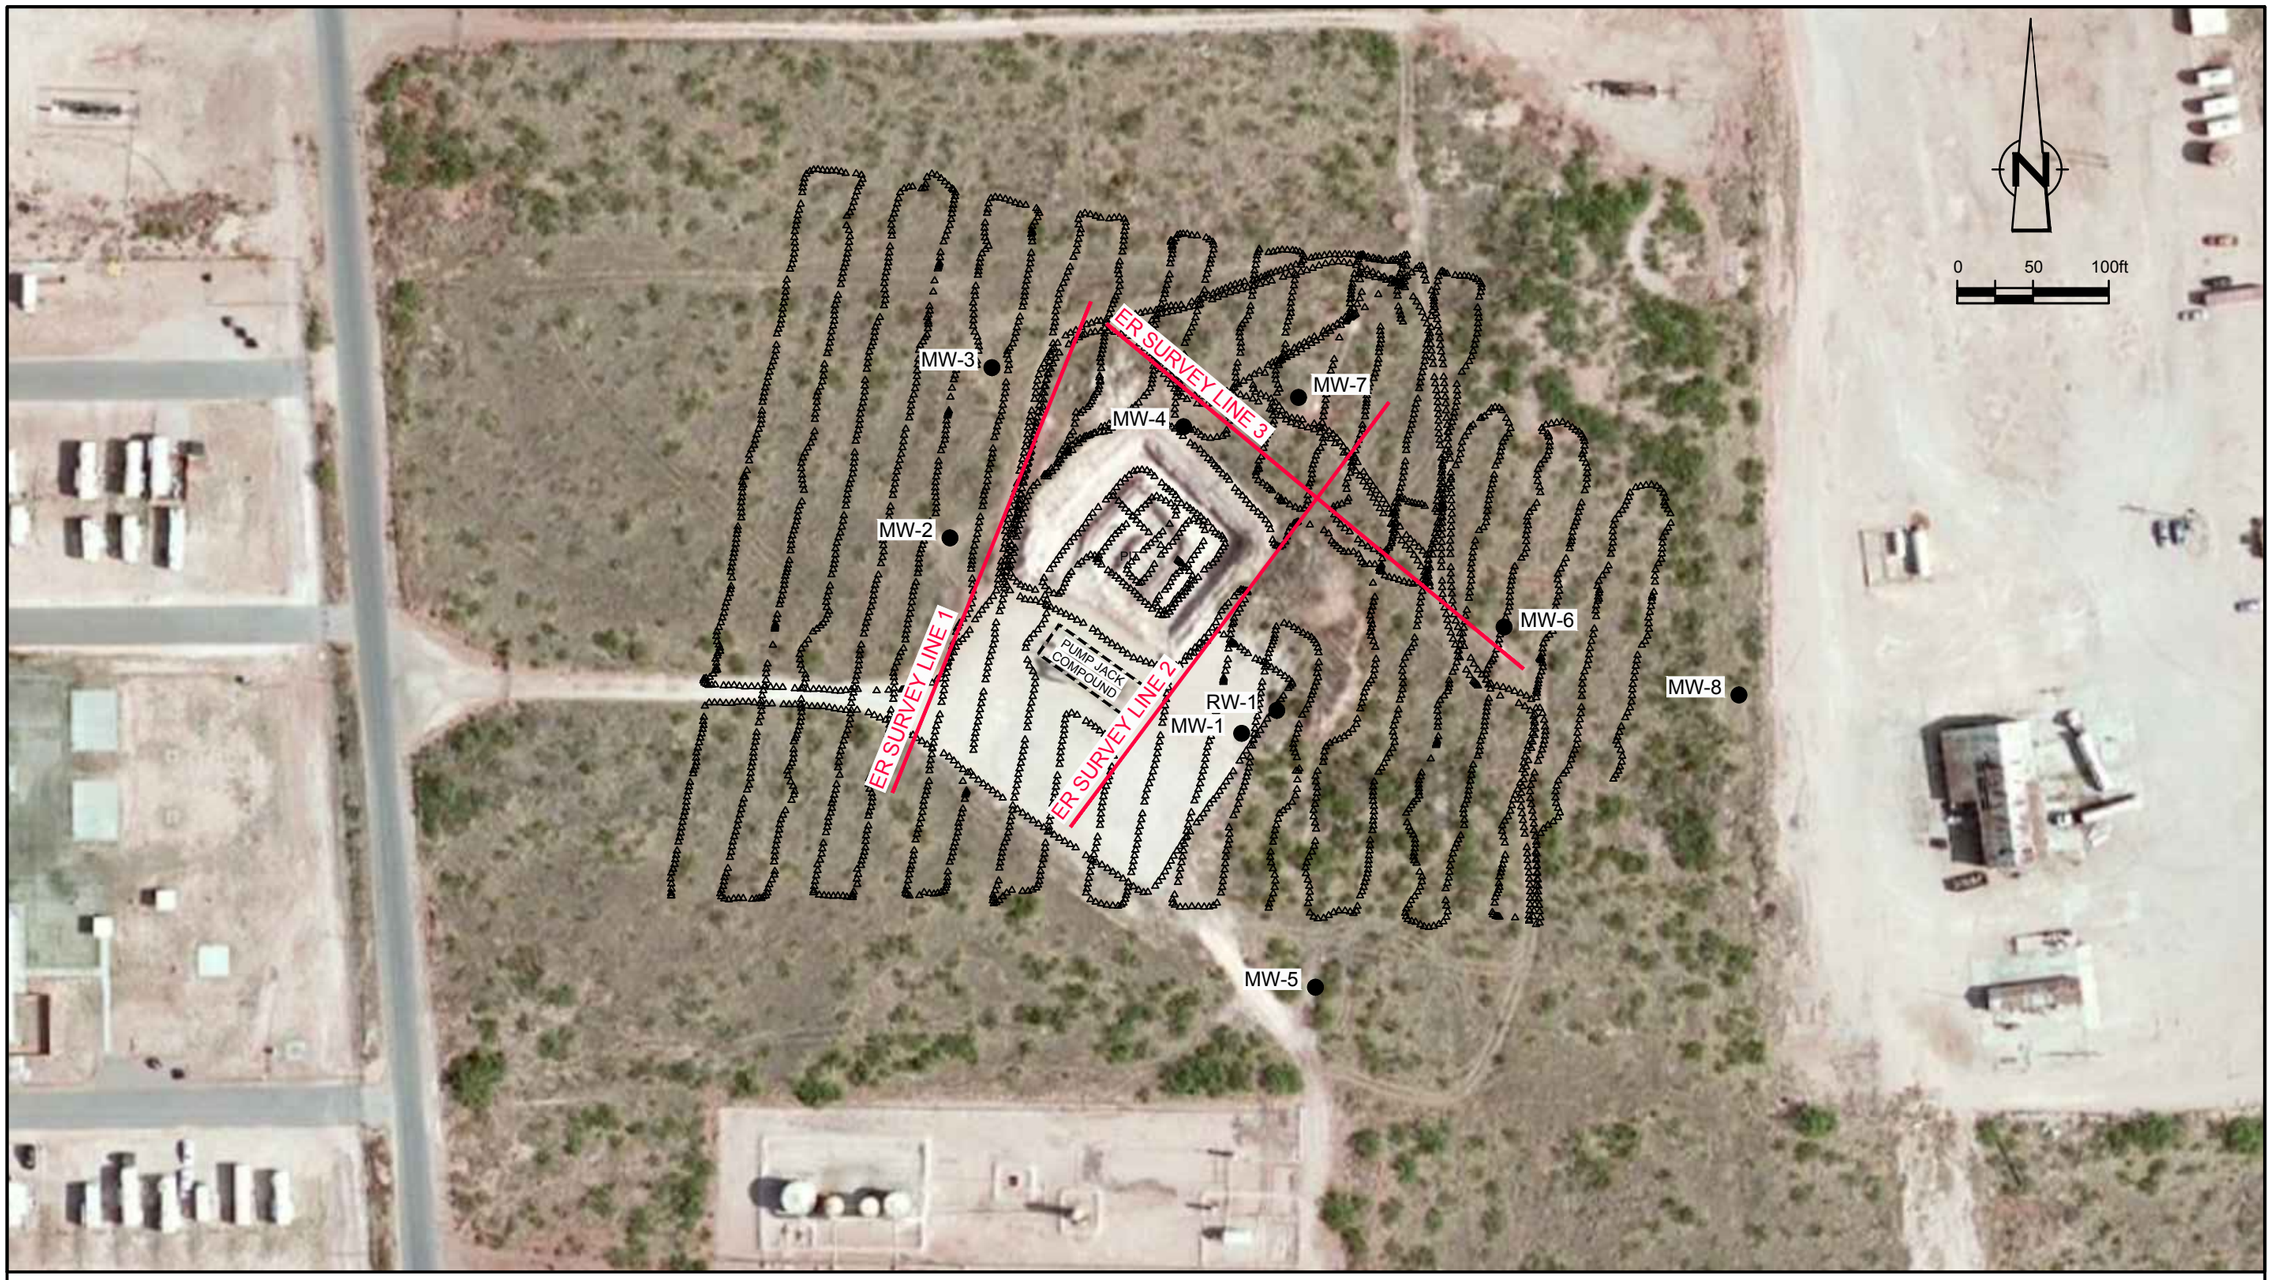
Review of the EM31 results reveals that the conductivity generally ranged from 5 to 50 mS/m, with the exception of the following. Several negative responses (contoured dark blue) were also observed, typically along linear trends in the southwest corner and along the northern boundary of the survey grid. These responses corresponded to locations where the EM31 survey crossed over metal pipes found on the ground surface. In locations where the survey was completed along the axis of a metal pipe the EM31 response was elevated, with peak values of approximately 70 mS/m. This result was observed in the northeast quadrant of the survey coverage, and is attributed to the pipe acting as an infinitely long conductor when the EM31 meter was oriented parallel to it.

Results from non-impacted areas including the survey coverage west of the former reserve pit indicate that the background conductivity responses typically ranged from 5 to 10 mS/m. Slightly anomalous responses were observed around the perimeter and within the floor of the former reserve pit. Peak responses up to 50 mS/m were observed at the top of slope in the north east corner of the former reserve pit. However, the elongated shape of this response suggests that this result is likely due to the presence of a buried metal object, such as a piece of metal pipe.

The slightly anomalous responses emanating from the former reserve pit appear to extend to the south and south east, beneath the pump jack compound and crushed aggregate pad to areas beyond the survey coverage. The direction of suspected chloride plume migration in the shallow subsurface is consistent with the flow of shallow groundwater beneath the Site. It must be noted that no anomalous responses in the shallow subsurface were observed immediately west and north of the reserve pit and that to the east, only slightly anomalous responses were observed.

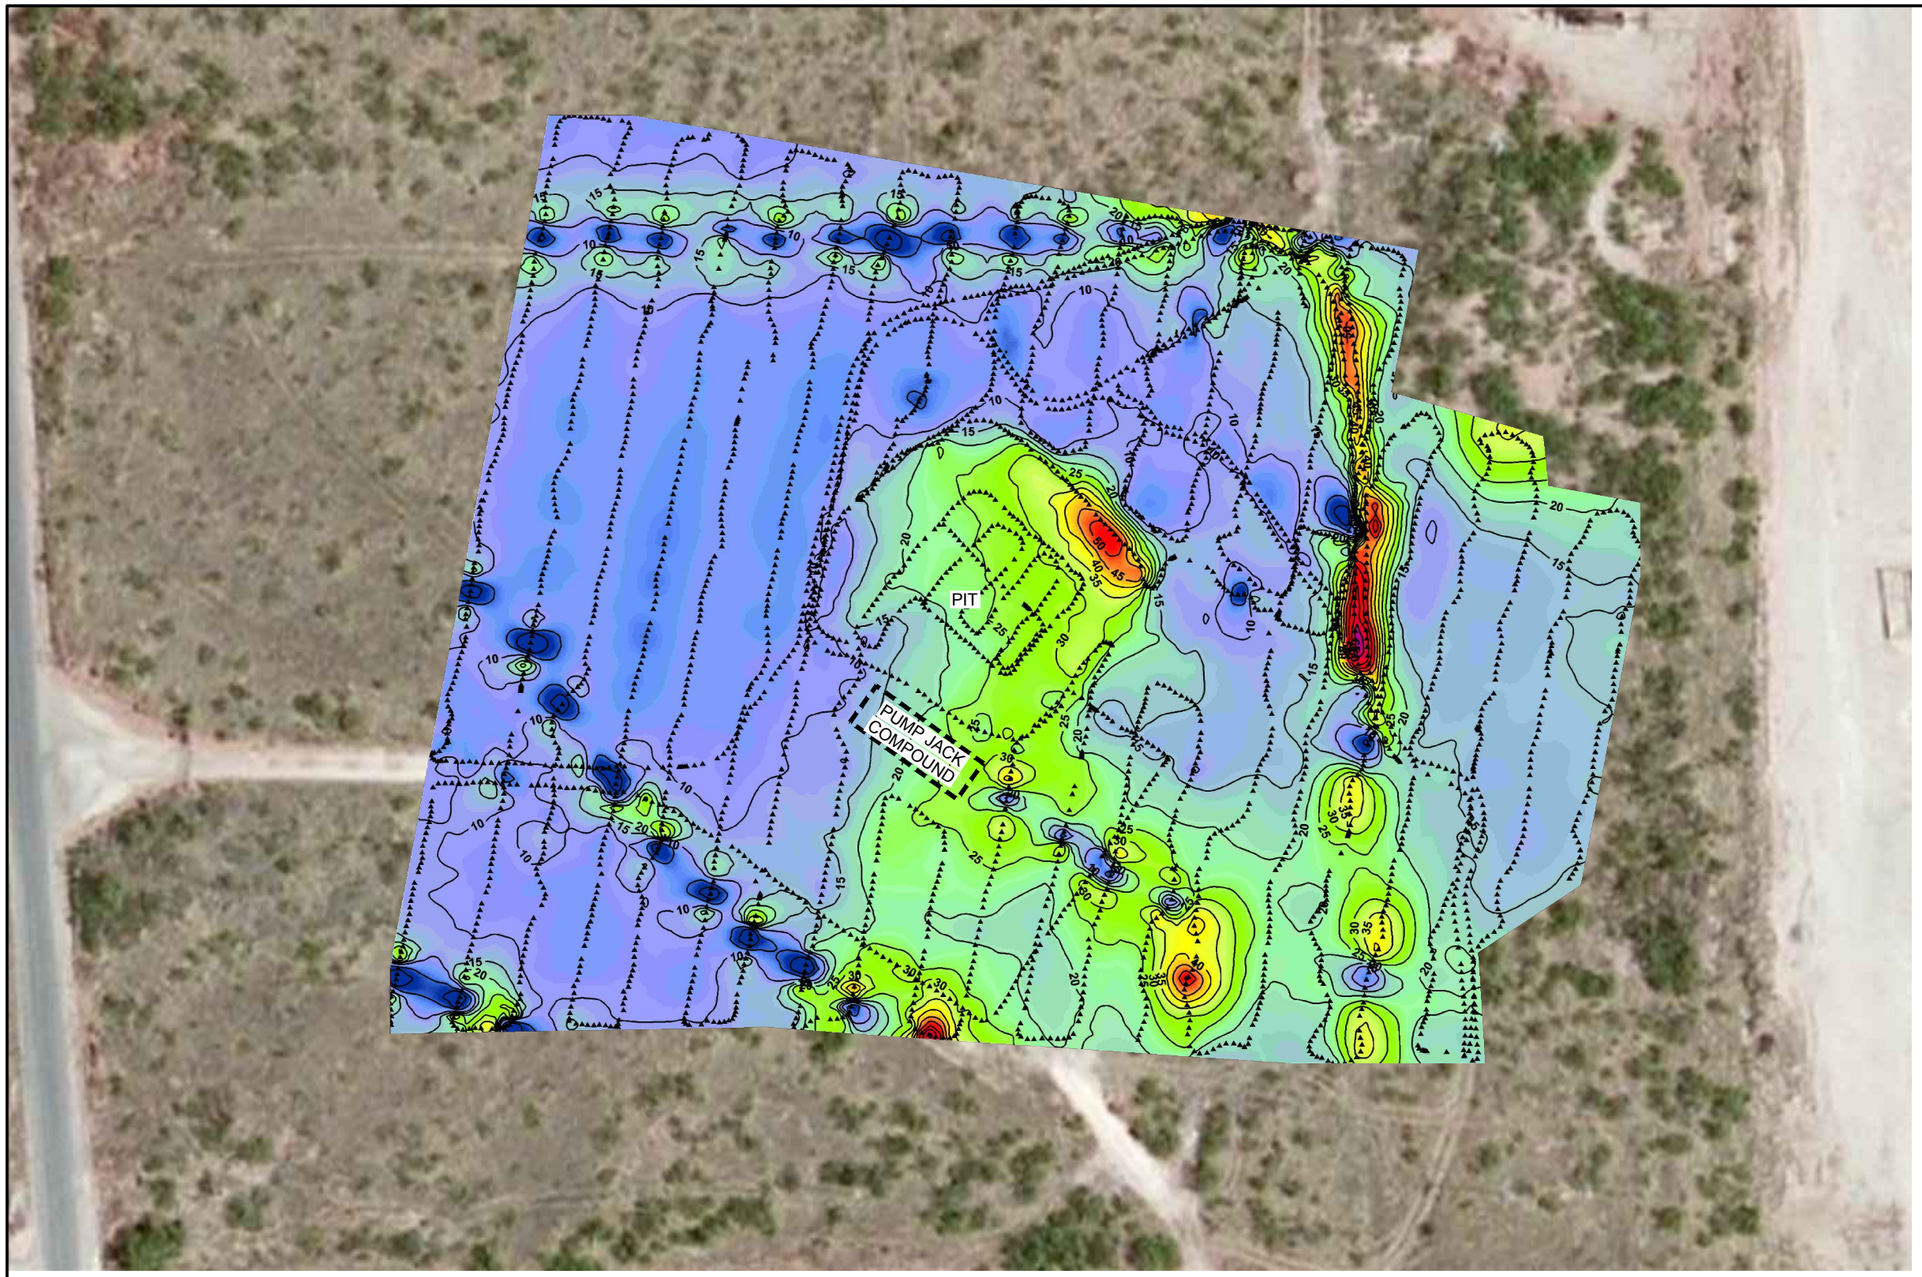
Figure 4

The EM31 data were processed as a colored contour plot, and superimposed over an aerial photograph outlining the surveyed area as presented on **Figure 4**. The highest intensity conductivity responses are colored red to purple, while areas of low response are colored blue. All remaining intermediate responses correspond to the color scale presented on the figure.

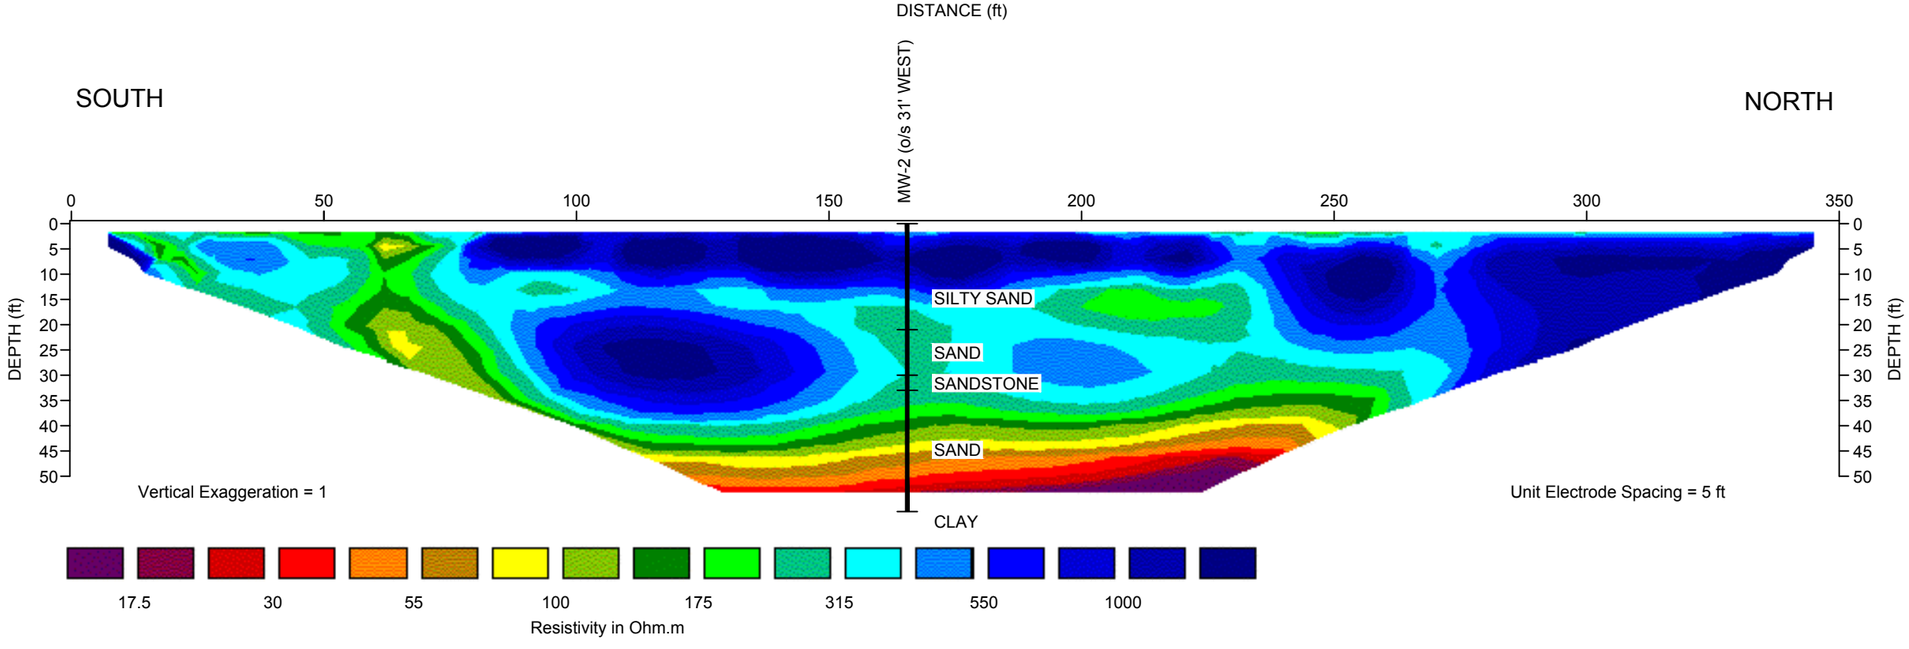
Figure 5

Line 1 was located along the western boundary of the reserve pit and crushed aggregate service pad. This area is upgradient of the direction of shallow groundwater flow, and thus was expected to characterize background conditions and corresponding resistivity responses. Review of the modeled resistivity results presented on **Figure 5** indicates that the response from ground surface to approximately 15 feet bgs was dominated by elevated resistivity values in excess of 750 Ohm.m. This response was attributed to silty sands and caliche observed in the field, and confirmed by the stratigraphic log for well MW-3. Between 15 and 35 feet bgs, the resistivity response generally ranged from 250 to 750 Ohm.m, and reflected the presence of interbedded sand and sandstone. Beneath this depth interval, low resistivities of 40 to 150 Ohm.m indicated the presence of a clay sequence.

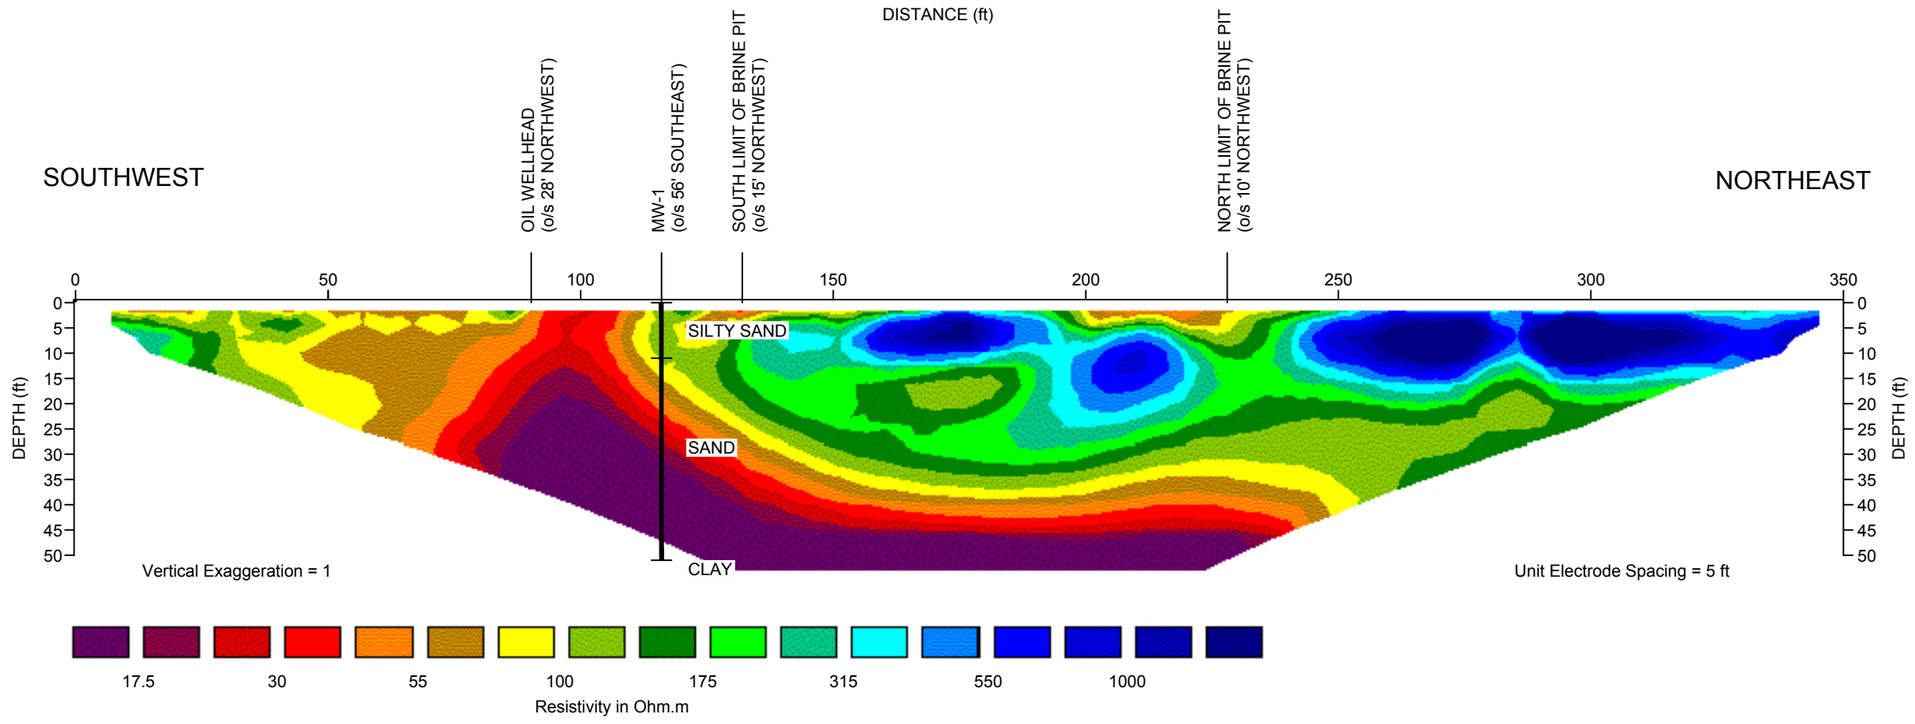
Figure 6

Line 2 transected the crushed aggregate pad and continued along the eastern boundary of the former reserve pit. The modeled resistivity results for Line 2 presented on **Figure 6** indicate that suspected chloride impacts appear to extend from the shallow subsurface south of the pit to the deeper subsurface adjacent to the pit. Low resistivity values ranging from 17.5 to 40 Ohm.m were observed on surface east of the oil wellhead, and also across the deeper saturated zone at depths of 40 to 50 feet bgs. Based on the stratigraphic log for well MW-1, the chloride has impacted a sand sequence overlying a clay confining layer. Resistivity responses of 55 to 175 Ohm.m indicate that the upper saturated zone (20 to 40 feet bgs) has also been impacted by chloride. At the north end of the survey coverage, resistivity responses of 750 to 2000 Ohm.m reveal that no chloride impacts have occurred in the shallow subsurface.

- The ER survey delineated the vertical extent of the suspected chloride impacts along Line 2 located adjacent to the oil wellhead and at depth along the eastern boundary of the former pit, where low resistivity responses indicative of chloride impacts were observed above a confining clay layer.
- To the north of the pit on survey Line 3, the ER survey confirmed the presence of un-impacted sand and caliche in the shallow subsurface and above the water table, and delineated chloride impacts in the saturated zone overlying the clay confining layer.

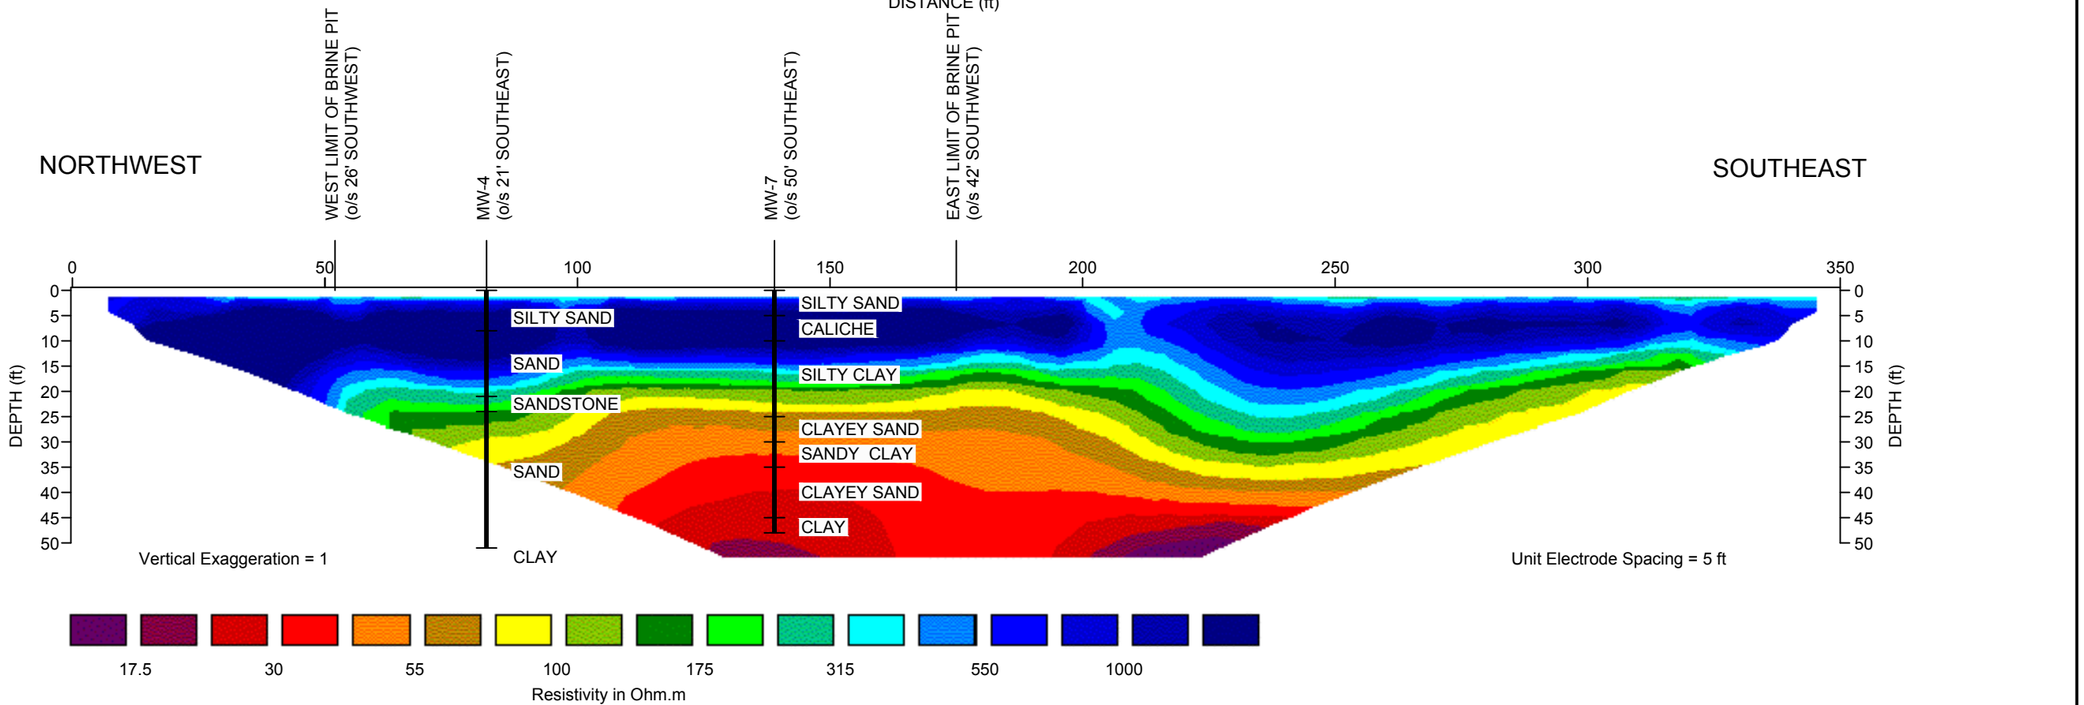
Figure 7

The modeled resistivity results for Line 3 presented on **Figure 7** reveal that the shallow overburden between 15 to 20 feet bgs yielded resistivity values ranging from 750 to 3000 Ohm.m. These results indicate that the interbedded sand and caliche at these depths have not been impacted by chloride. However, the underlying saturated zone was characterized by responses of 17.5 to 100 Ohm.m, with the more conductive responses located at the base of the section where clay was encountered. The resistivity response between 20 to 50 feet bgs indicates that soils at this depth have been impacted by chloride which emanated from the former pit. Similar to the results observed for the other survey lines, the chloride impacts appear to occur in sandy sequences located above a clay confining layer.

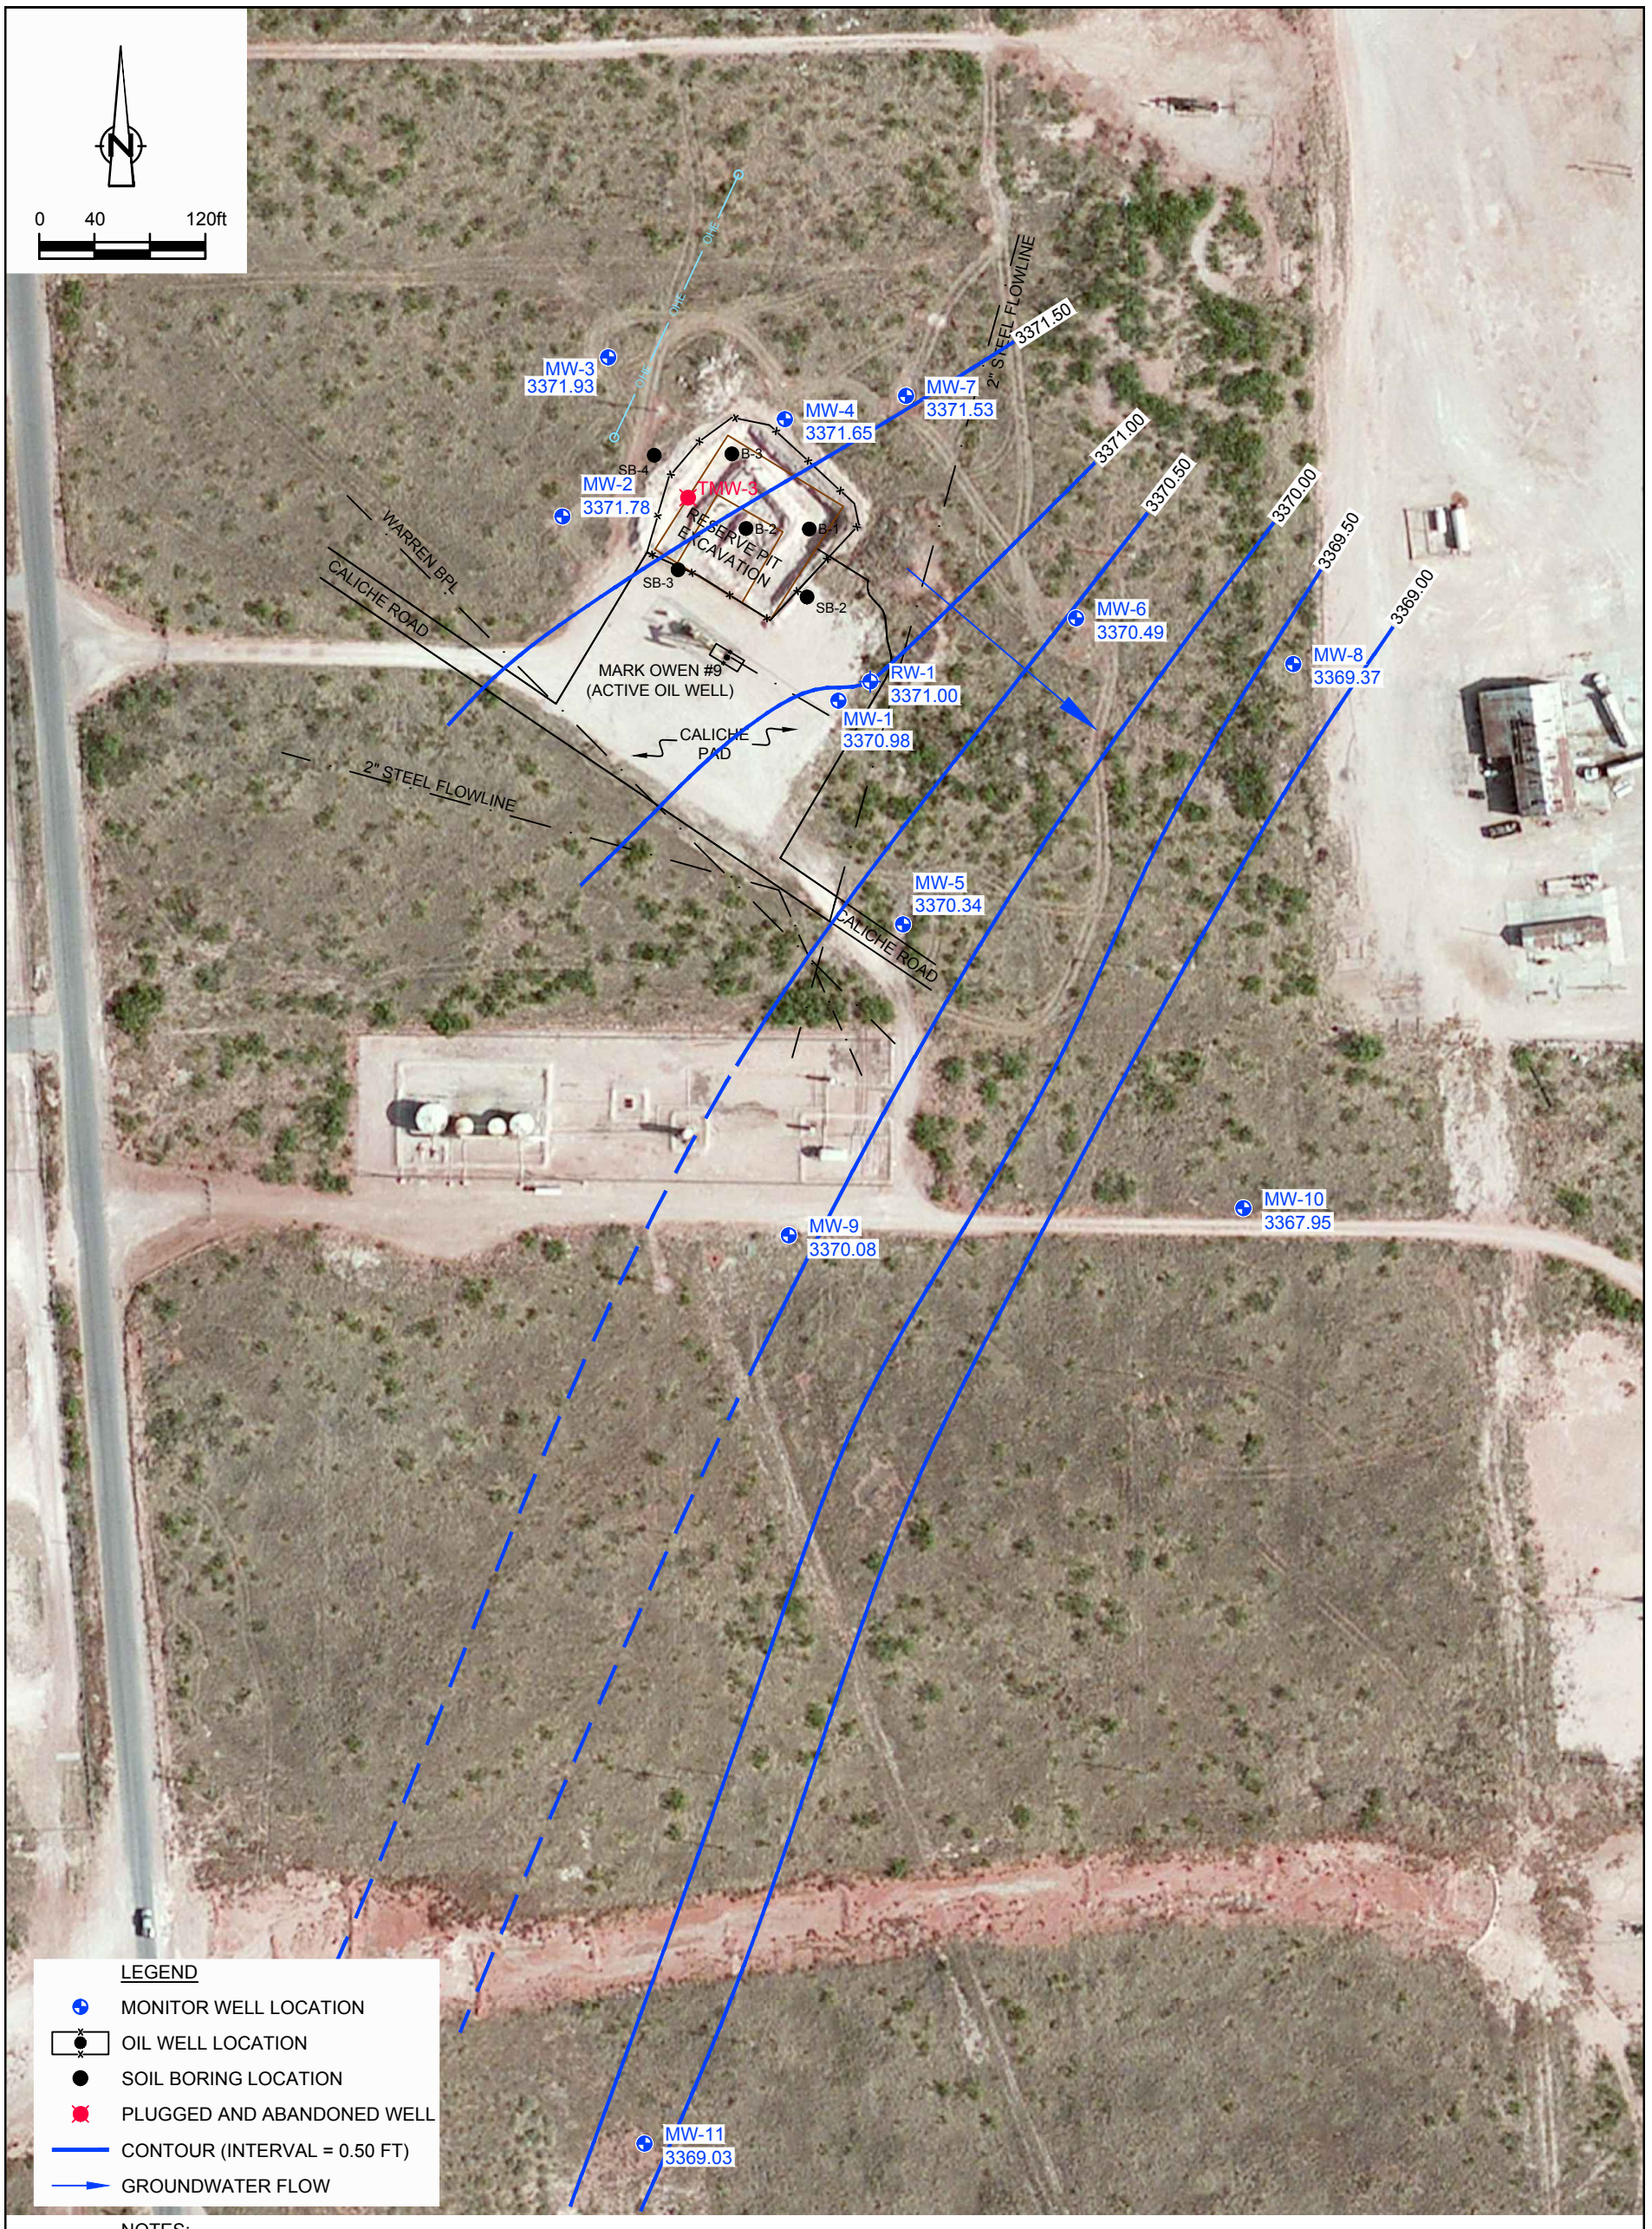
Figure 8

Groundwater elevation data are presented in **Table 2** and are consistent with elevations from the 2013 data. Groundwater gradient maps for March, June, September and November 2013 are presented as **Figures 8, 9, 10** and **11**, respectively. Groundwater elevations ranged from 3367.95 feet above mean sea level (amsl) to 3371.93 feet amsl on March 18, 2013, from 3367.73 feet to 3371.77 feet amsl on June 6, 2013, from 3367.50 feet to 3371.87 feet amsl on September 11, 2013, and from 3367.86 feet to 3371.87 feet amsl on November 19, 2013. Groundwater flow at the Site is to the southeast at a gradient of 0.0056-foot/foot. Potentiometric surface maps for each quarter of groundwater sampling in 2013 are included as **Figure 8** through **Figure 11**.

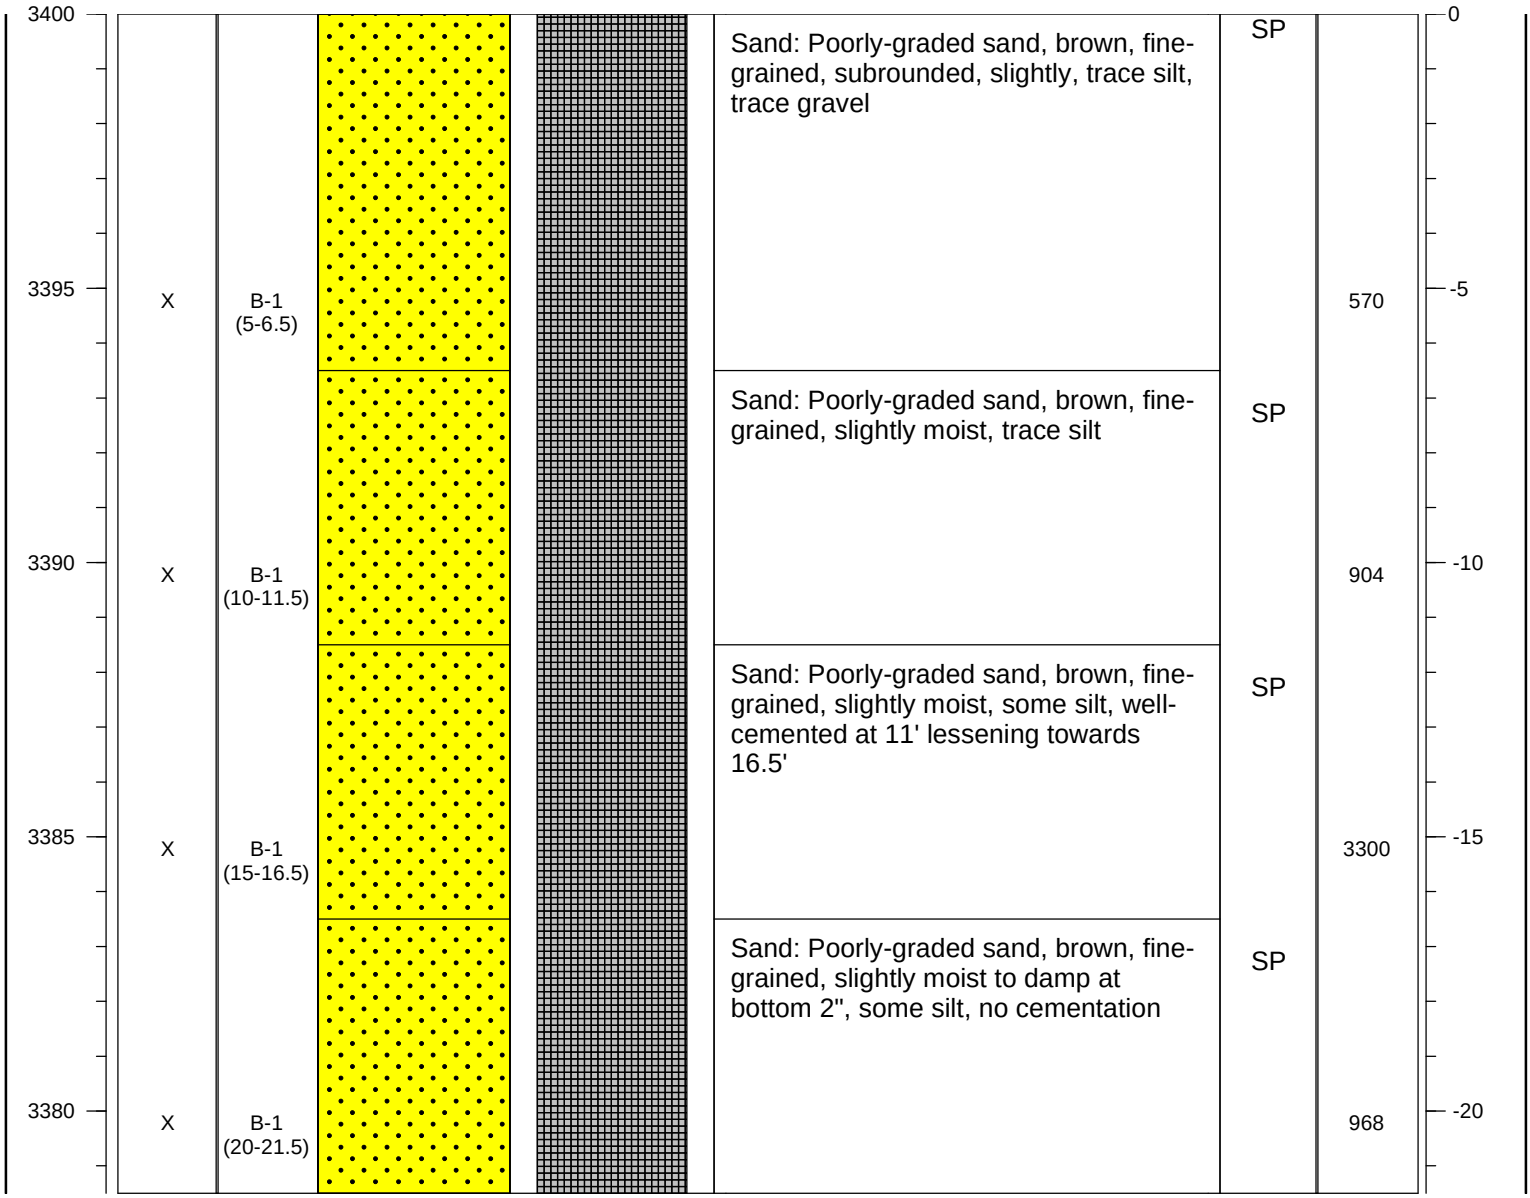
SOIL BORING NO: B-1
DRILL TYPE: Air Rotary
BORE HOLE DIAMETER: 4 inches
DRILLED BY: White Drilling
DATE/TIME HOLE STARTED: November 18, 2013 at 1400
DATE/TIME HOLE COMPLETED: November 18, 2013 at 1440

Soil samples collected from B-1 indicated concentrations of chloride above the site specific NMOCD Recommended Remediation Action Level (RRAL) of 250mg/kg. Soil samples collected from soil borings B-2 and B-3 indicated chloride concentrations in soil below the 250 mg/kg RRAL. The corresponding laboratory analytical report has been included in **Appendix C**.
