THIRD ANNUAL GROUNDWATER MONITORING REPORT
CHESAPEAKE ENERGY CORPORATION
STATE M LEASE (AP-72)
LEA COUNTY, NEW MEXICO

CHESAPEAKE ENERGY CORPORATION
STATE M LEASE (AP-72)
THIRD ANNUAL GROUNDWATER MONITORING REPORT
MAY 25, 2017

This ***Third Annual Groundwater Monitoring Report*** (Report) summarizes the groundwater monitoring activities conducted at the Site during the following quarterly sampling events:

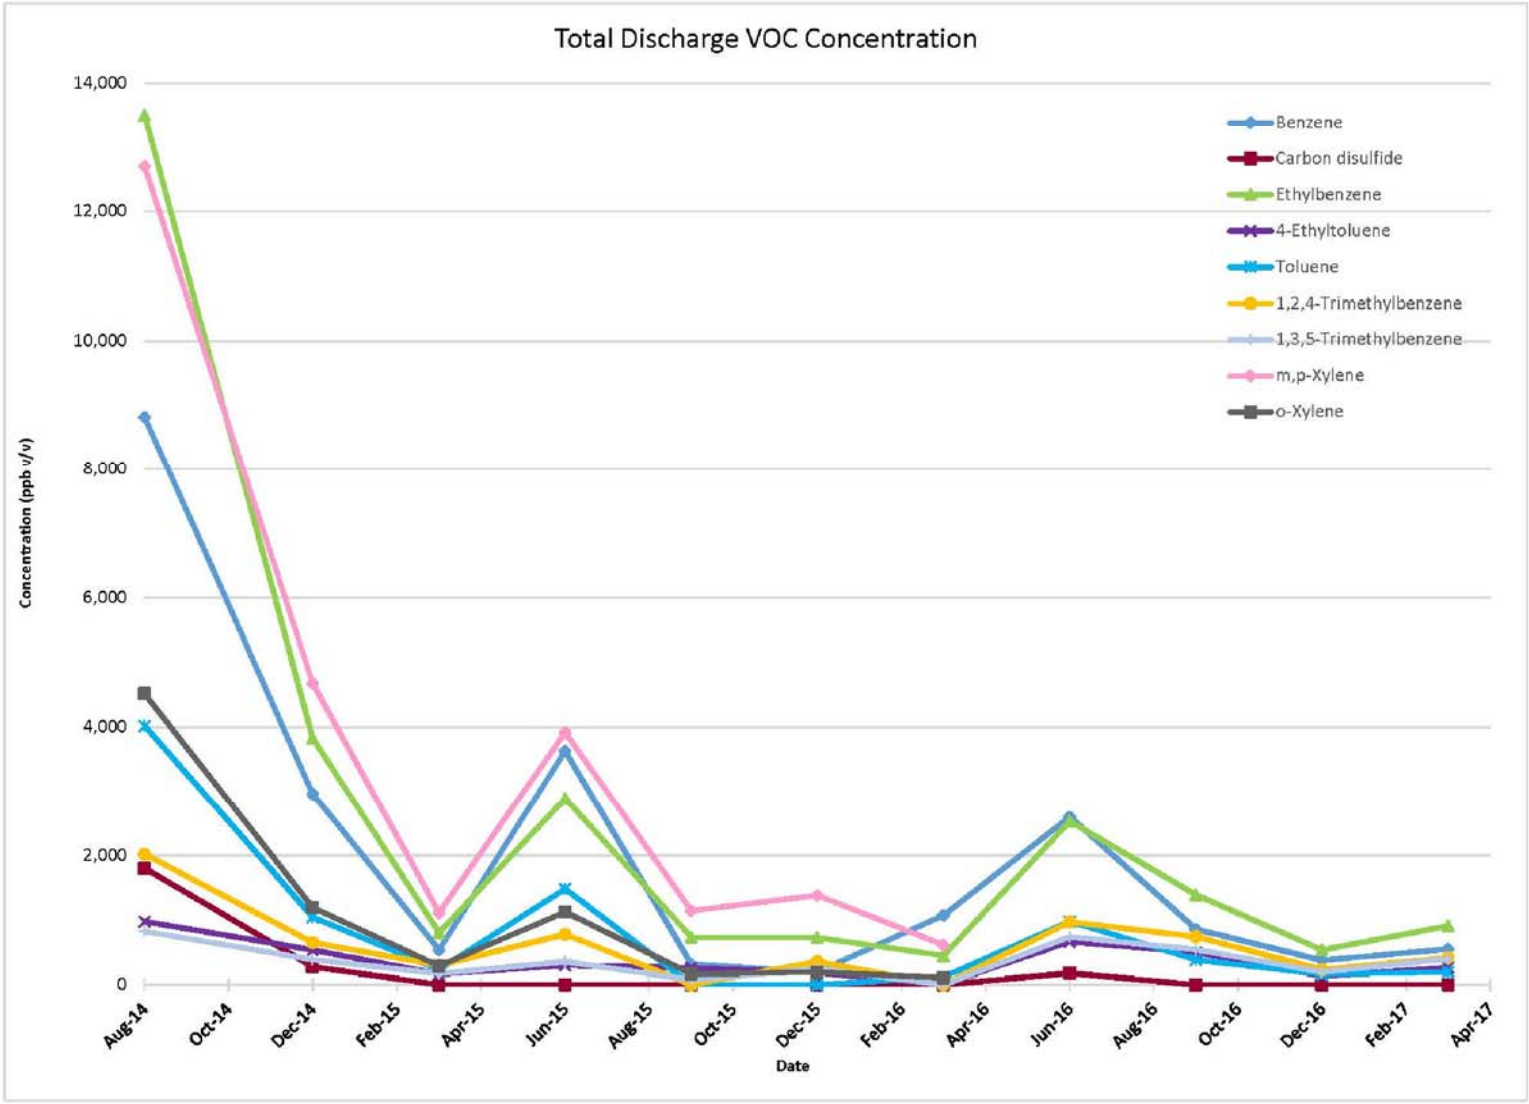
PROJECT NUMBER	FIGURE NUMBER
CHKHSTM101	3

Figure 3 presents a graph of the VOC concentrations observed in the discharge air stream versus time. As can be seen on this figure, the levels of VOC observed in the air discharge stream have decreased dramatically since startup. These data indicate that the System is effective at removing the hydrocarbon vapors from the subsurface. Removal of hydrocarbon vapors coupled with the influx of oxygen drawn into the impacted area by the System enhances biodegradation of the hydrocarbon impacts observed in this area.

- Operation of the SVE System at the Site should continue until the LNAPL observed on the groundwater in the monitoring well MW-1R area has been adequately eliminated.

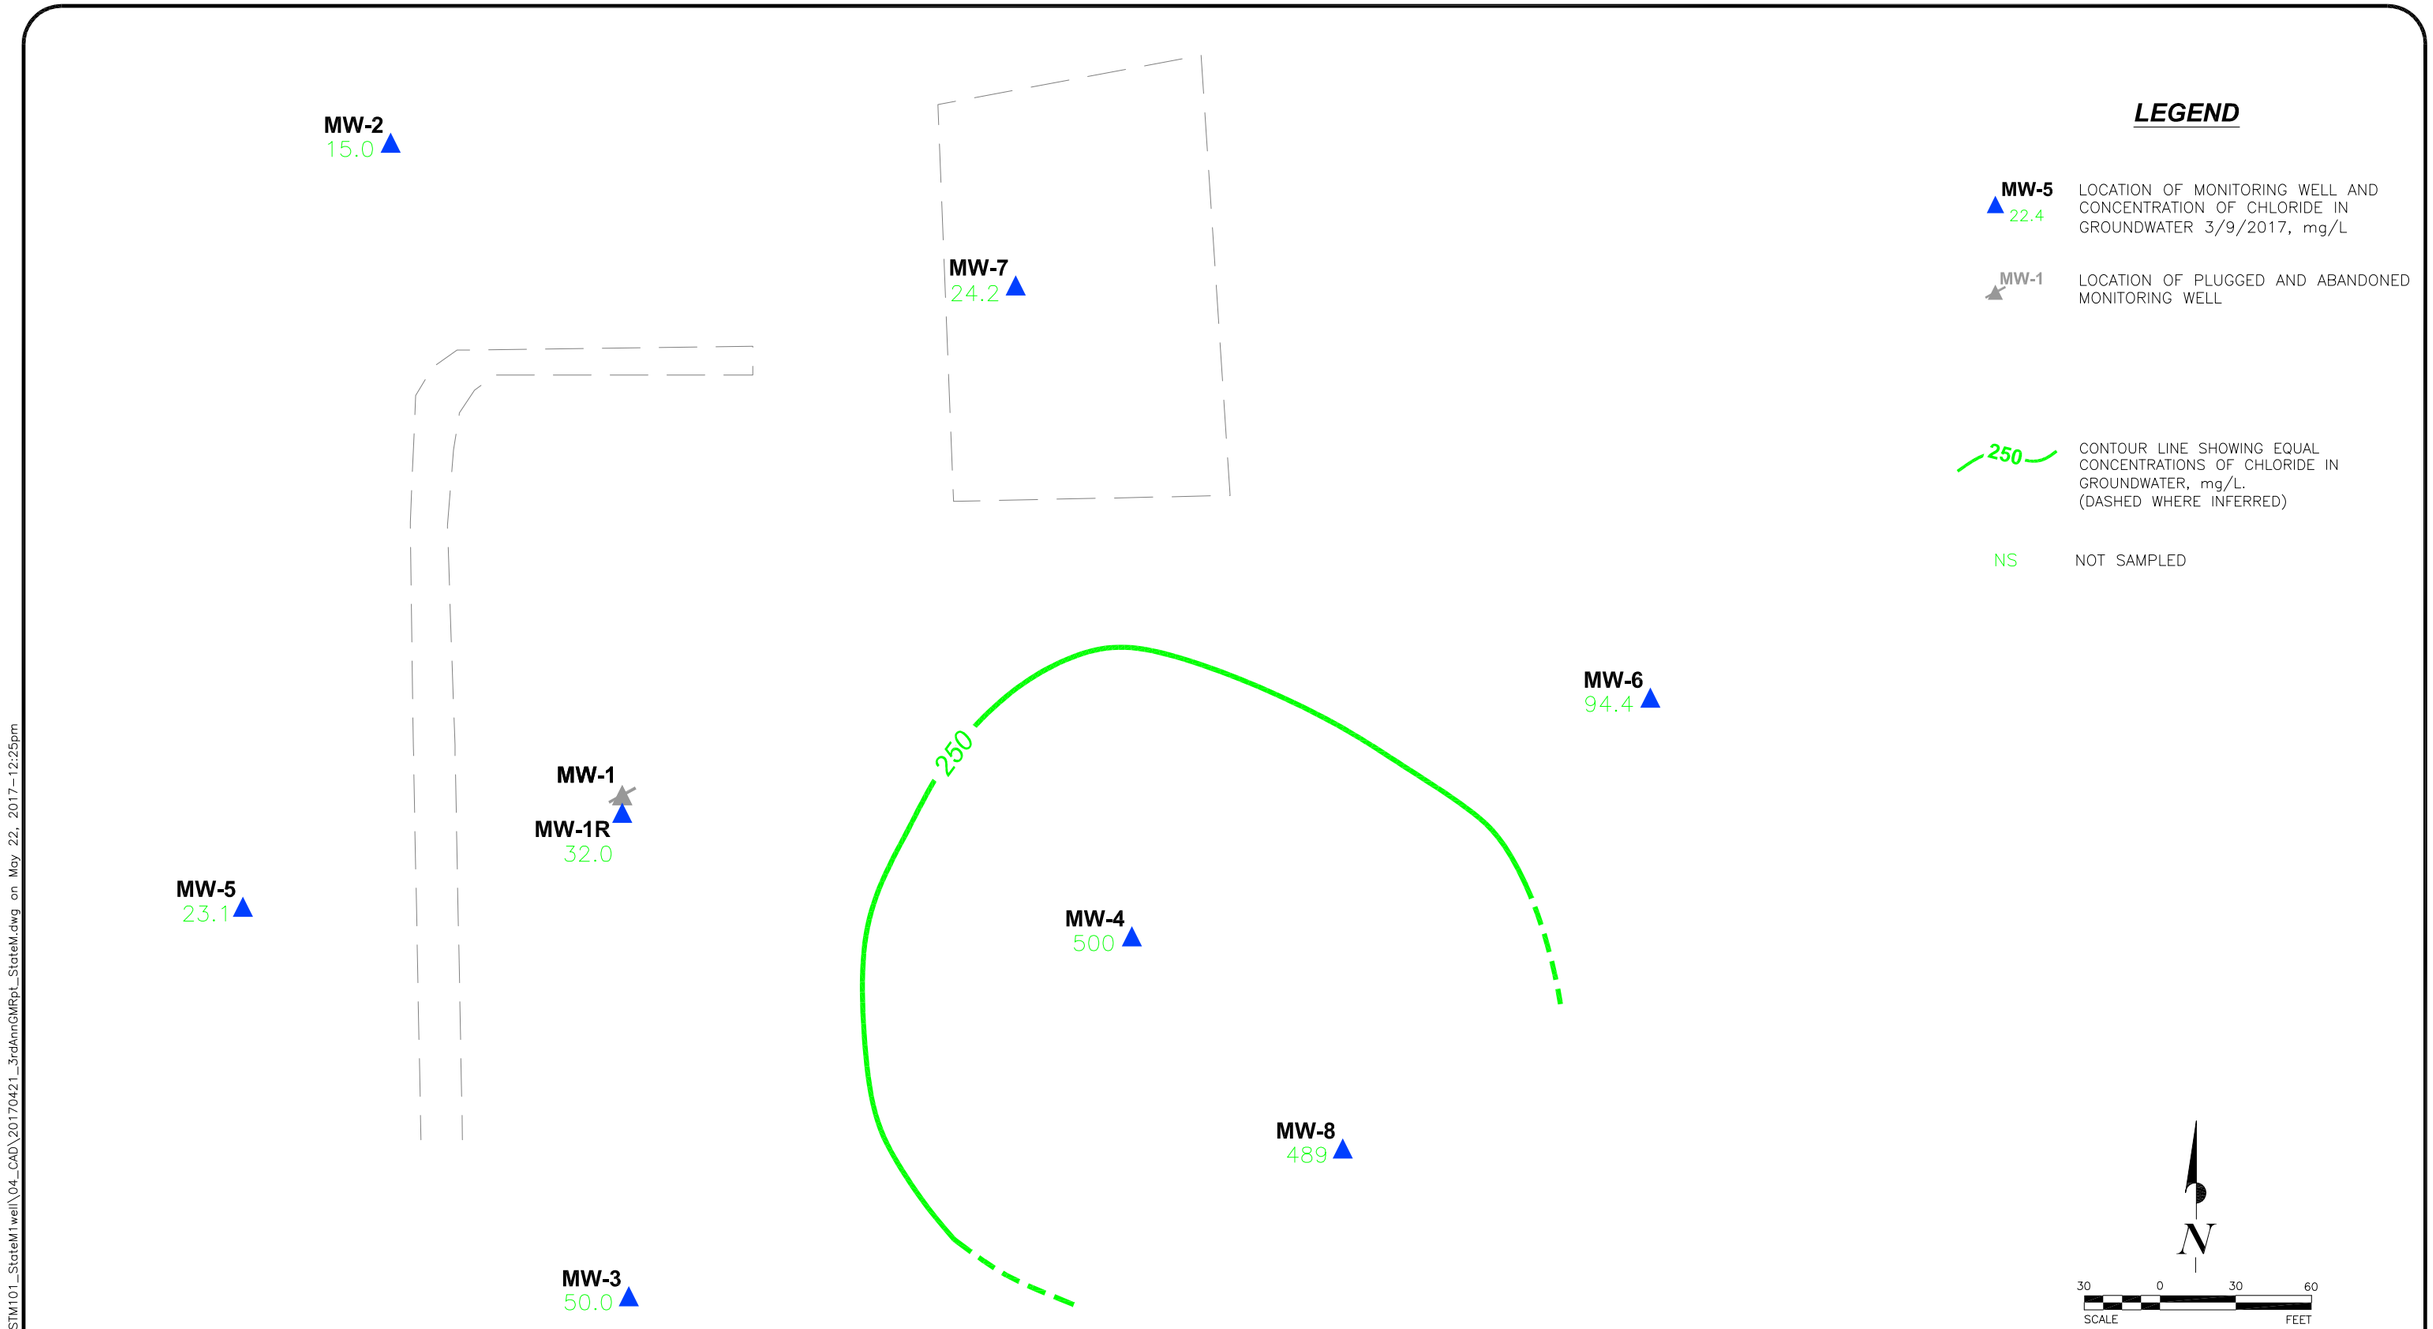
PROJECT NUMBER	FIGURE NUMBER
CHKHSTM101	8

The twelfth quarterly groundwater sampling event was conducted at the Site during the period March 8-9, 2017. As can be seen in **Table 4**, the groundwater samples collected from monitoring wells MW-4 (500 mg/L) and MW-8 (489 mg/L) during this sampling event exhibited concentrations of chloride that exceed the Limit of 250 mg/L. **Figure 8** presents an isopleth of the chloride concentrations observed in the groundwater samples collected during this sampling event. As can be seen on this figure, the highest levels of chloride observed in Site groundwater are observed in monitoring wells MW-4 and MW-8, in the southeast portion of the Site.

- As specified in the Plan, quarterly monitoring of the groundwater within the eight monitoring wells at the Site should be continued until the levels of chloride observed in the groundwater samples fall below the Limit of 250 mg/L for eight quarters. The next groundwater monitoring event at the Site is scheduled to be conducted in June 2017.
