Release Notification

Site Name Big Eddy Unit 039	Site Type Production Well and Storage Facility
Date Release Discovered 2/21/2019	API# *(if applicable)* 30-015-20945

FIGURE 1
SITE LOCATION MAP
BIG EDDY UNIT 039
UNIT G SEC 29 T21S R28E
EDDY COUNTY, NEW MEXICO
XTO ENERGY, INC.

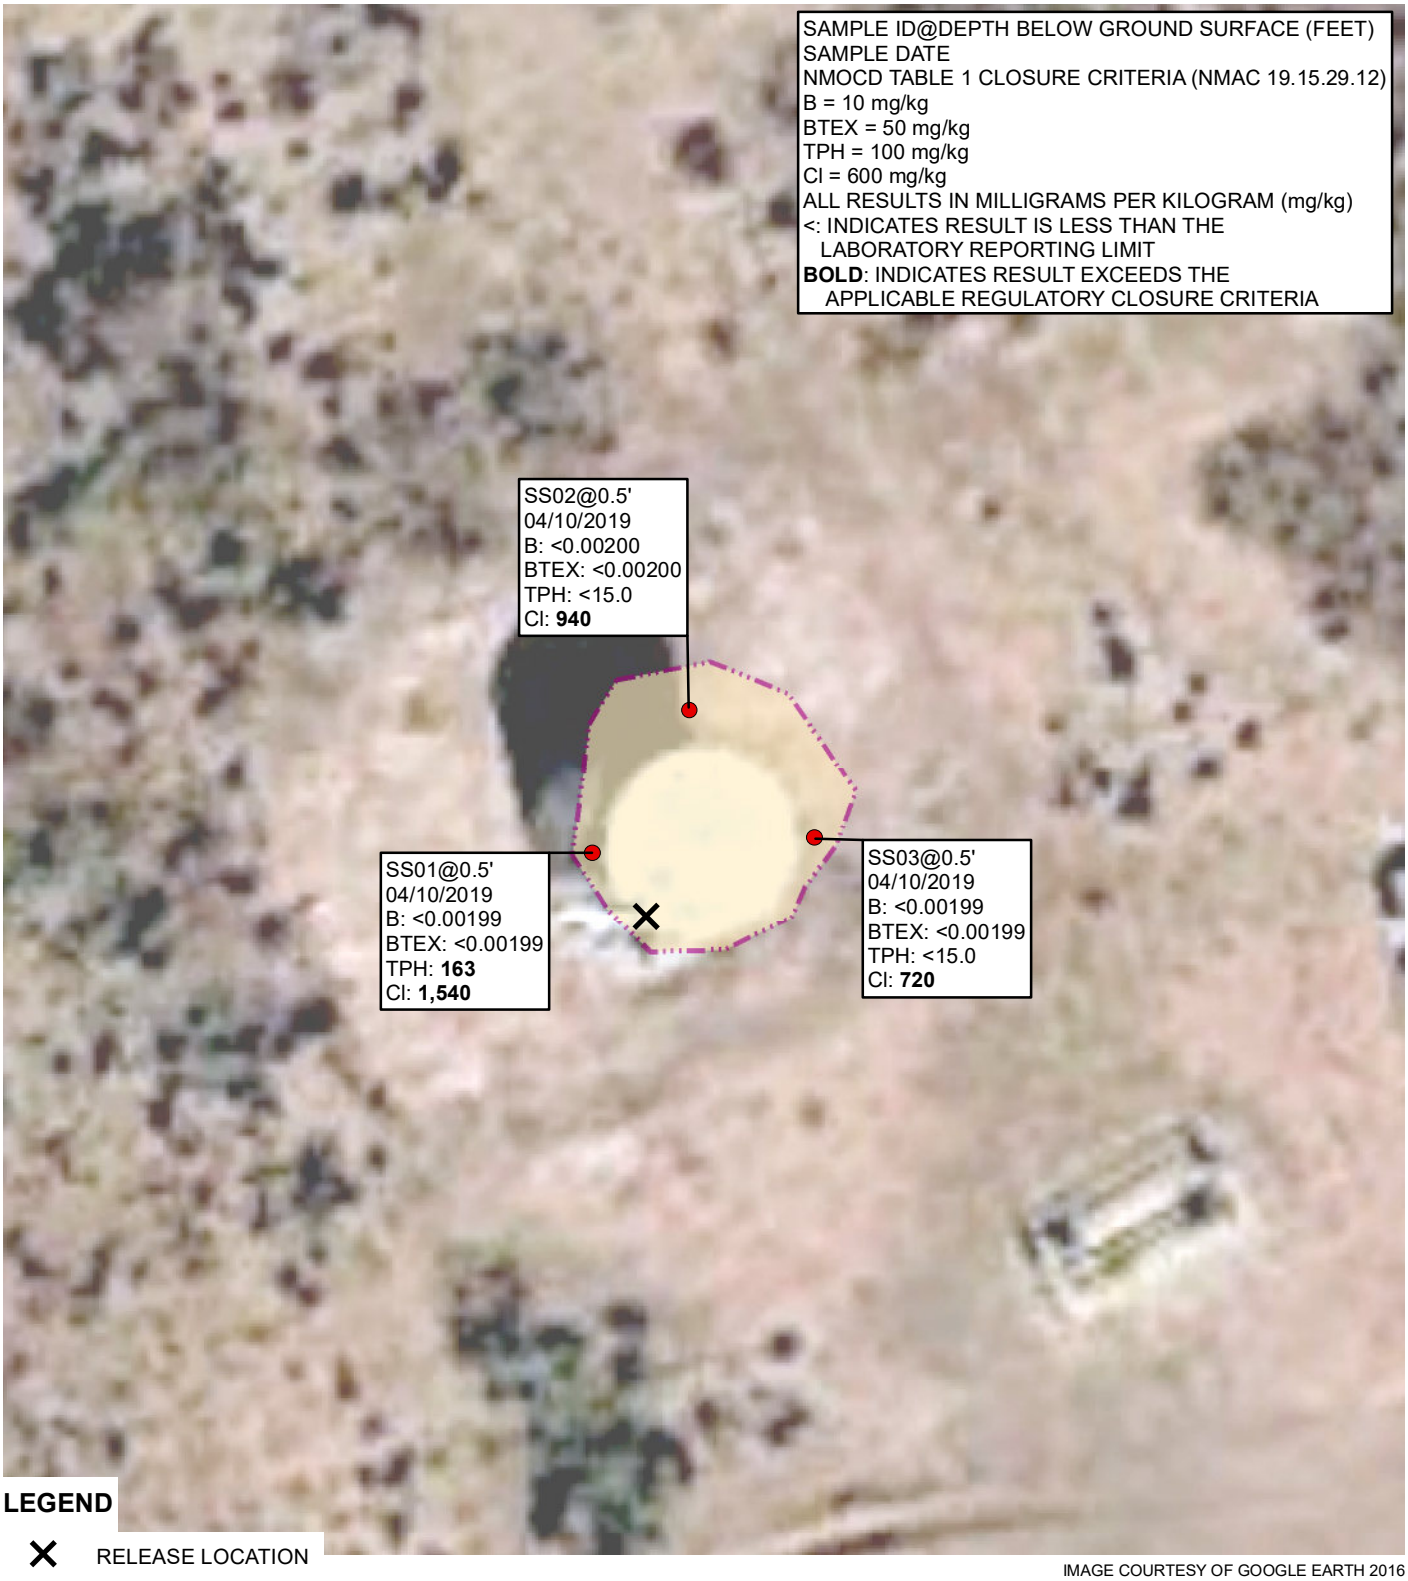
FIGURE 2
PRELIMINARY SOIL SAMPLE LOCATIONS
BIG EDDY UNIT 039
UNIT G SEC 29 T21S R28E
EDDY COUNTY, NEW MEXICO
XTO ENERGY, INC.

- RELEASE LOCATION
- PRELIMINARY SOIL SAMPLE WITH CONCENTRATIONS EXCEEDING APPLICABLE CLOSURE CRITERIA
- RELEASE EXTENT
