AN EVALUATION OF THE NAVAJO REFINERY WASTEWATER TREATMENT FACILITIES, ARTESIA, NEW MEXICO

Prepared for
The New Mexico Water Quality
Control Commission
January 14, 1974

By
Earl Backenstow, P. E.
Water Quality Division
New Mexico Environmental Improvement Agency

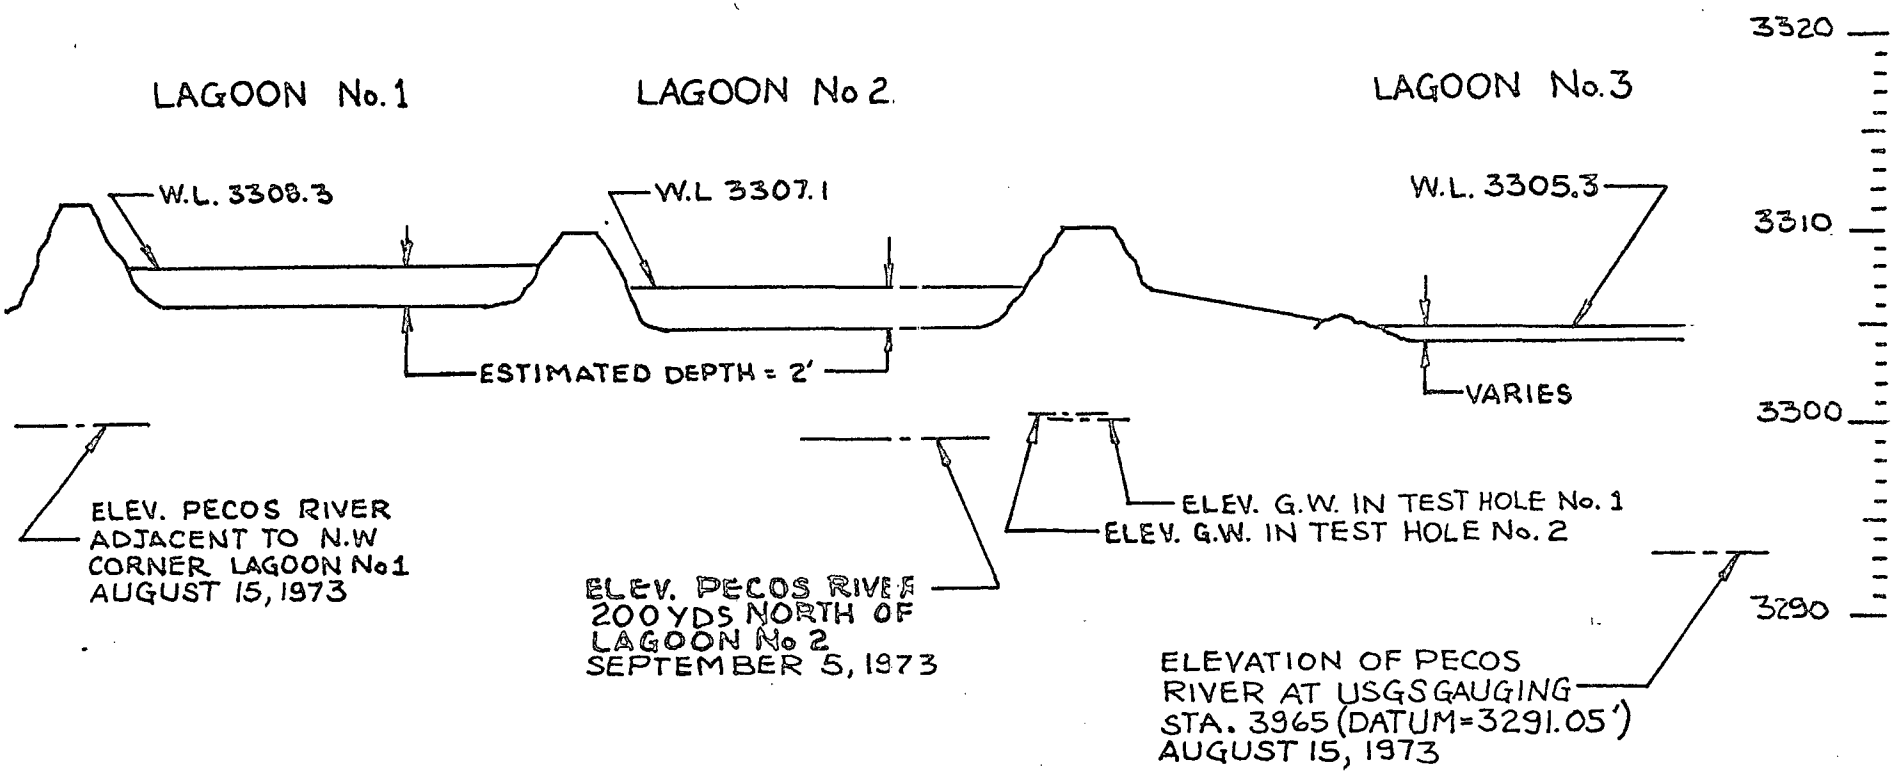
FIGURE 2

evaporation rates increase and the size of the playa shrinks accordingly. A photo of lagoon three, taken at location N is shown in Appendix B. Figure 2 is a hydraulic profile of the three lagoons.

NAVAJO REFINERY WASTEWATER TREATMENT FACILITY HYDRAULIC PROFILE

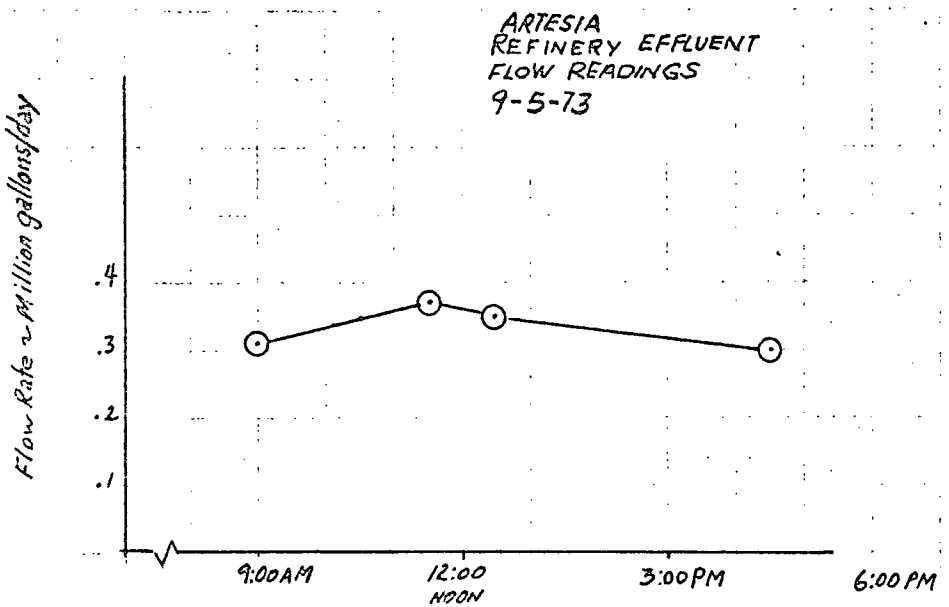
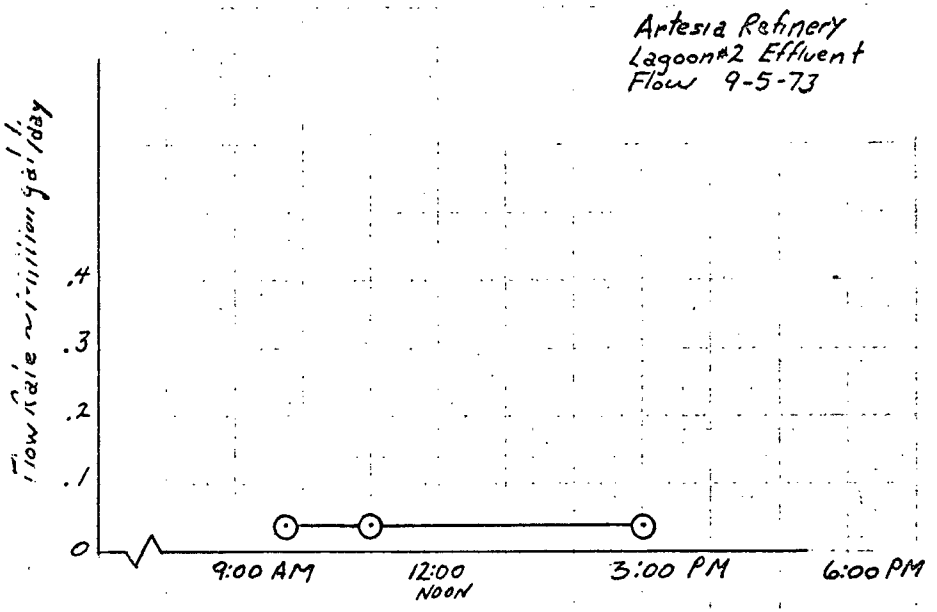
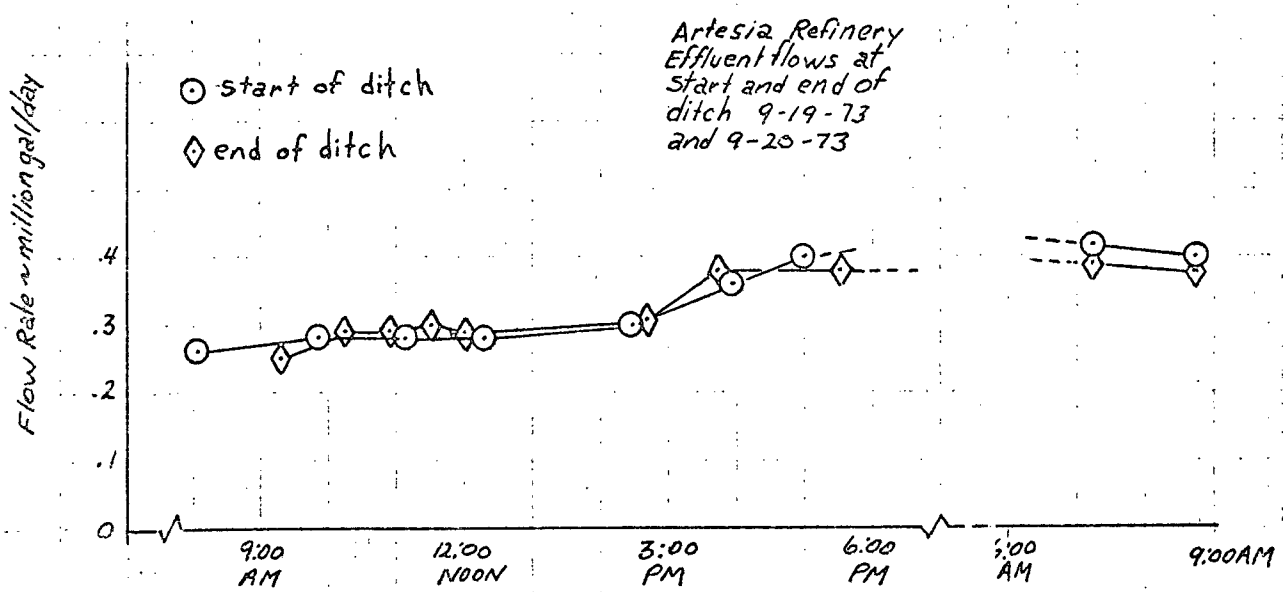
FIGURE 5
REFINERY WASTEWATER FLOW DATA

The refinery effluent flow was measured with a six-inch portable parshall flume. The flume was installed in the effluent ditch leading from the refinery to the treatment lagoons. The location of the flume is indicated on Figure 1 and photographs of the flume installed in the ditch are shown in Appendix B. Flows ranged from 0.30 to 0.40 mgd. The average flow was calculated to be 0.32 mgd. Refinery personnel stated that the flow remains fairly constant twenty-four hours a day, 365 days a year (reference Figure 5).

The average flow from lagoon two was measured with a three-inch parshall flume on September 5, 1973. The flow remained constant at 0.04 mgd (Reference Figure 5). However, the amount of flow from lagoon two will vary considerably with evaporation. (3) (4) (5) In the summer, when evaporation rates are very high, the discharge may go to zero for a short time. In the winter, when evaporation rates are low, the discharge will increase. The area of lagoon three will decrease and increase corresponding to fluctuations in evaporation.

An attempt was made to determine flow losses in the ditch. Flows were measured at the beginning and end of the ditch on September 19 and September 20 (reference Figure 5). The flows recorded the nineteenth showed an increase rather than a decrease in flow from the beginning to the end of the ditch. The increase is attributed to rainfall and surface runoff which occurred in the area on September 18 and 19. The flows recorded for a short time on September 20 indicate a decrease in flow of 0.02 mgd.
