CIP YARD CLEANUP
FINAL REPORT

PROJECT NO. 92245

JANUARY 9, 2002

Interim Report
Yard Cleanup

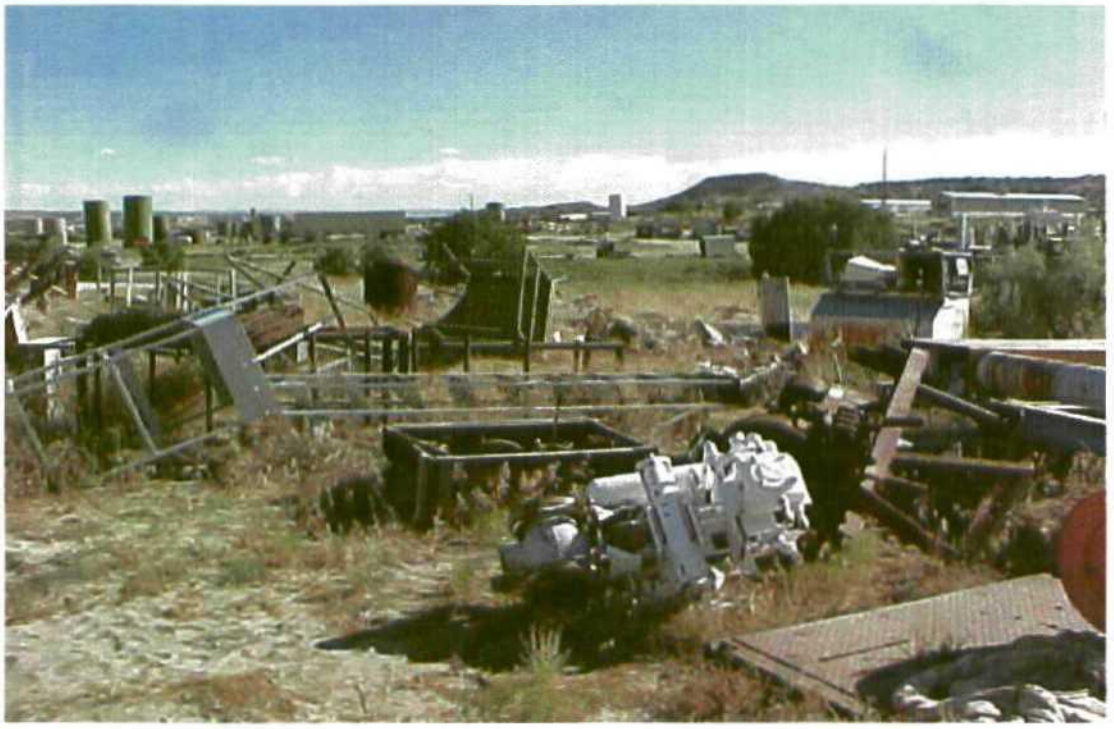
Photo 6: Photograph remaining debris located in cell I-1 and I-2.
