GW - 258

INSPECTIONS & DATA

BURLINGTON
RESOURCES

RE: Burlington Resources Compressor Station Site Inspections 2000. **Manzanares GW-05, Gobernador GW-056, Pump Mesa GW-148, Quinn GW-239, Sandstone GW-193, Rattlesnake GW-093, Buena Vista GW-255, Pump Canyon GW-057, Hart Canyon GW-058, Cedar Hill GW-258, and Middle Mesa GW-07:**

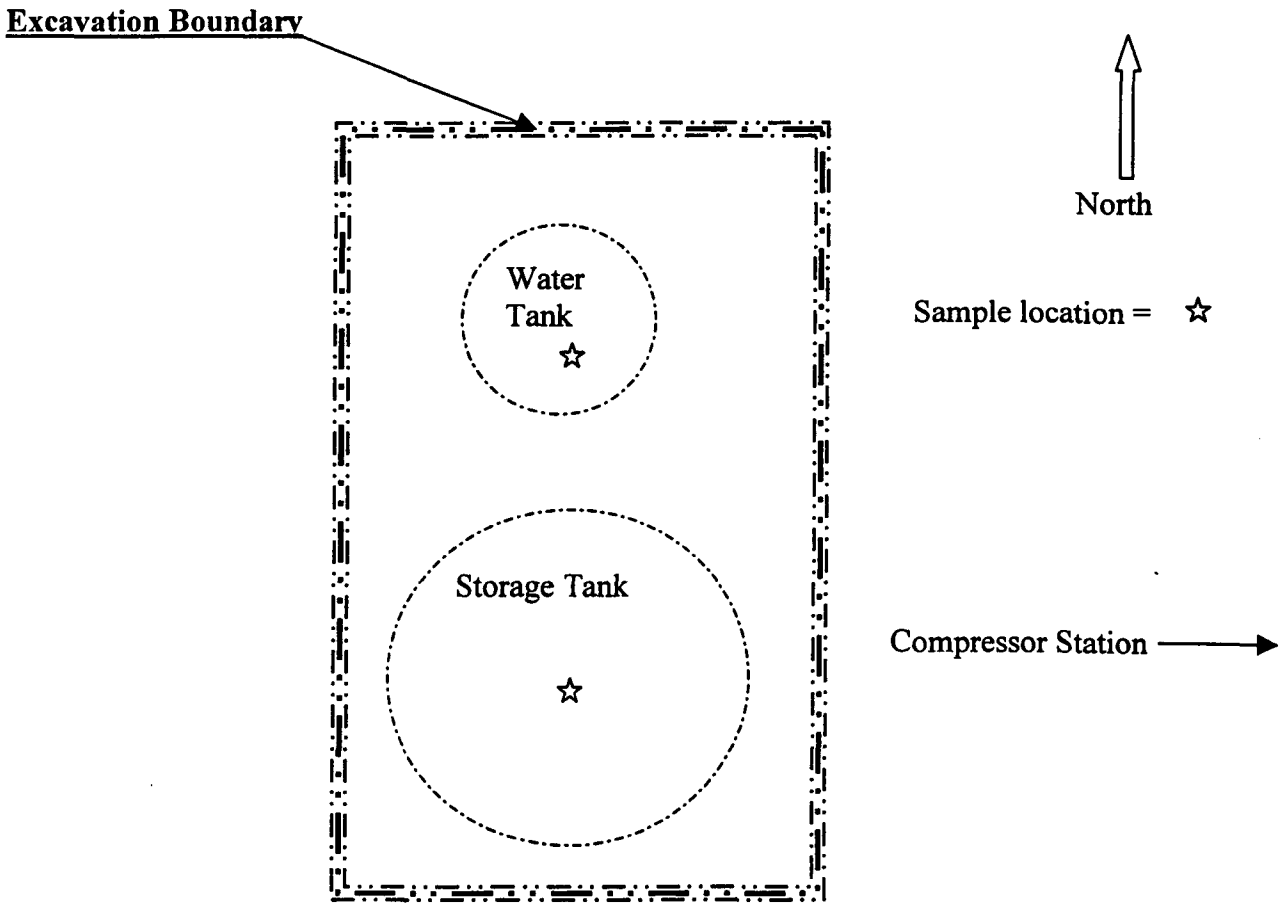
1. Area under both tanks excavated following the extent of soil contamination staining
2. Samples were collected at the deepest point of contamination under each tank.
3. The contamination was confined to area within berm perimeter (20 feet x 30 feet) and to a maximum depth under the storage tank of 16 feet.
4. Soil was replaced with clean fill and compacted and new water tank and the old storage tank were placed on liners and a berm reconstructed
5. Contaminated soil was land farmed at Quinn Compressor Station location

Sample from Water Tank collected at 8 feet PID field reading 0.0 ppm

Sample from Storage Tank collected at 16 feet BTEX = < 50 ug/kg
DRO/GRO = <30 ug/kg
PID = 0.0 ppm

2. Oil and water observed in condensate underground wastewater storage tank leak detector. ***The fiberglass wastewater storage tank was removed and replaced with a new metal tank. The condition of the fiberglass tank was satisfactory with no evidence of leaking. Historic contamination was detected adjacent to the wastewater tank and followed under the condensate storage tank during the excavation process. The source of the contamination was believed to be the storage tank. A laboratory sample for clean closure conformation was collected under this tank. The extent of contamination was determined to be limited to the extent of the bermed containment encompassing both storage tanks, approximately 20 feet x30 feet and 16 feet in depth at the deepest point. The impacted soils were removed and land farmed at the Quinn Compressor Station. The excavation was backfilled with clean soils and the facility was rebuilt. A diagram of the excavation and analytical results are included in Attachment 2.***

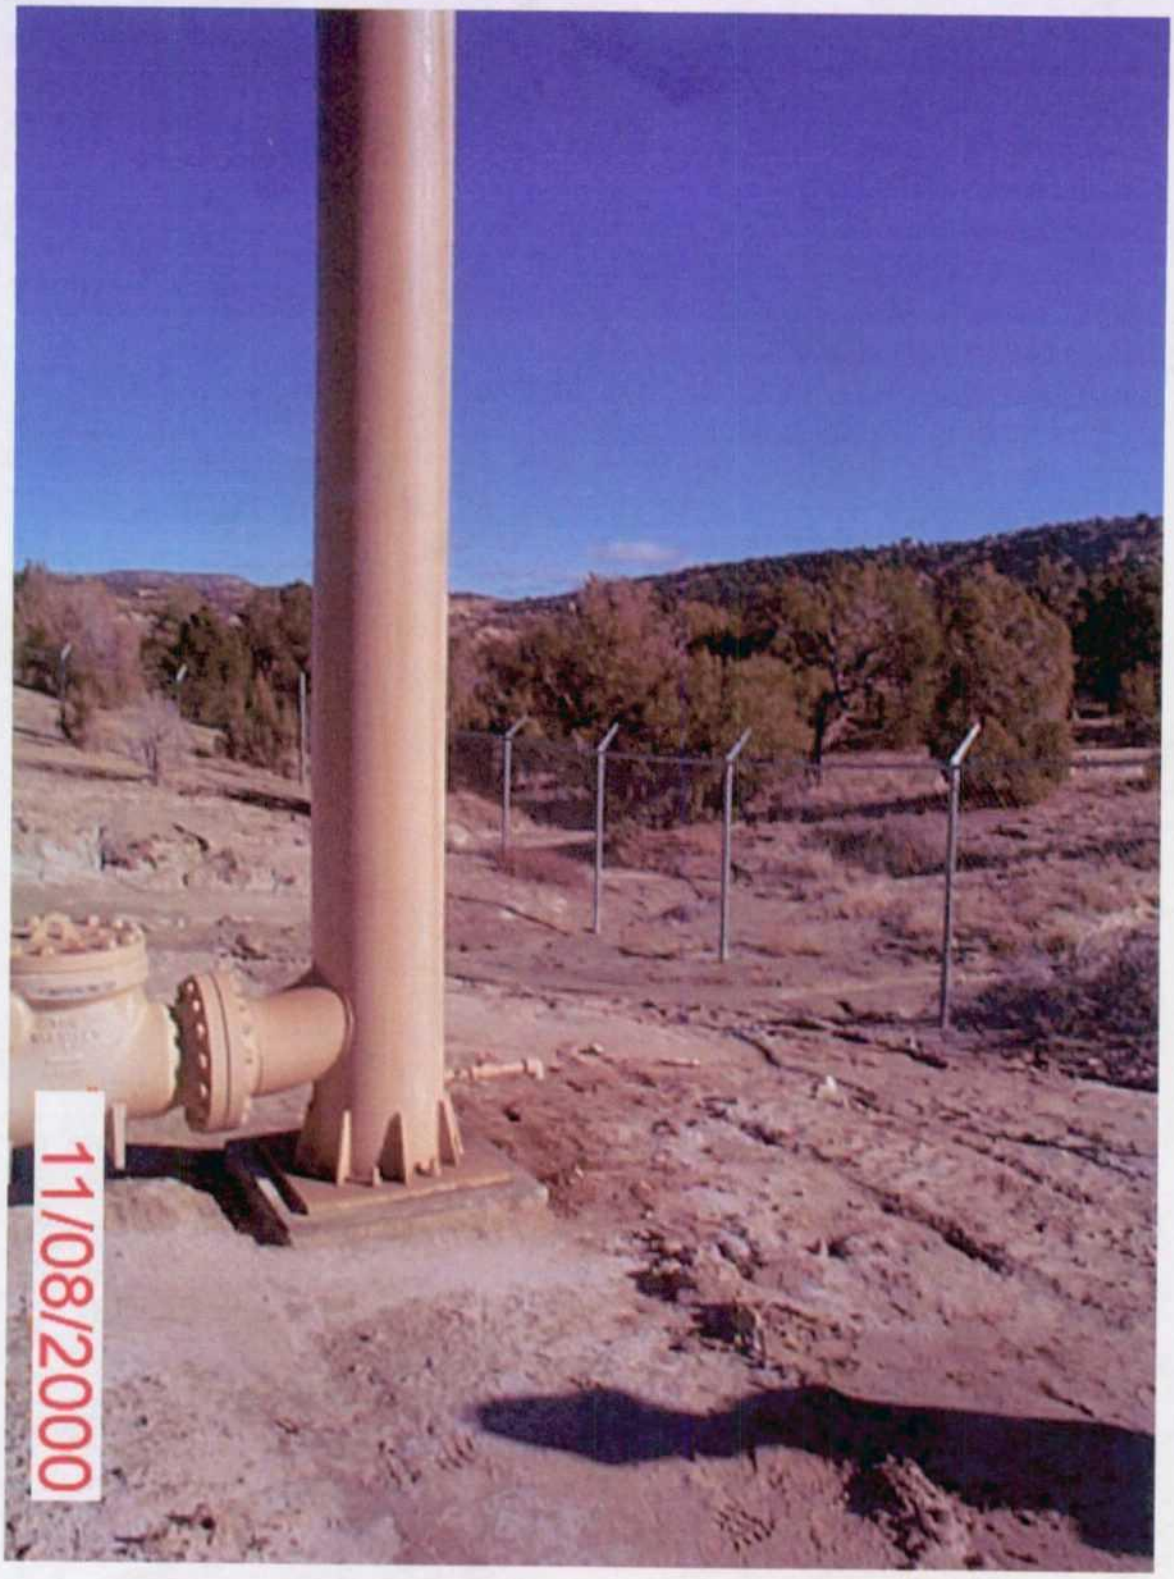
Picture #2- Plant ESD and normal vent stack located east of plant.

Plant main vent system has oil accumulating on stack and system is located in stormwater drain area. ***The staining was caused by hydrocarbons and water that have accumulated in the Emergency Shut Down stack between shutdowns. Shut downs are infrequent and only in an emergency. The oil staining was observed to be insignificant and unlikely to contribute to a reportable storm water release. However, the soil was cleaned and will be monitored for future stack accumulations and any resulting soil staining will be remediated.***

2. Process Areas: All process and maintenance areas which show evidence that leaks and spills are reaching the ground surface must be either paved and curbed or have some type of spill collection device incorporated into the design.
ESD VENT - MOUNTED IN ARROYO - NEEDS PROPER CONTAINMENT/CONTROL TO SATISFY STORMWATER PLAN - VISUAL OIL ON STACK
PIC # 2

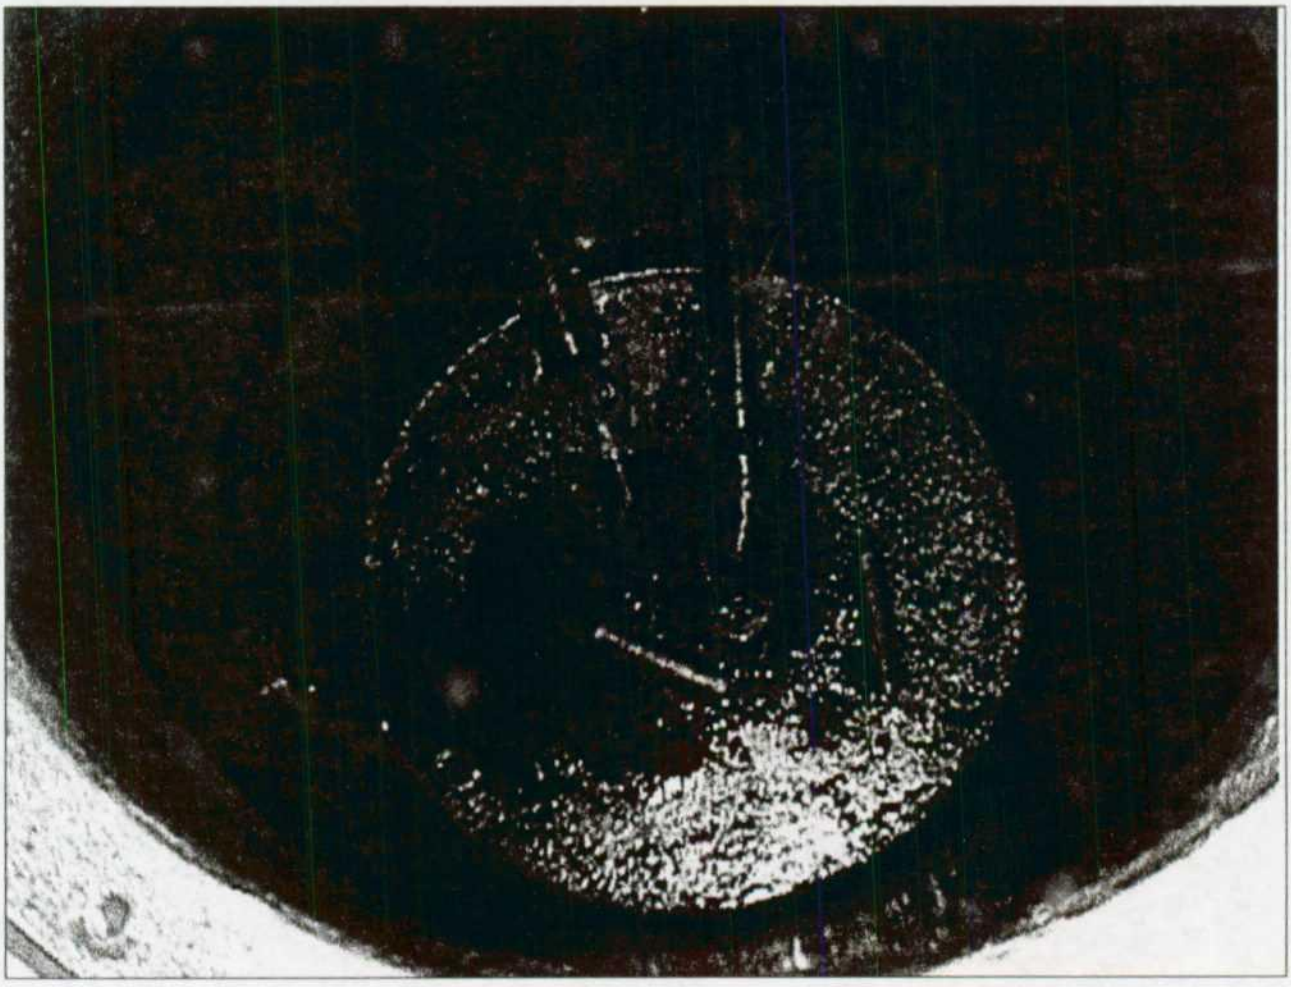
Photograph:

Comments: *No problems were observed. Kevin Johnson was present for all sump inspections.*

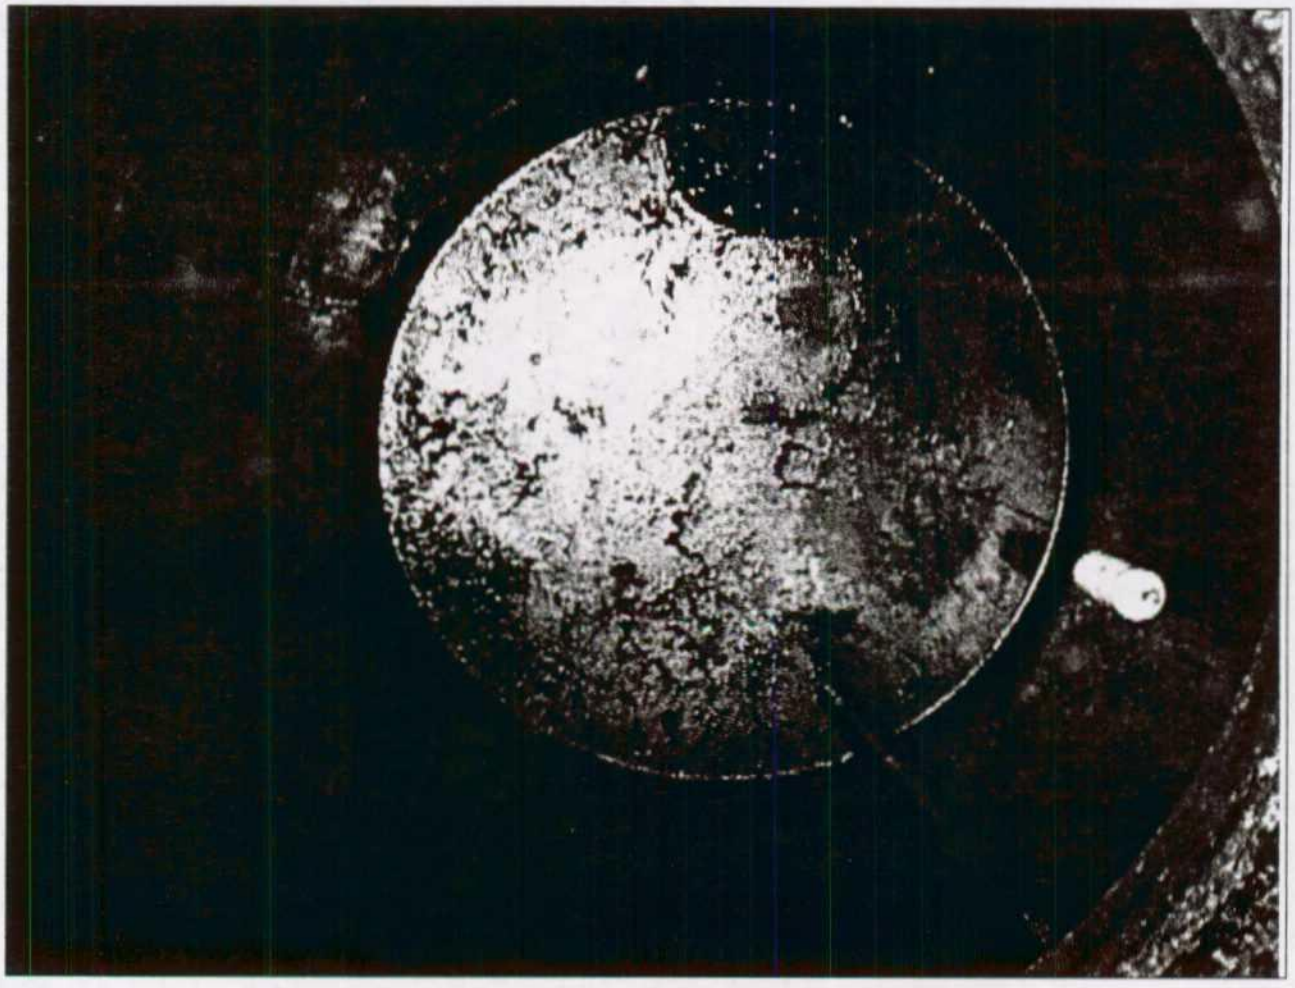
Compressor Station:	*Cedar Hill*
Section:	29
Township	30N
Range:	10W
Date of Inspection:	5/26/99
Plan Expiration Date:	9/30/01
OCD Notified Date:	5/18/99 Written Correspondence to Santa Fe

Comments: *No problems were observed. Kevin Johnson was present for all sump inspections.*

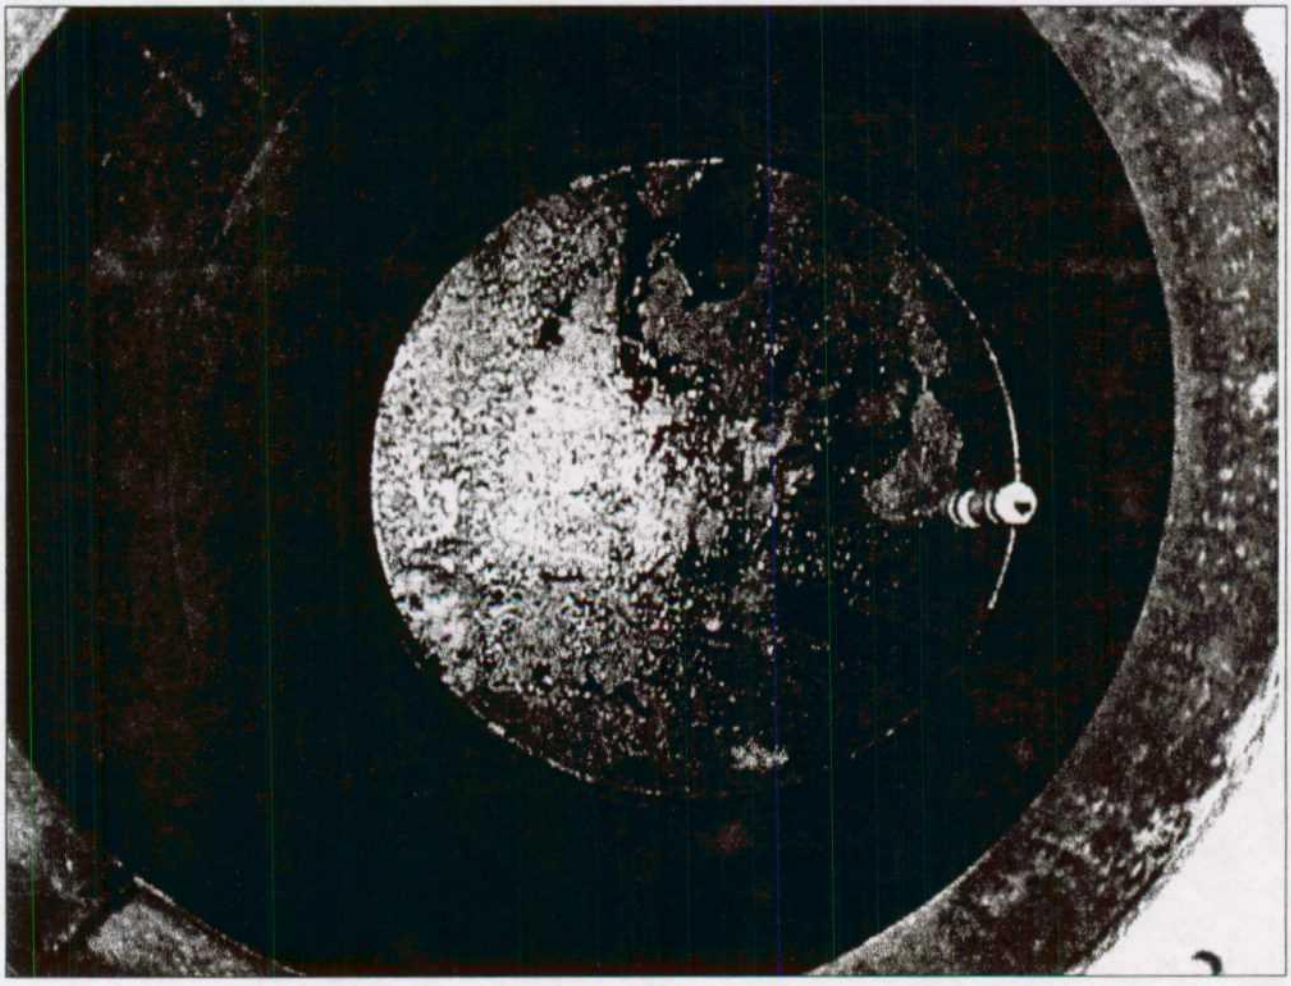
Compressor Station:	*Frances Mesa*
Section:	27
Township	30N
Range:	7W
Date of Inspection:	5/27/99
Plan Expiration Date:	6/9/00
OCD Notified Date:	5/18/99 Written Correspondence to Santa Fe

Comments: *No problems were observed. Kevin Johnson was present for all sump inspections.*

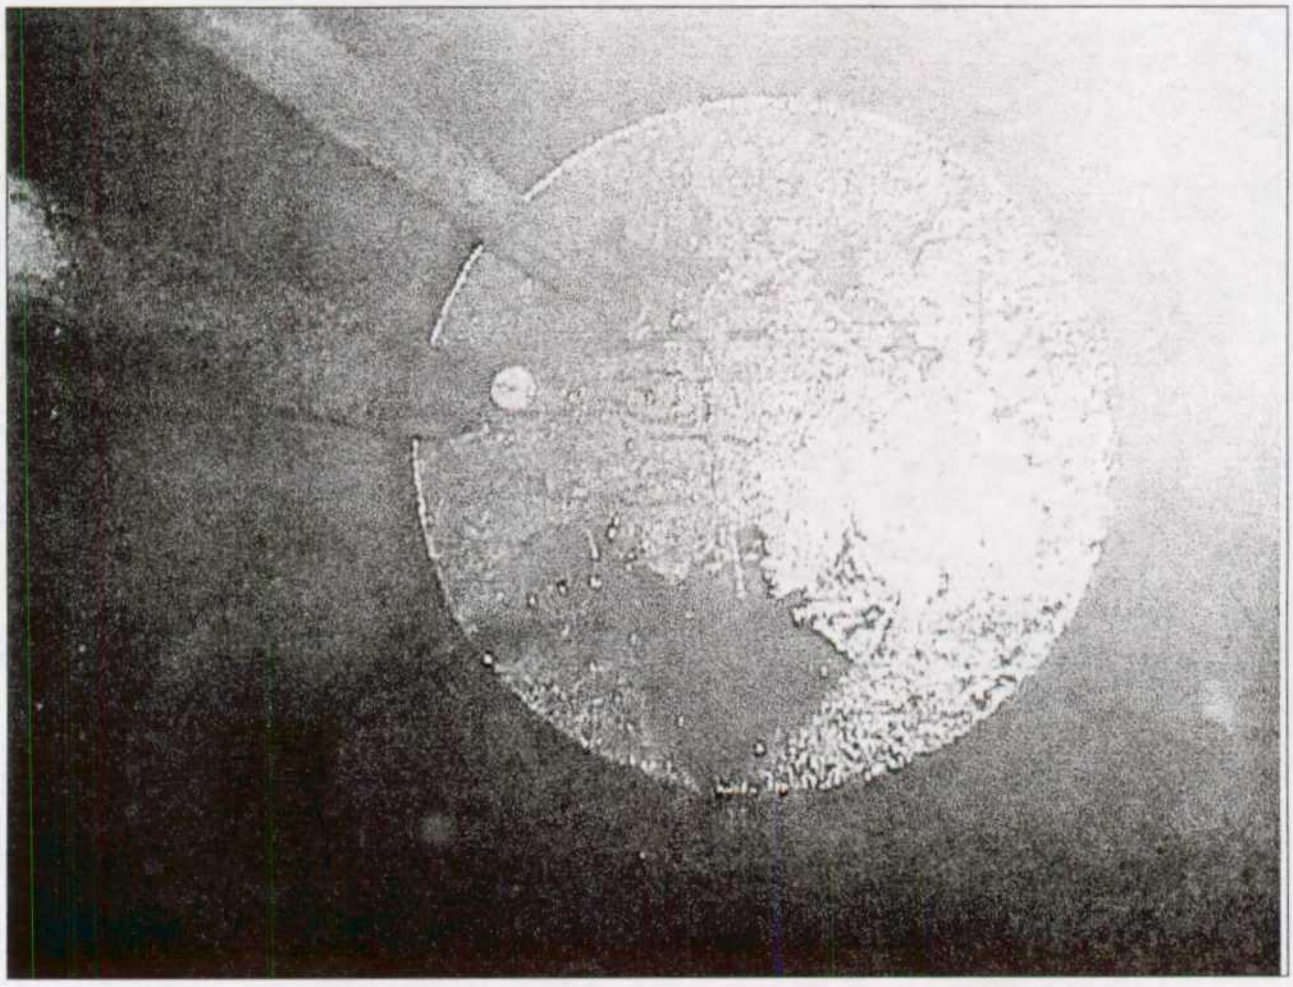
Compressor Station:	*Gobernador Compressor*
Section:	10
Township	31N
Range:	7W
Date of Inspection:	5/26/99
Plan Expiration Date:	1/11/00
OCD Notified Date:	5/18/99 Written Correspondence to Santa Fe

Comments: *No problems were observed. Kevin Johnson was present for all sump inspections.*

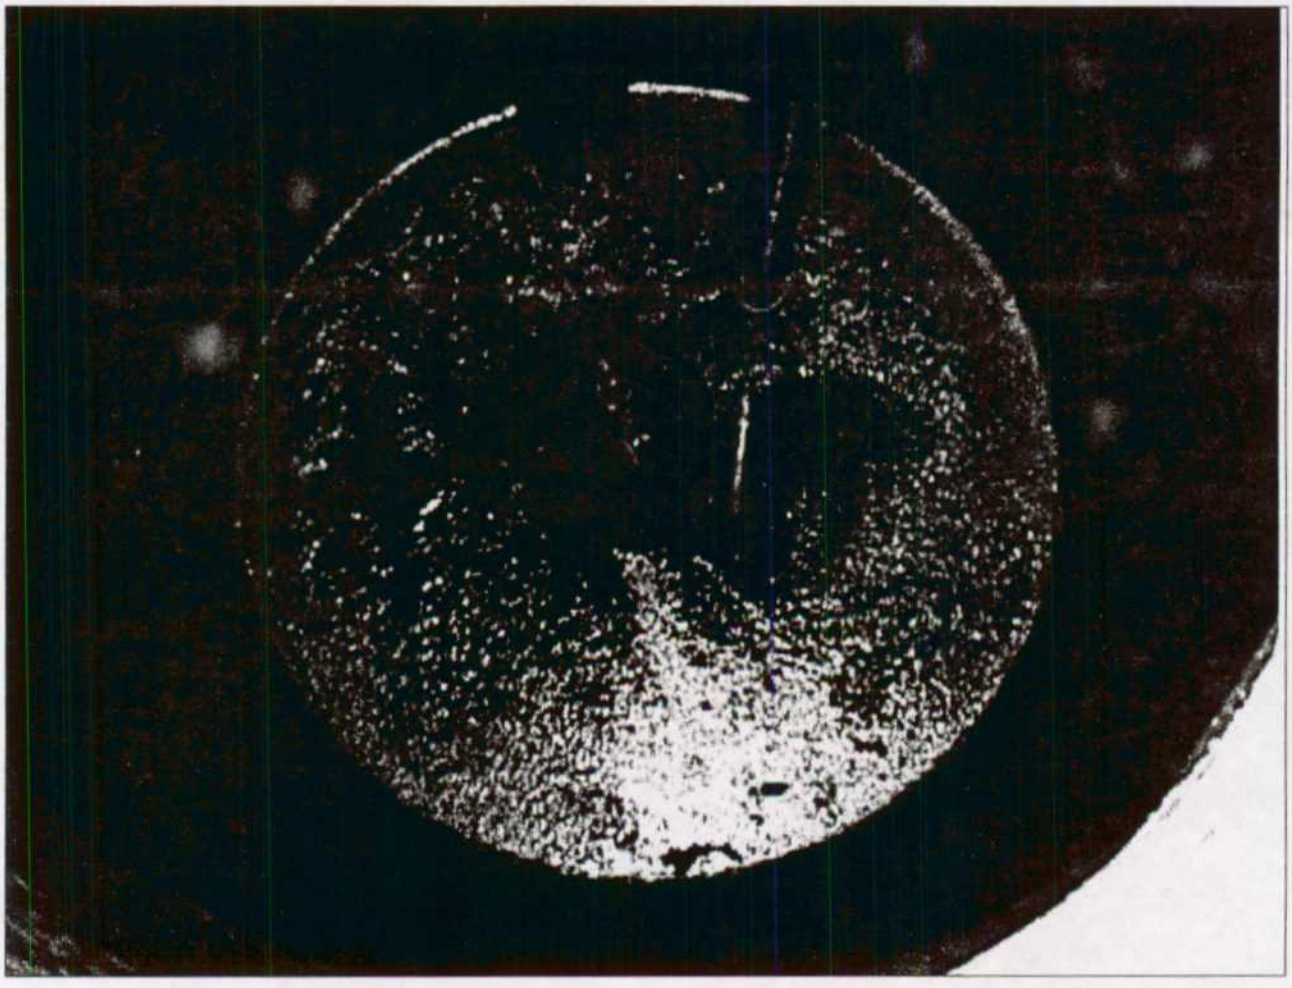
Compressor Station:	*Hart Canyon*
Section:	20
Township	31N
Range:	10W
Date of Inspection:	5/26/99
Plan Expiration Date:	0/11/00
OCD Notified Date:	5/18/99 Written Correspondence to Santa Fe

Comments: *No problems were observed. Kevin Johnson was present for all sump inspections.*

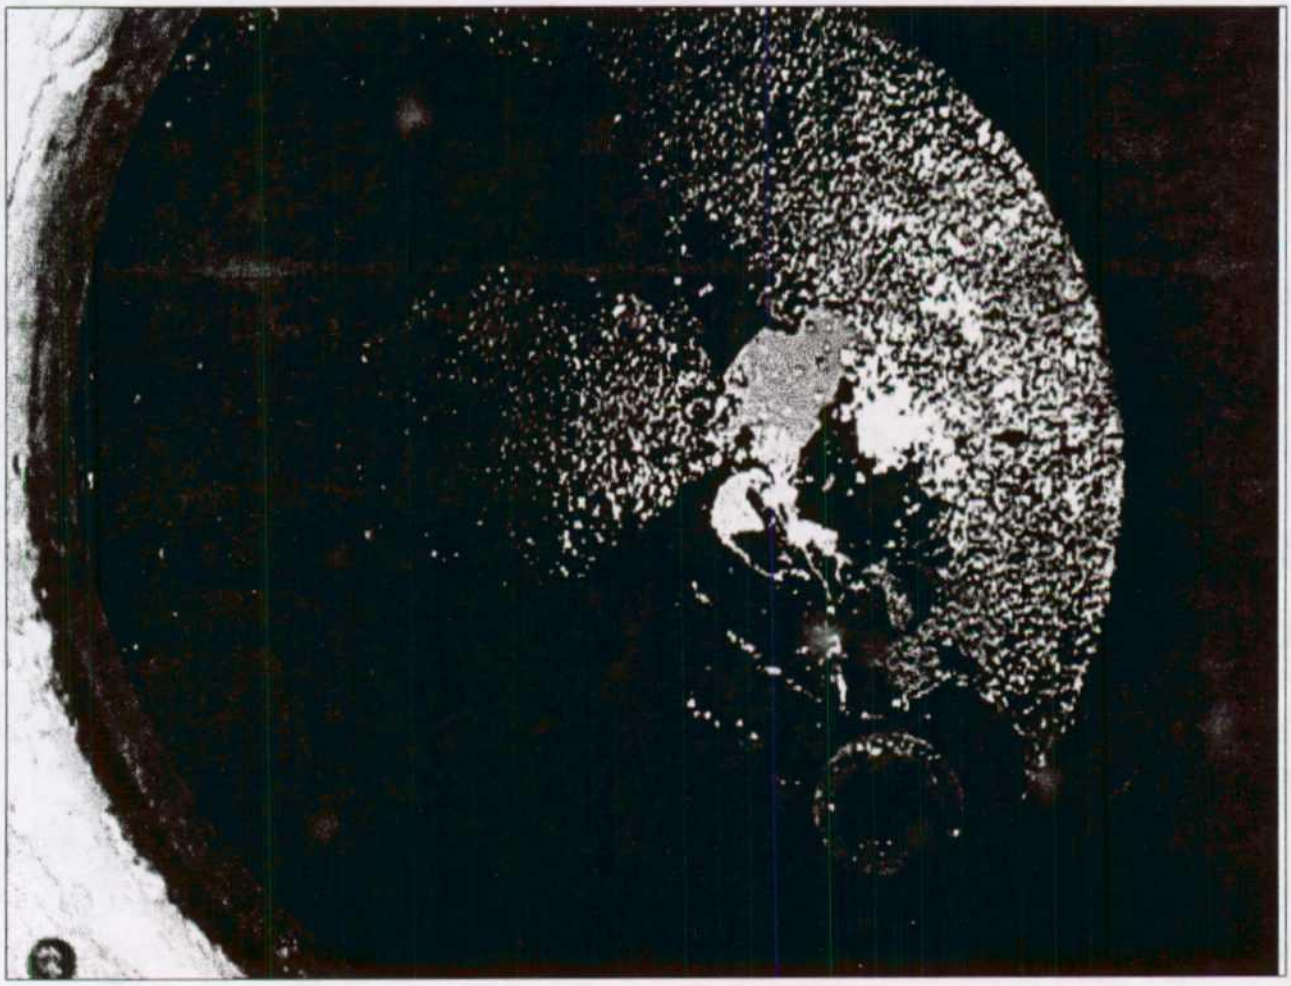
Compressor Station:	*Manzanares*
Section:	4
Township	29N
Range:	8W
Date of Inspection:	5/27/99
Plan Expiration Date:	0/11/00
OCD Notified Date:	5/18/99 Written Correspondence to Santa Fe

Comments: *No problems were observed. Kevin Johnson was present for all sump inspections.*

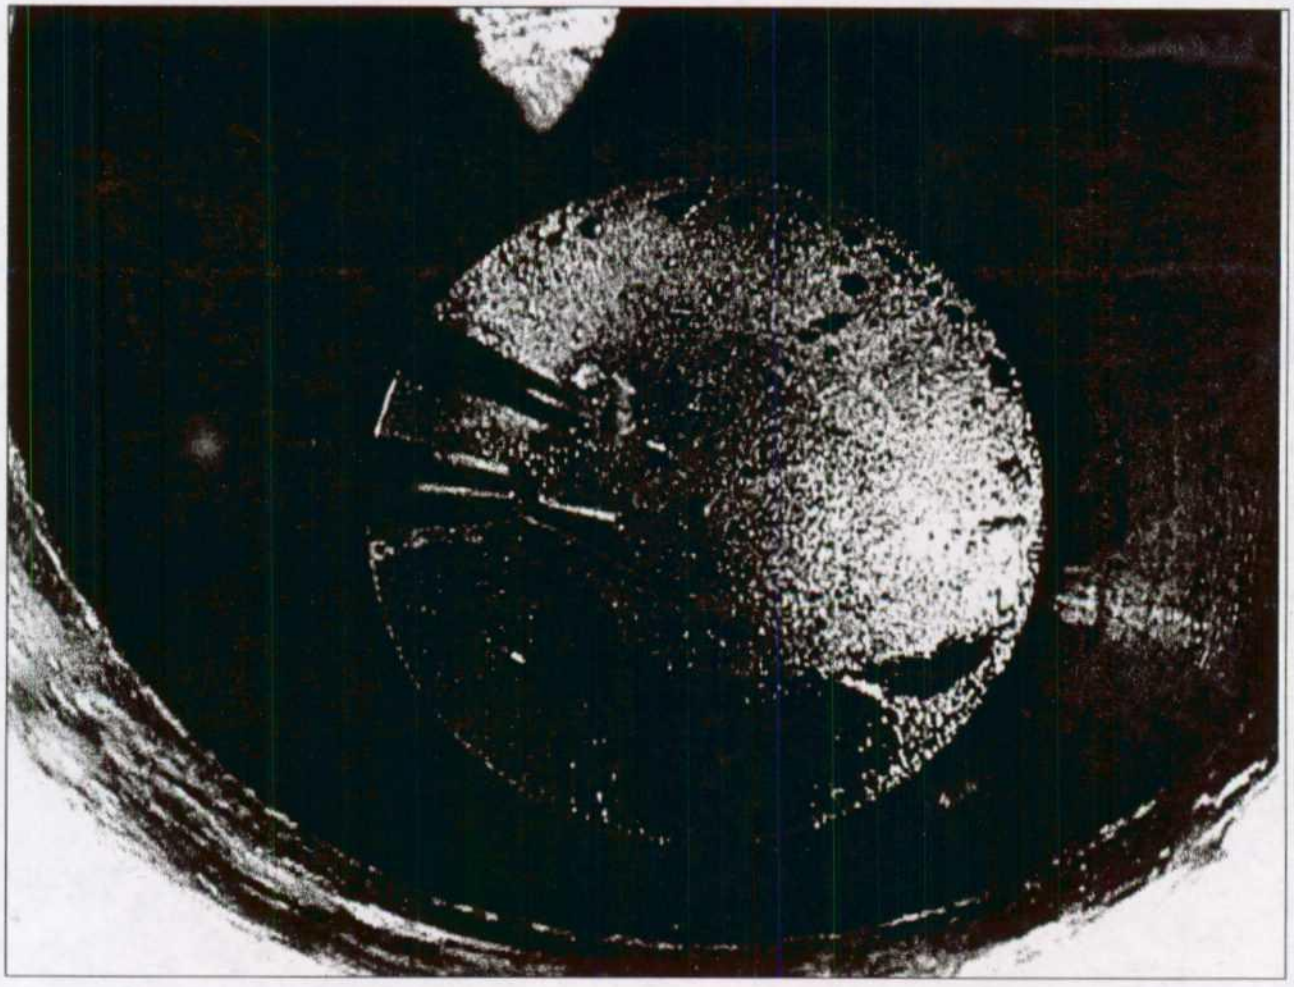
Compressor Station:	*Middle Mesa Compressor*
Section:	10
Township	31N
Range:	7W
Date of Inspection:	5/26/99
Plan Expiration Date:	1/14/01
OCD Notified Date:	5/18/99 Written Correspondence to Santa Fe

Comments: *No problems were observed. Kevin Johnson was present for all sump inspections.*

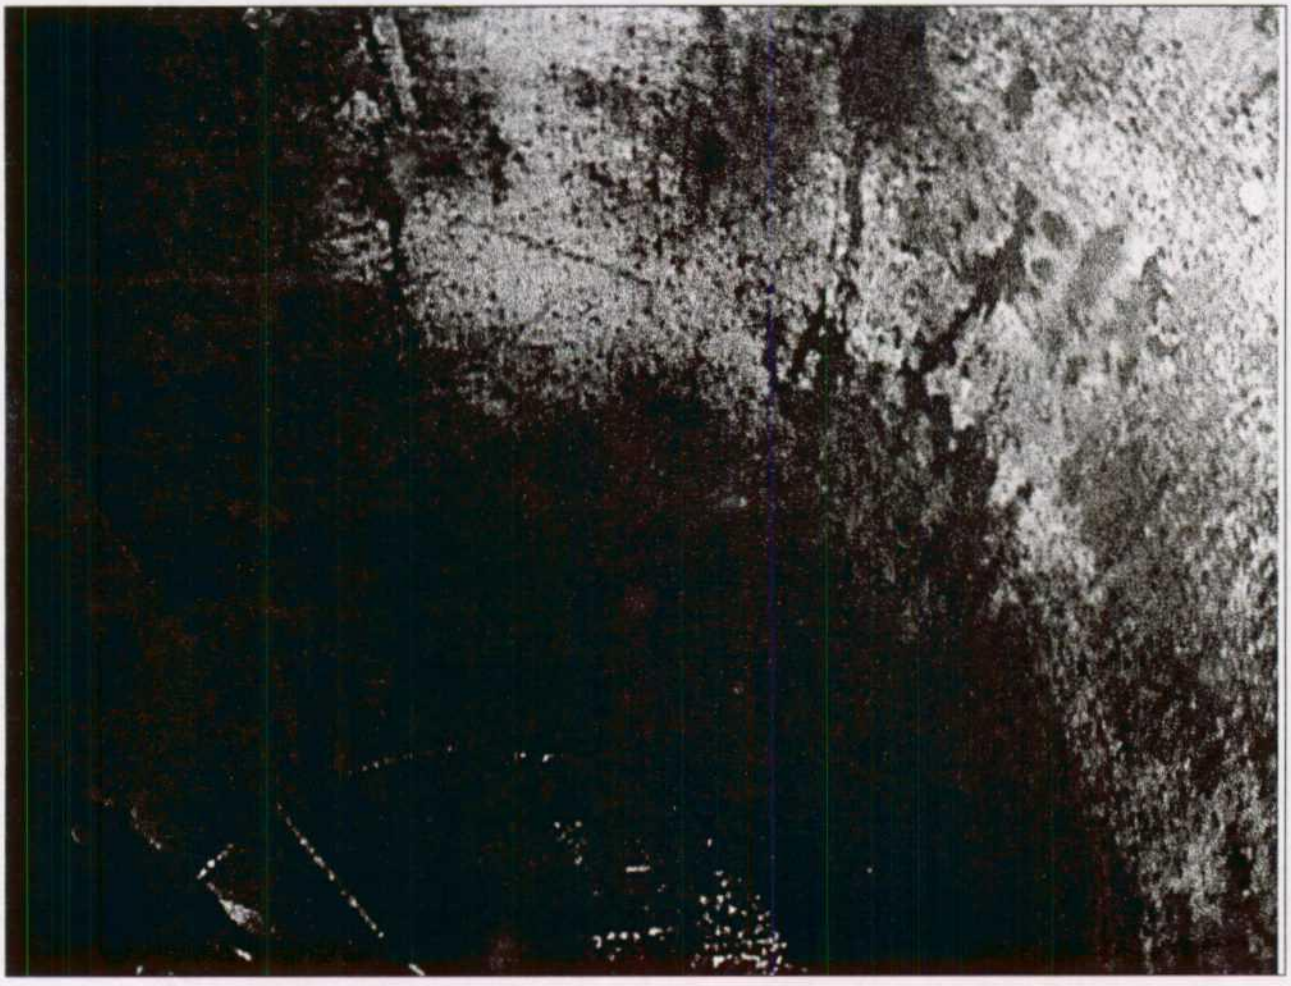
Compressor Station:	*Pump Canyon*
Section:	24
Township	30N
Range:	9W
Date of Inspection:	5/25/99
Plan Expiration Date:	11/7/00
OCD Notified Date:	5/18/99 Written Correspondence to Santa Fe

Comments: *No problems were observed. Kevin Johnson was present for all sump inspections.*

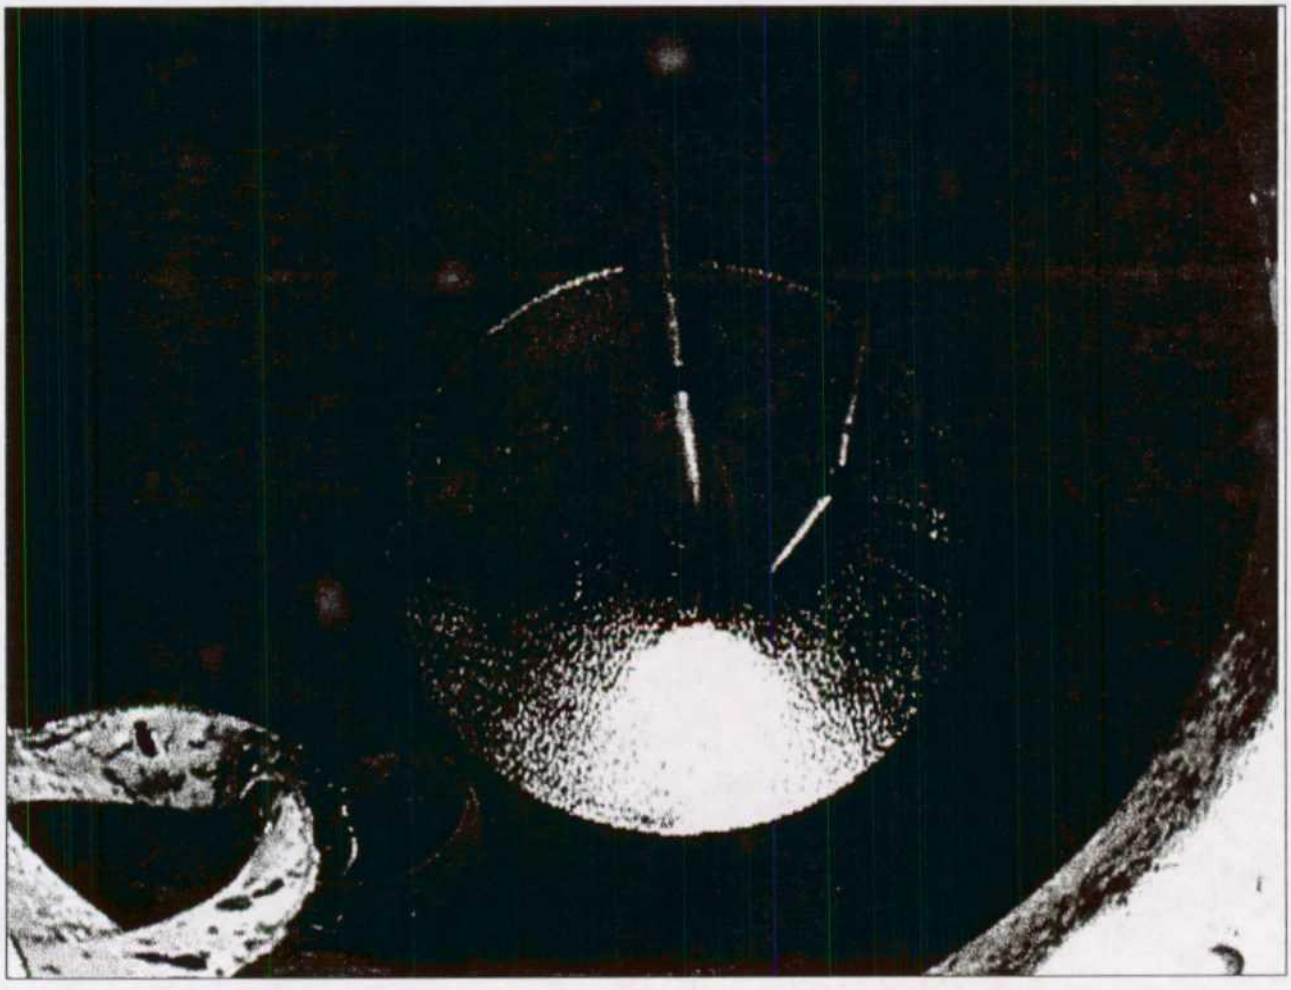
Compressor Station:	*Pump Mesa*
Section:	27
Township	30N
Range:	7W
Date of Inspection:	5/25/99
Plan Expiration Date:	8/19/03
OCD Notified Date:	5/18/99 Written Correspondence to Santa Fe

Comments: *No problems were observed. Kevin Johnson was present for all sump inspections. OCD was not present.*

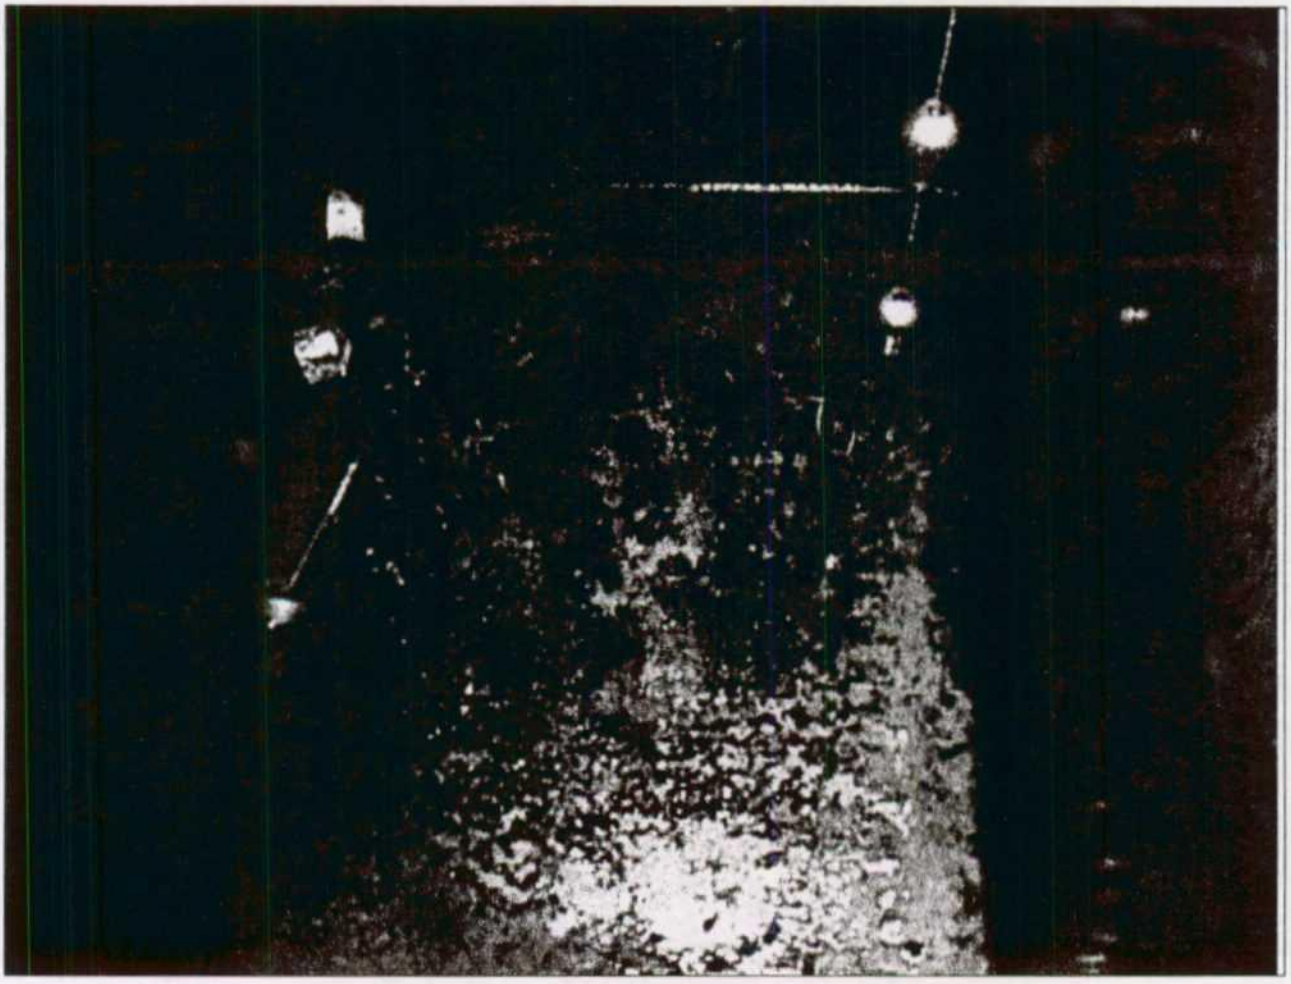
Compressor Station:	*Quinn*	
Section:	16	
Township	31N	
Range:	8W	
Date of Inspection:	5/25/99	
Plan Expiration Date:	8/9/01	
OCD Notified Date:	5/18/99	Written Correspondence to Santa Fe

Comments: *No problems were observed. Kevin Johnson was present for all sump inspections.*

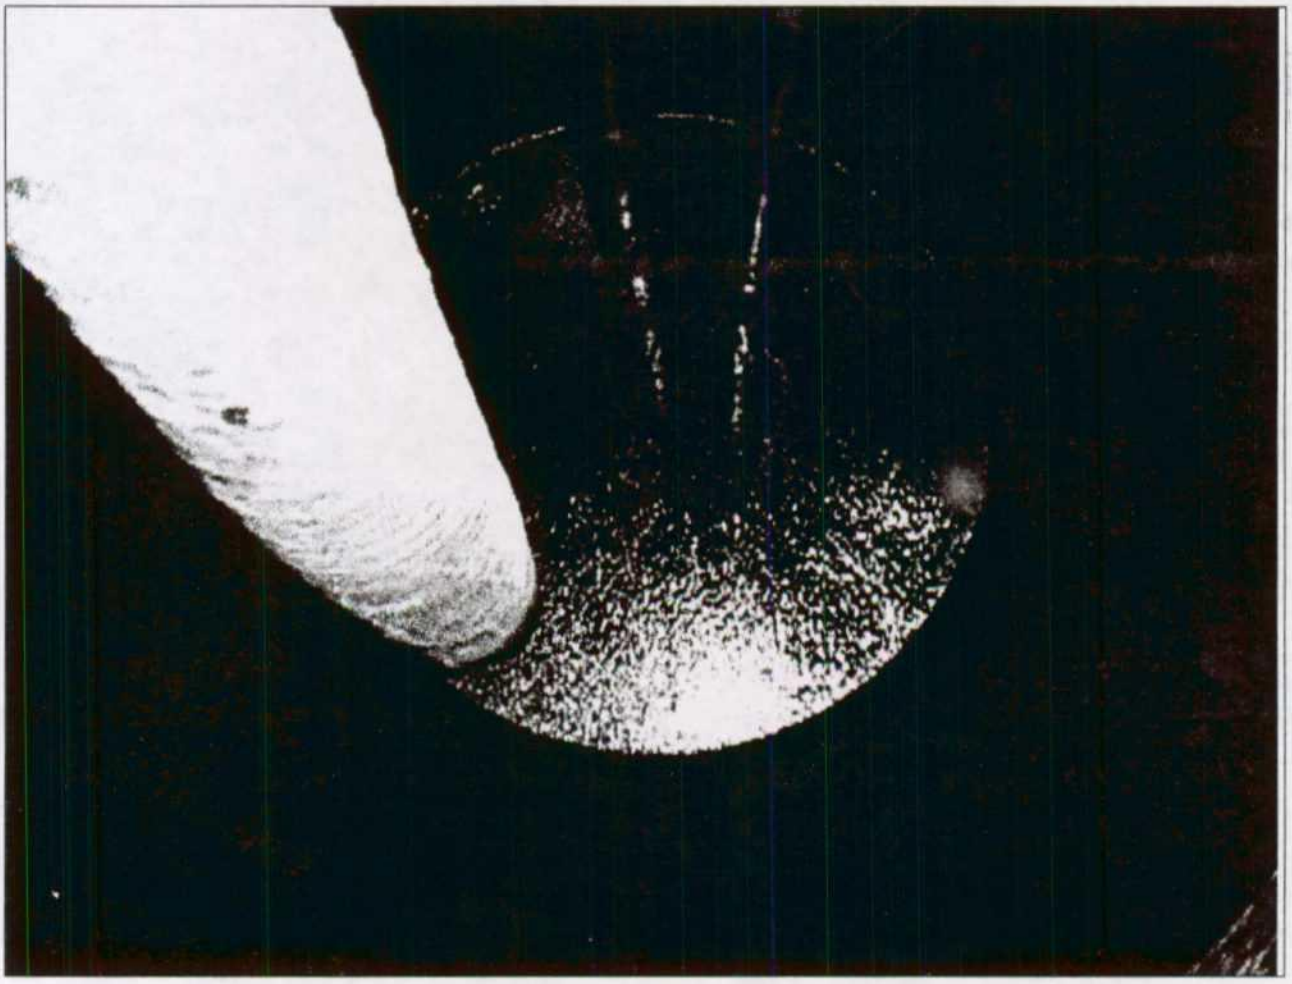
Compressor Station:	*Rattlesnake*
Section:	10
Township	31N
Range:	7W
Date of Inspection:	5/25/99
Plan Expiration Date:	1/17/02
OCD Notified Date:	5/18/99 Written Correspondence to Santa Fe

Comments: *No problems were observed. Kevin Johnson was present for all sump inspections.*

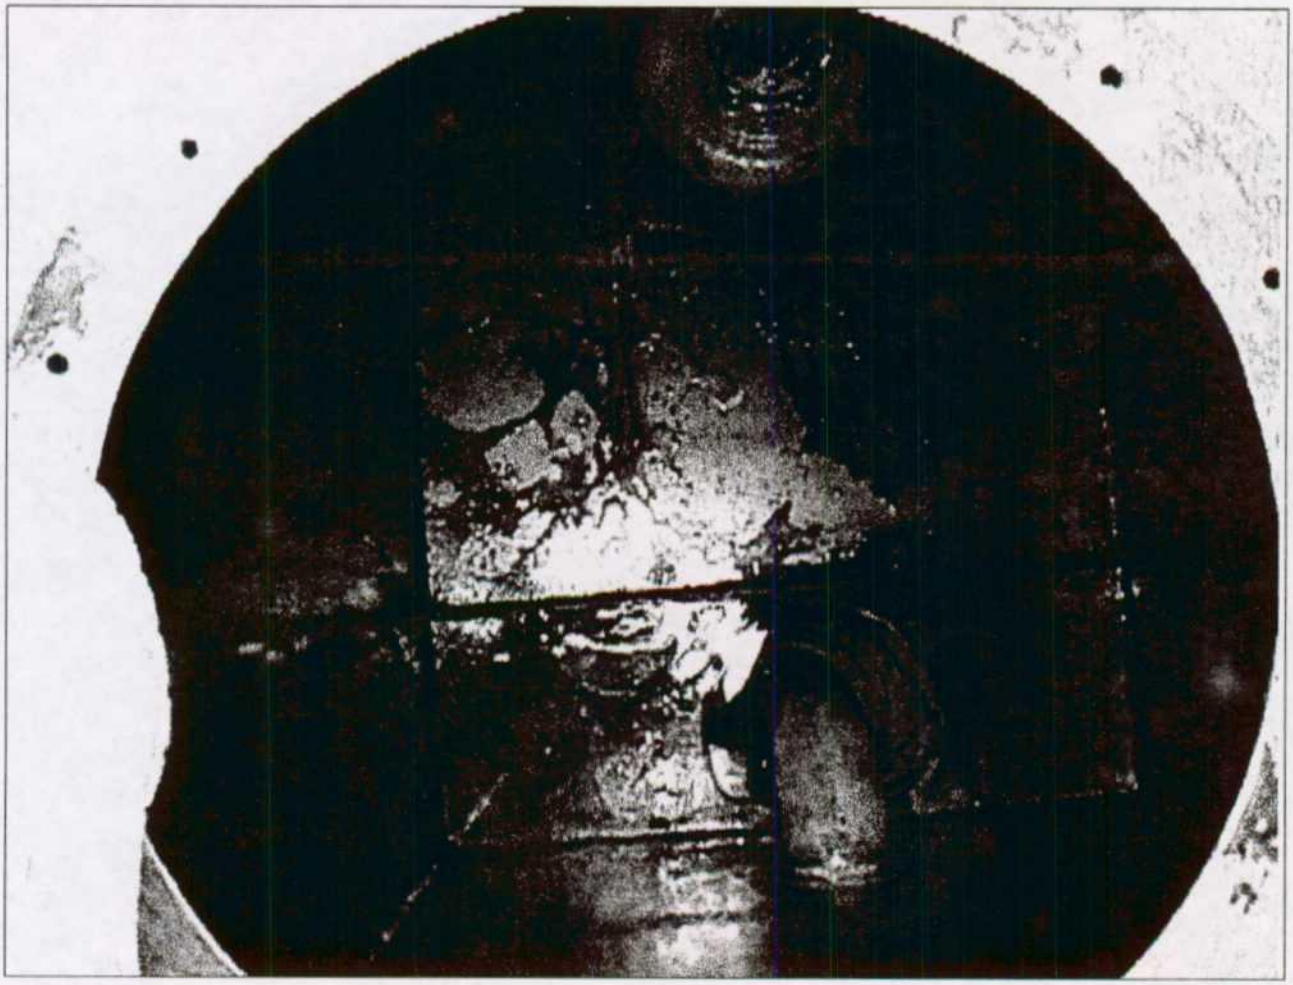
Compressor Station:	*Sims Mesa*
Section:	22
Township	30N
Range:	7W
Date of Inspection:	5/27/99
Plan Expiration Date:	8/19/03
OCD Notified Date:	5/18/99 Written Correspondence to Santa Fe

Comments: *No problems were observed. Kevin Johnson was present for all sump inspections.*

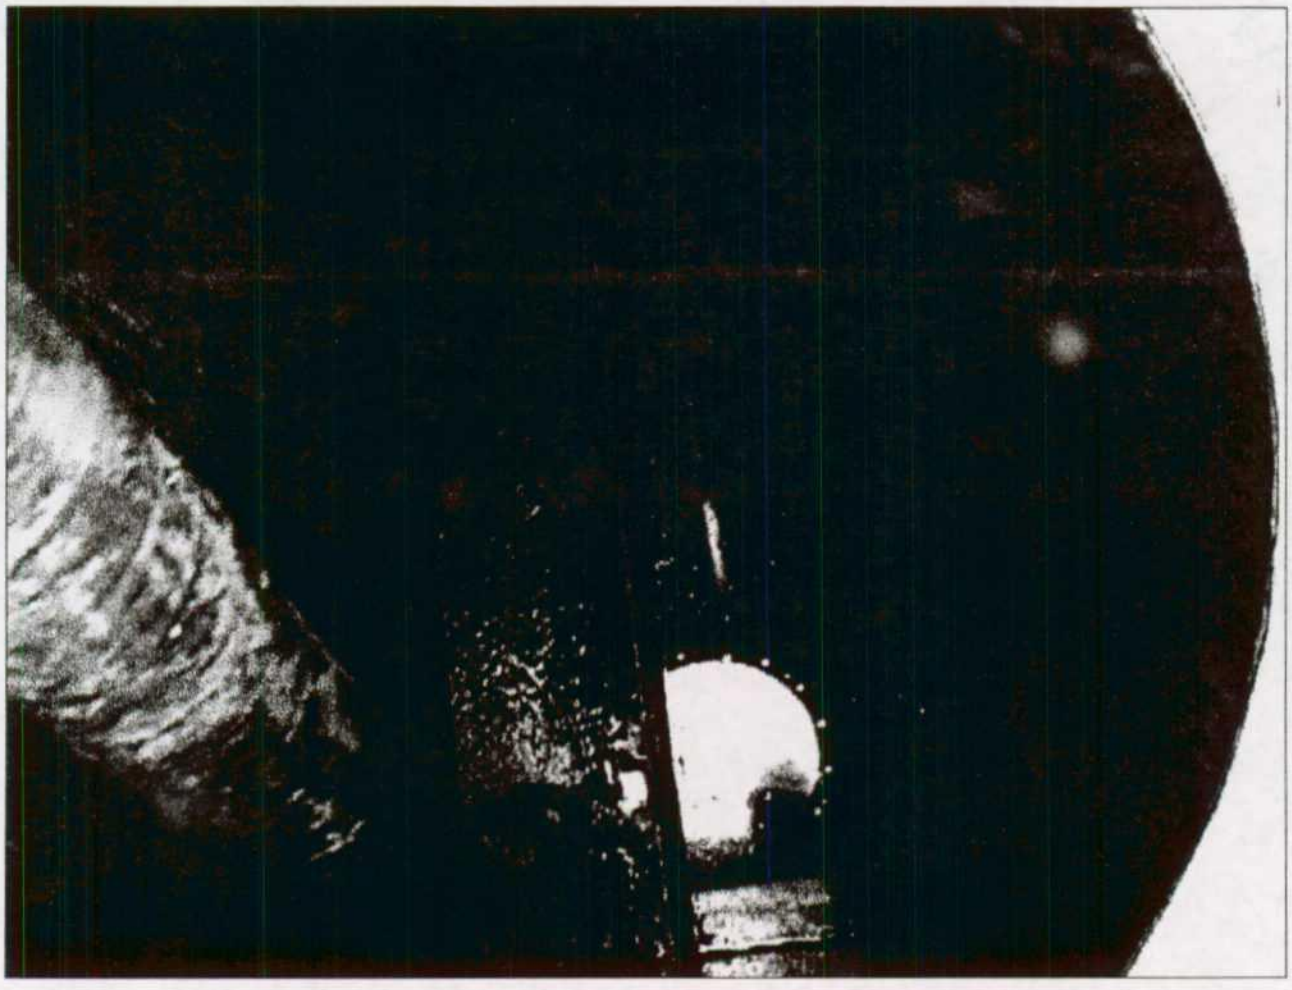
Compressor Station:	*Sandstone*
Section:	32
Township	31N
Range:	8W
Date of Inspection:	5/25/99
Plan Expiration Date:	6/9/00
OCD Notified Date:	5/18/99 Written Correspondence to Santa Fe

Comments: *No problems were observed. Kevin Johnson was present for all sump inspections.*
