Louis Dreyfus Natural Gas

Re: MKL #5
Section 6, T26N, R07W, NW/NE
Rio Arriba County, New Mexico

PIT REMEDIATION AND CLOSURE REPORT

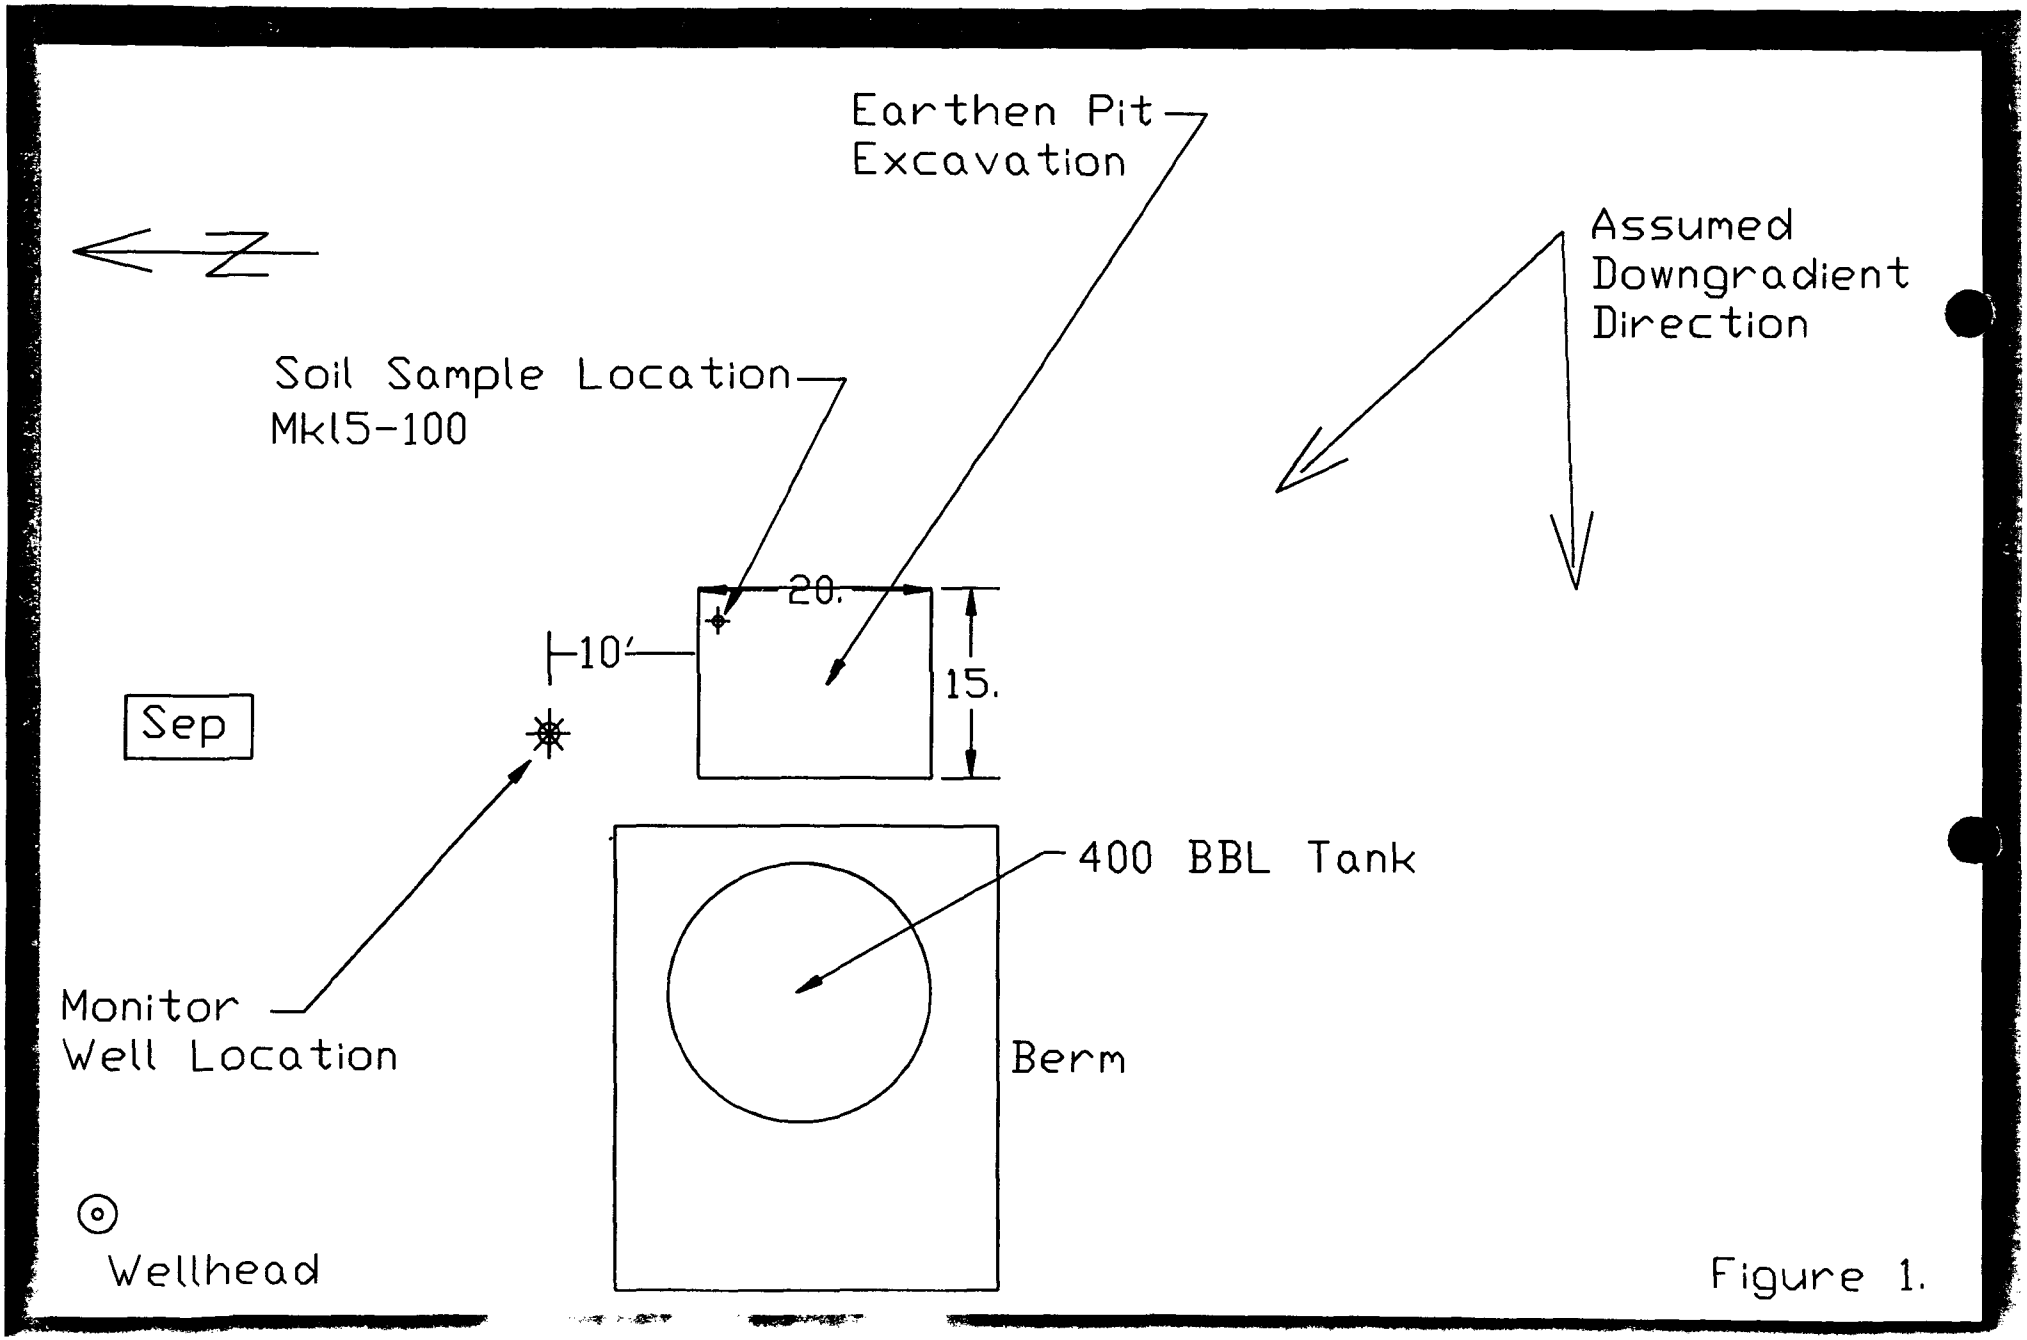
Figure 1.

CES with the help of Phillip Environmental installed the monitor well to a depth of approximately 37 feet. The monitor well is located 10' from the northwest corner of the excavation (Please see attached Figure 1). The bottom 15' of the 4" PVC pipe was slotted (Please see attached Figure 2) and the top 22' was completed with unscreened PVC pipe. The bottom of the monitor well has a 4" screw-on plug that prevents sediments from entering the bottom of the well. All of the joints were composed of screw-together threads. Silica sand was backfilled 2' above the slotted interval. Above the sand a 2' bentonite plug was placed. The remainder of the open hole was grouted to within 2' of groundlevel. From this point to the surface, the PVC pipe was cemented in place. A riser was left on the monitoring well approximately 3' above ground level. T-posts and fluorescent flagging was placed on all sides of the monitor well to protect it before leaving.

As confirmed with NMOCD, CES recommends that a second interval of BTEX water analyses should be collected from the monitor well within 60 days. If the BTEX concentration is below groundwater standards as found in this first interval, the monitoring well should be grouted to the surface and abandoned. "No Further Action" would be applied for to NMOCD for groundwater remediation. The contaminated soil in the soil farm should be regularly tilled as the weather warms until it has been reduced to less than 100 PPM from a laboratory TPH analysis. The excavation could then be backfilled and a "Closure Package" prepared for distribution to NMOCD.

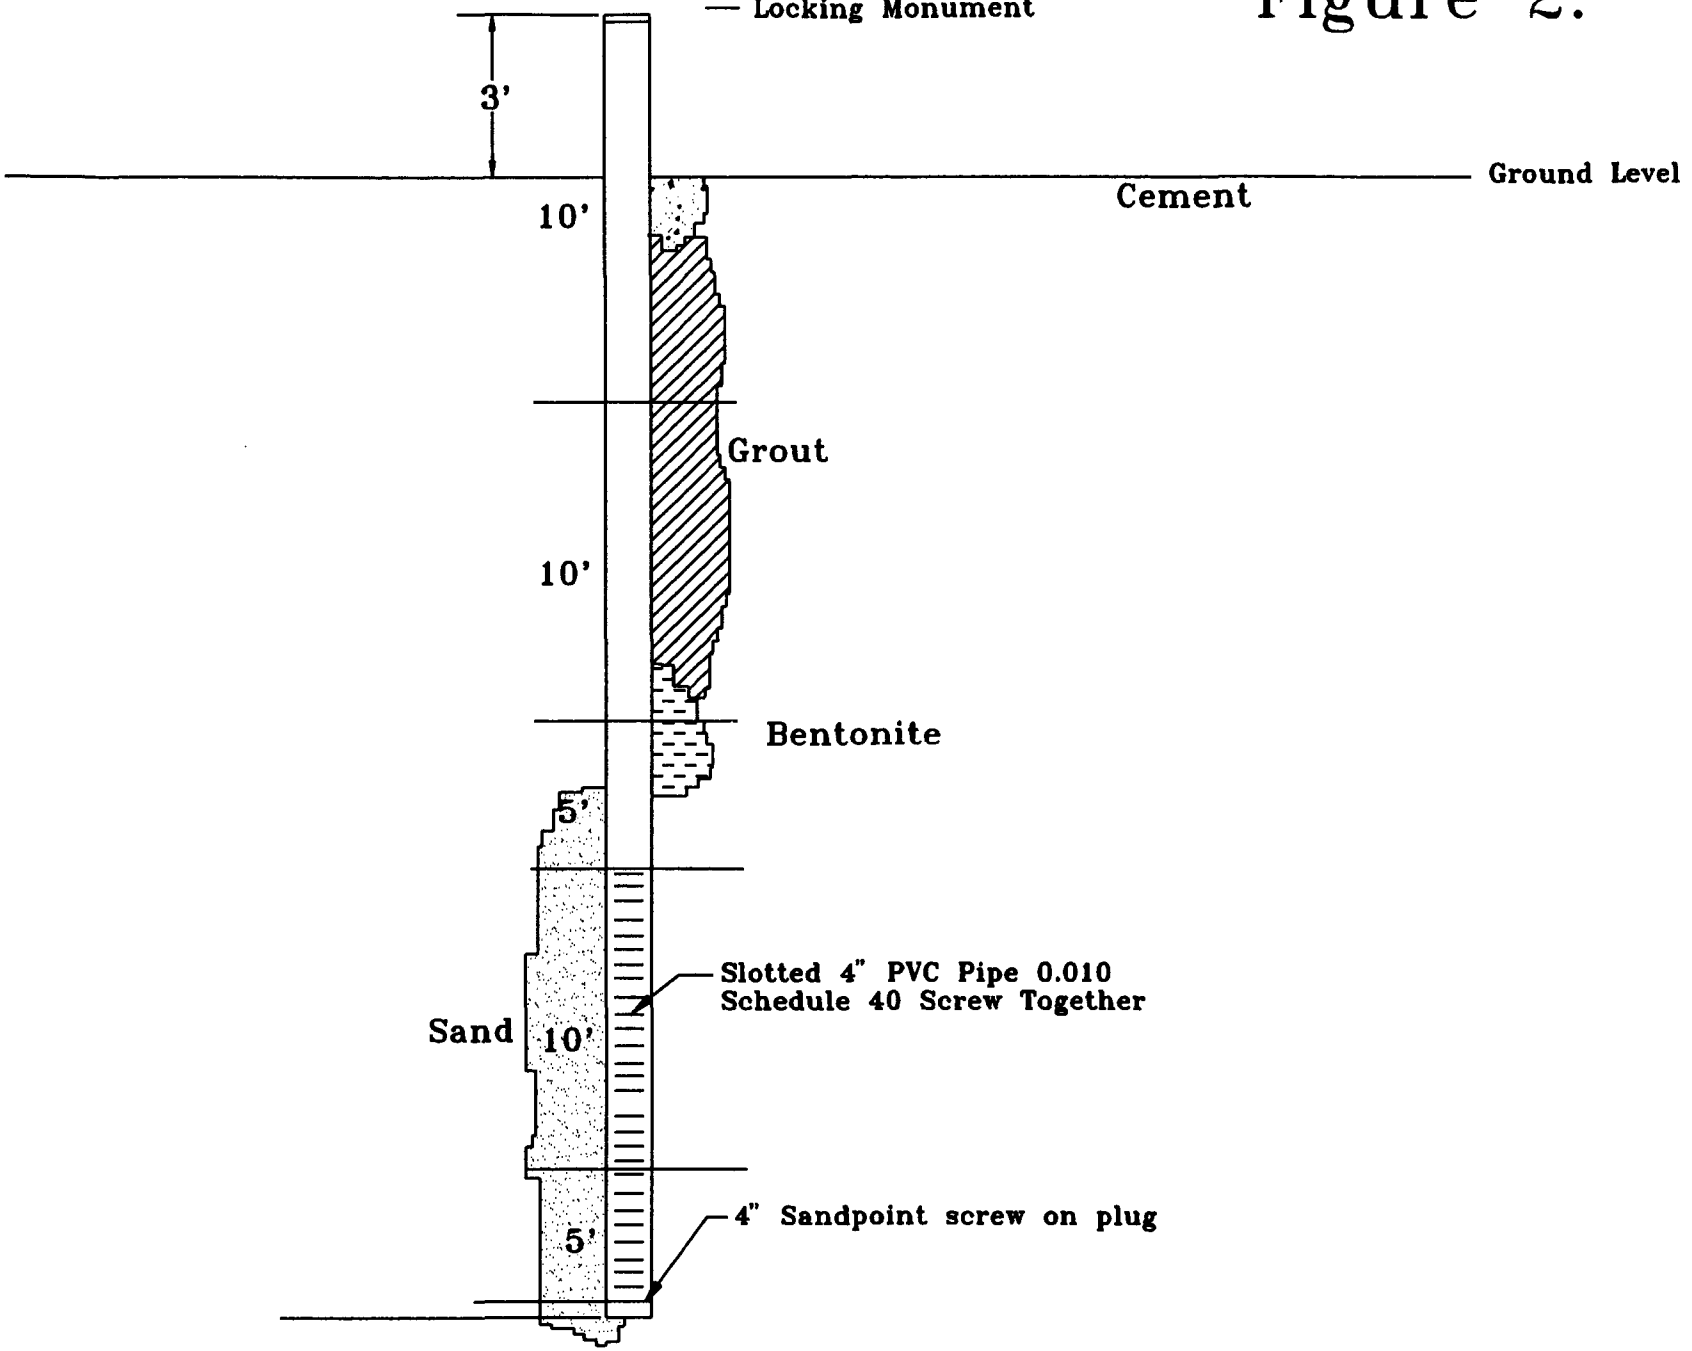
Figure 2.

— Locking Monument
3'
Ground Level
Cement
10'
Grout
10'
Bentonite
5'
Slotted 4" PVC Pipe 0.010
Schedule 40 Screw Together
Sand
10'
5'
4" Sandpoint screw on plug

During the drilling operations, soil samples were gathered approximately every 5' of depth. Samples were collected from split-spoon samplers driven 24" into the soil. The soil was placed in baggies and tested with the PID Meter for hydrocarbons. The depth to water from the top of the casing riser measured 18'-9 5/8". Considering the height of the riser, that makes the first measured depth to groundwater approximately 15'-9".

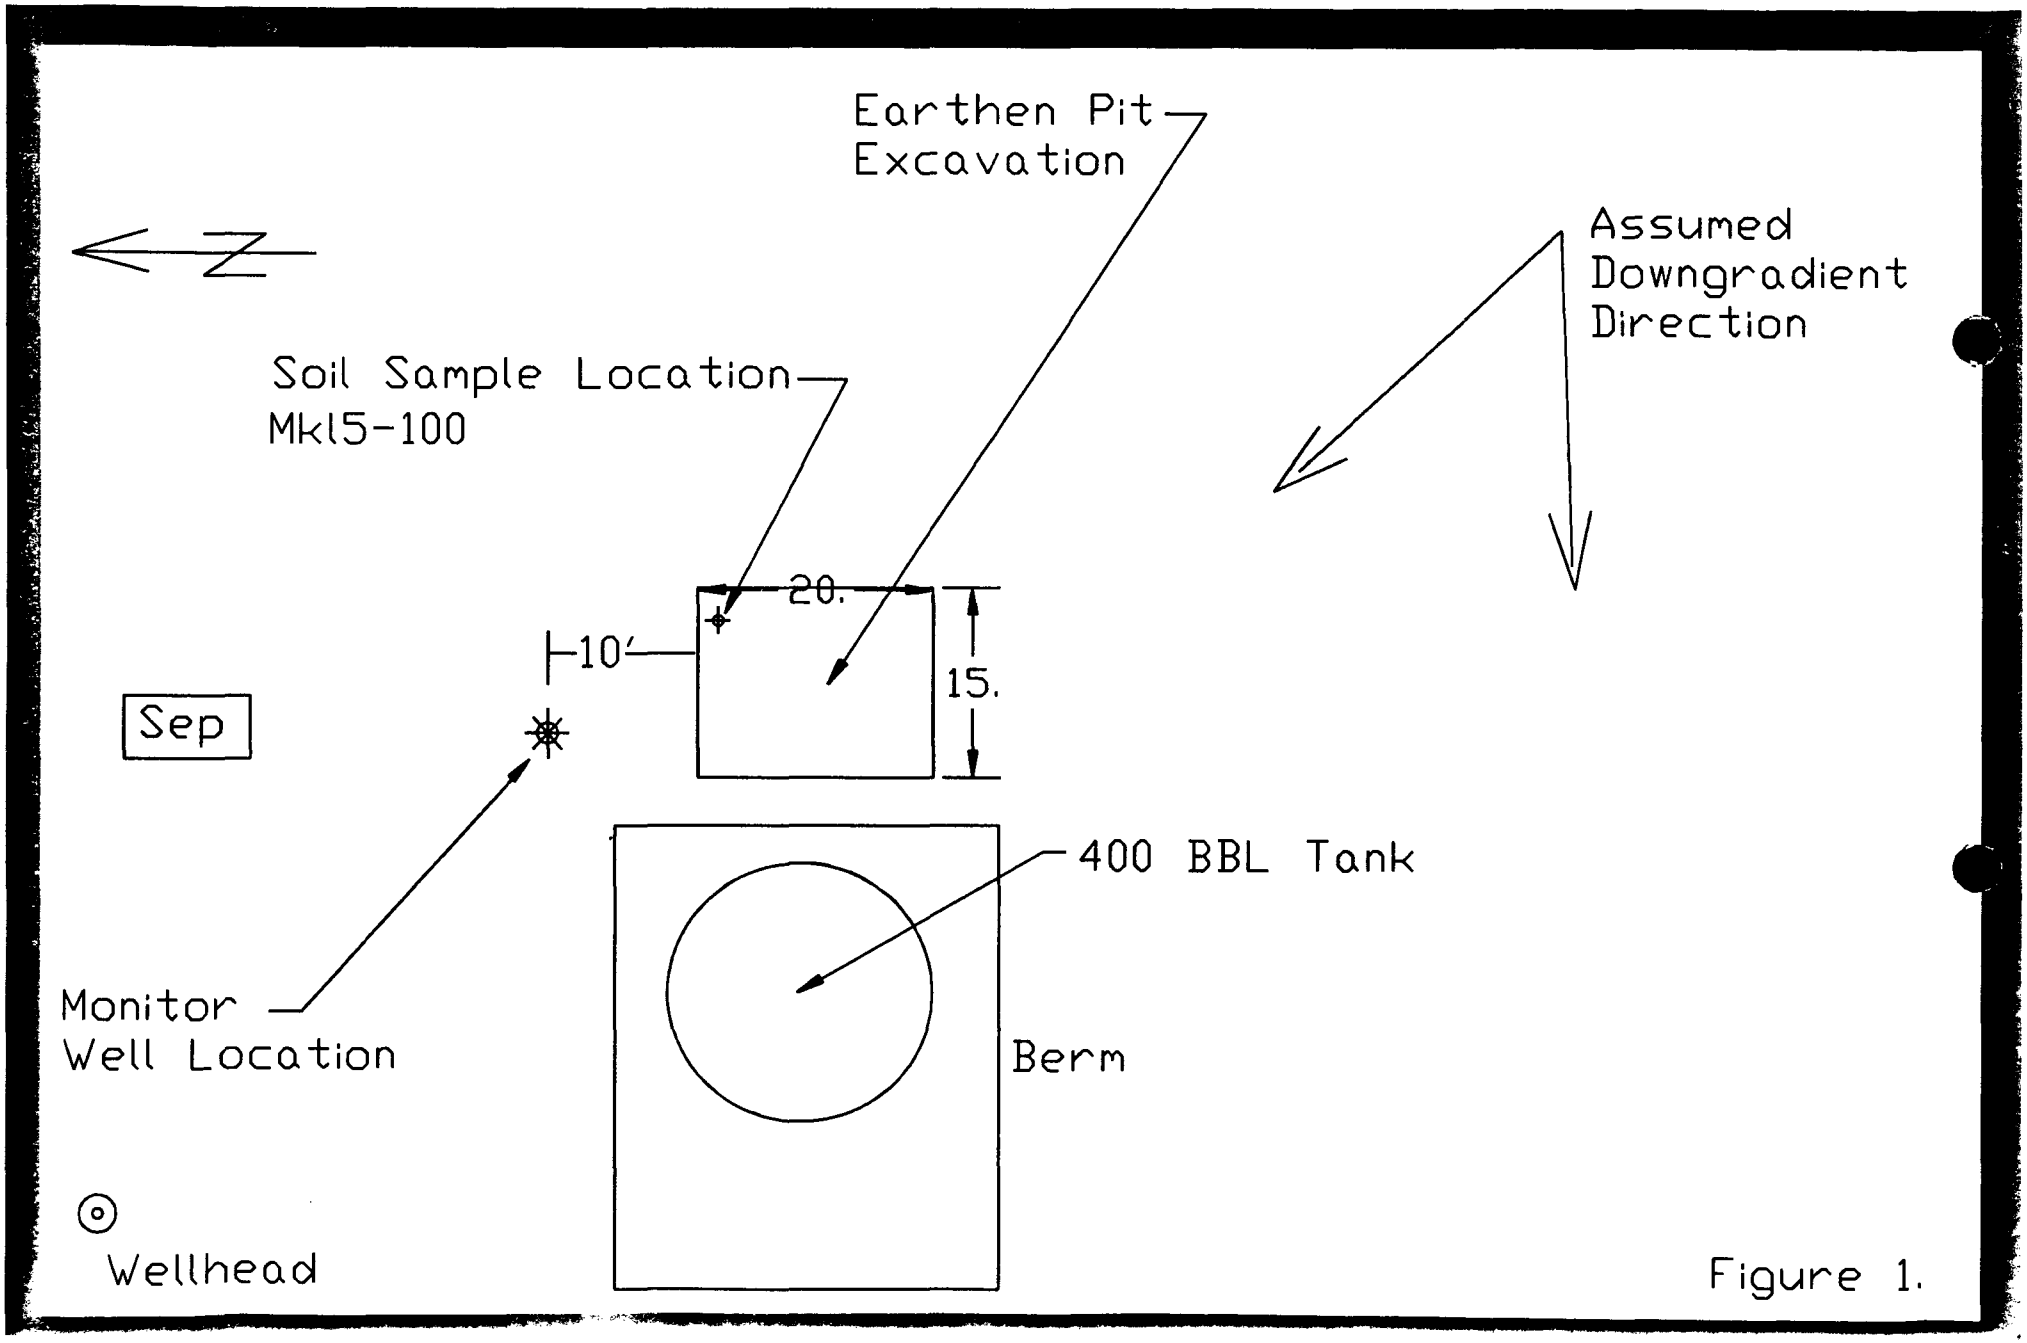
Figure 1.

CES with the help of Phillip Environmental installed the monitor well to a depth of approximately 37 feet. The monitor well is located 10' from the northwest corner of the excavation (Please see attached Figure 1). The bottom 15' of the 4" PVC pipe was slotted (Please see attached Figure 2) and the top 22' was completed with unscreened PVC pipe. The bottom of the monitor well has a 4" screw-on plug that prevents sediments from entering the bottom of the well. All of the joints were composed of screw-together threads. Silica sand was backfilled 2' above the slotted interval. Above the sand a 2' bentonite plug was placed. The remainder of the open hole was grouted to within 2' of groundlevel. From this point to the surface, the PVC pipe was cemented in place. A riser was left on the monitoring well approximately 3' above ground level. T-posts and fluorescent flagging was placed on all sides of the monitor well to protect it before leaving.

As confirmed with NMOCD, CES recommends that a second interval of BTEX water analyses should be collected from the monitor well within 60 days. If the BTEX concentration is below groundwater standards as found in this first interval, the monitoring well should be grouted to the surface and abandoned. "No Further Action" would be applied for to NMOCD for groundwater remediation. The contaminated soil in the soil farm should be regularly tilled as the weather warms until it has been reduced to less than 100 PPM from a laboratory TPH analysis. The excavation could then be backfilled and a "Closure Package" prepared for distribution to NMOCD.

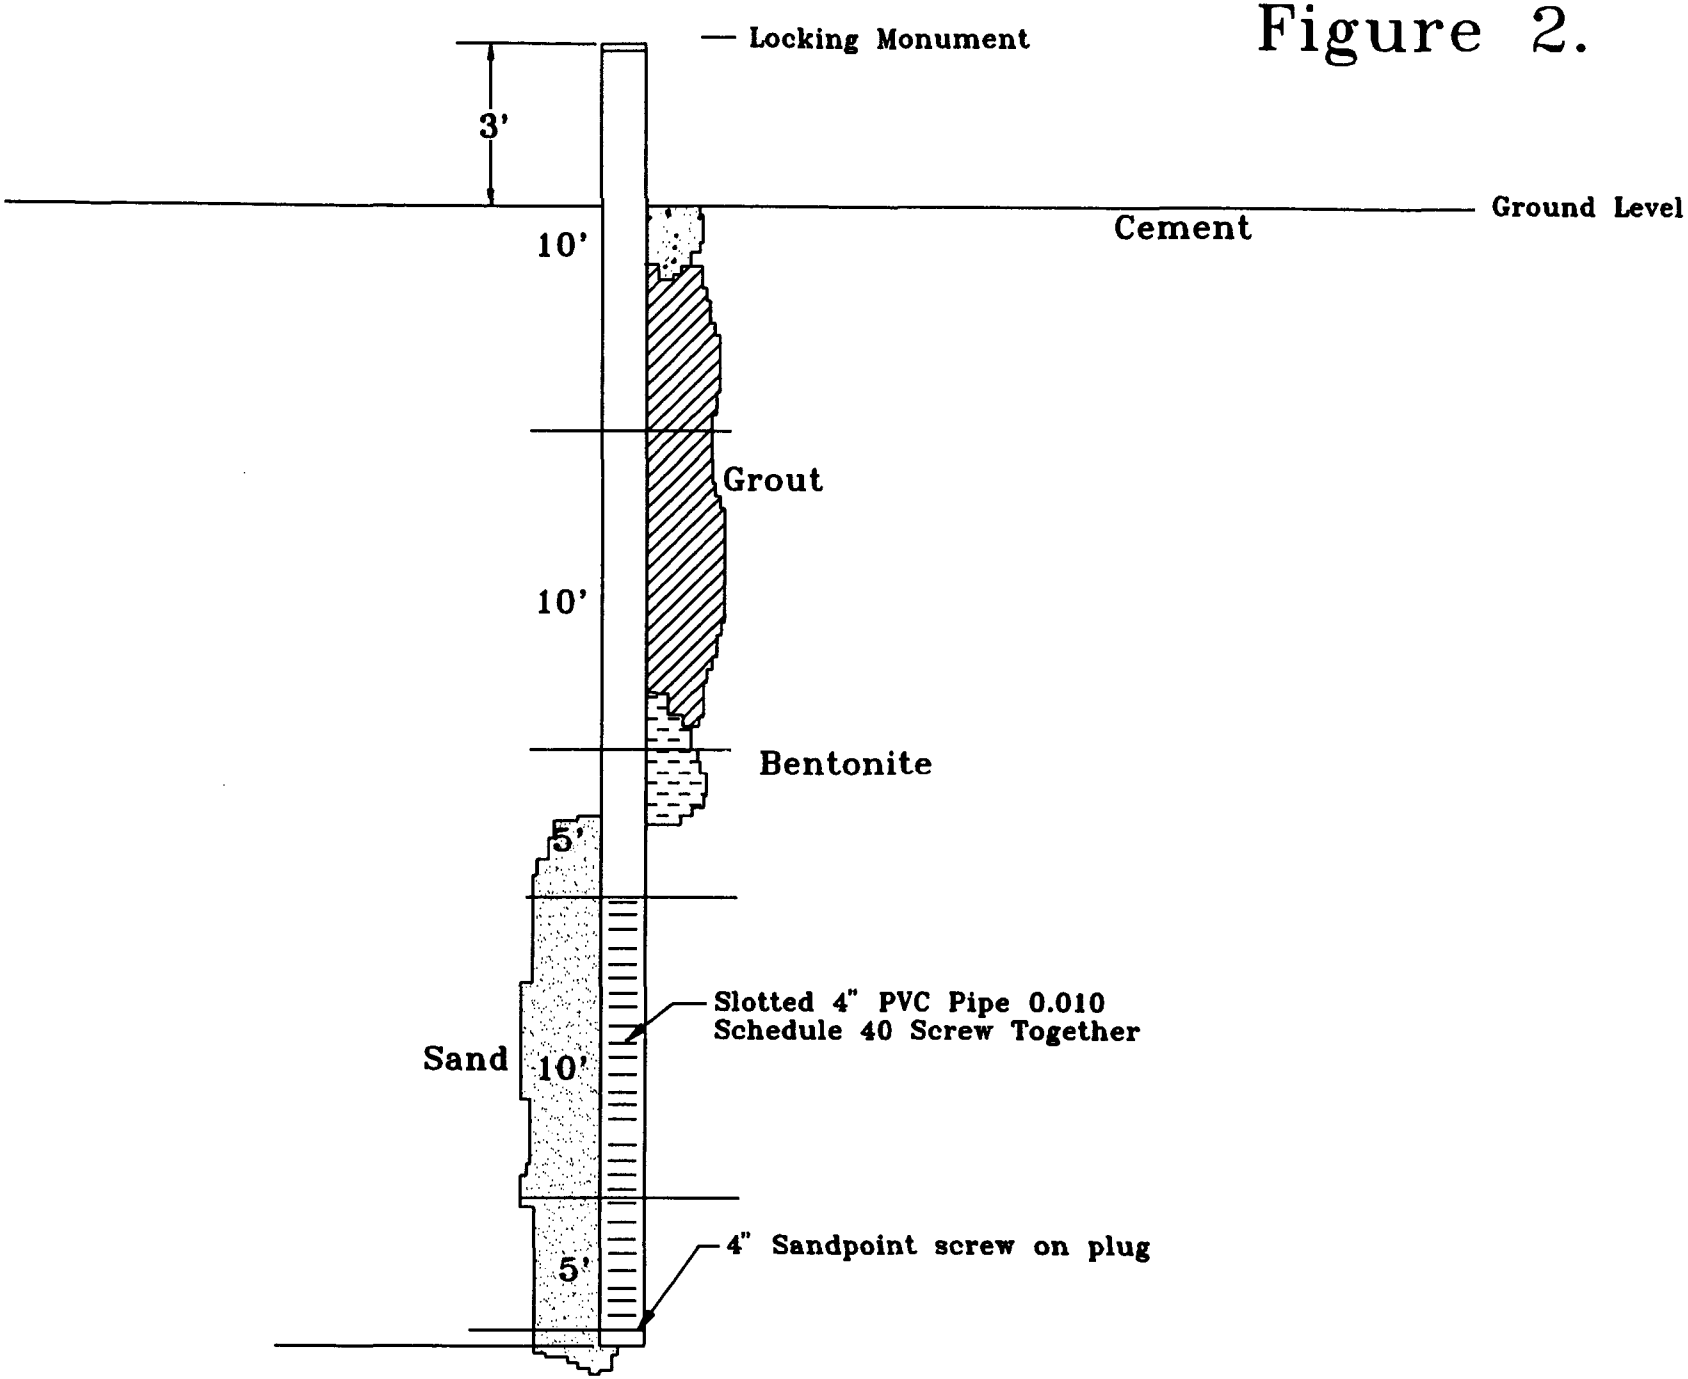
Figure 2.

Locking Monument
3'
Ground Level
Cement
10'
Grout
10'
Bentonite
5'
Slotted 4" PVC Pipe 0.010
Schedule 40 Screw Together
Sand
10'
5'
4" Sandpoint screw on plug

During the drilling operations, soil samples were gathered approximately every 5' of depth. Samples were collected from split-spoon samplers driven 24" into the soil. The soil was placed in baggies and tested with the PID Meter for hydrocarbons. The depth to water from the top of the casing riser measured 18'-9 5/8". Considering the height of the riser, that makes the first measured depth to groundwater approximately 15'-9".

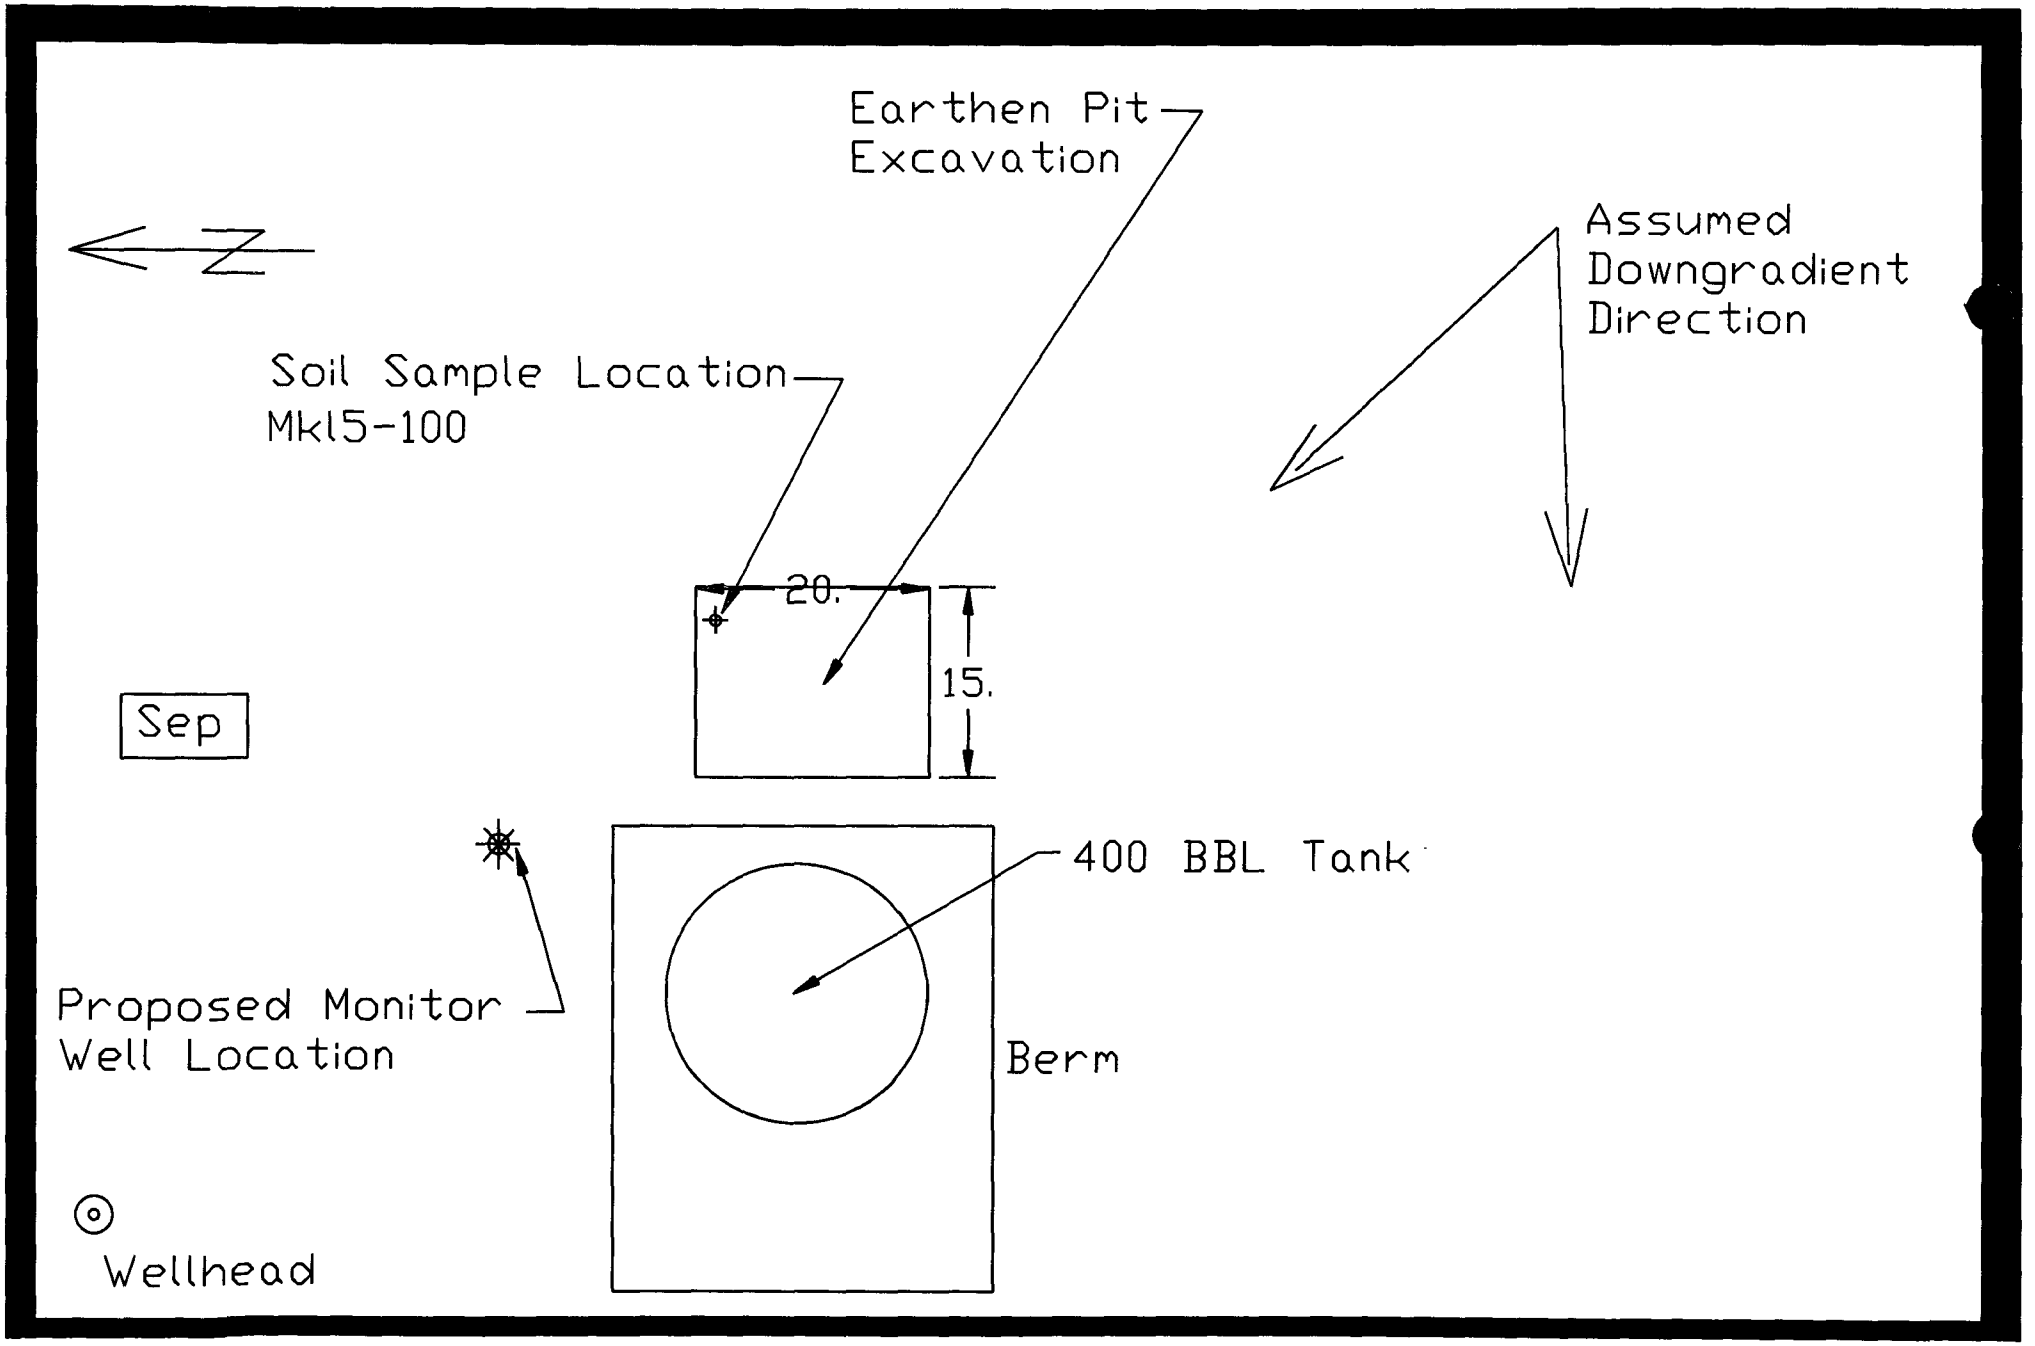
Earthen Pit
Excavation
Assumed
Downgradient
Direction
Soil Sample Location
Mkl5-100
20.
15.
Sep
400 BBL Tank
Proposed Monitor
Well Location
Berm
Wellhead
