LT Environmental, Inc.
3300 North "A" Street
Building 1, Unit 103
Midland, Texas 79705
432.704.5178

January 3, 2020

RE: Closure Request
PLU CVX JV PC 003H
Remediation Permit Number 2RP-3153
Eddy County, New Mexico

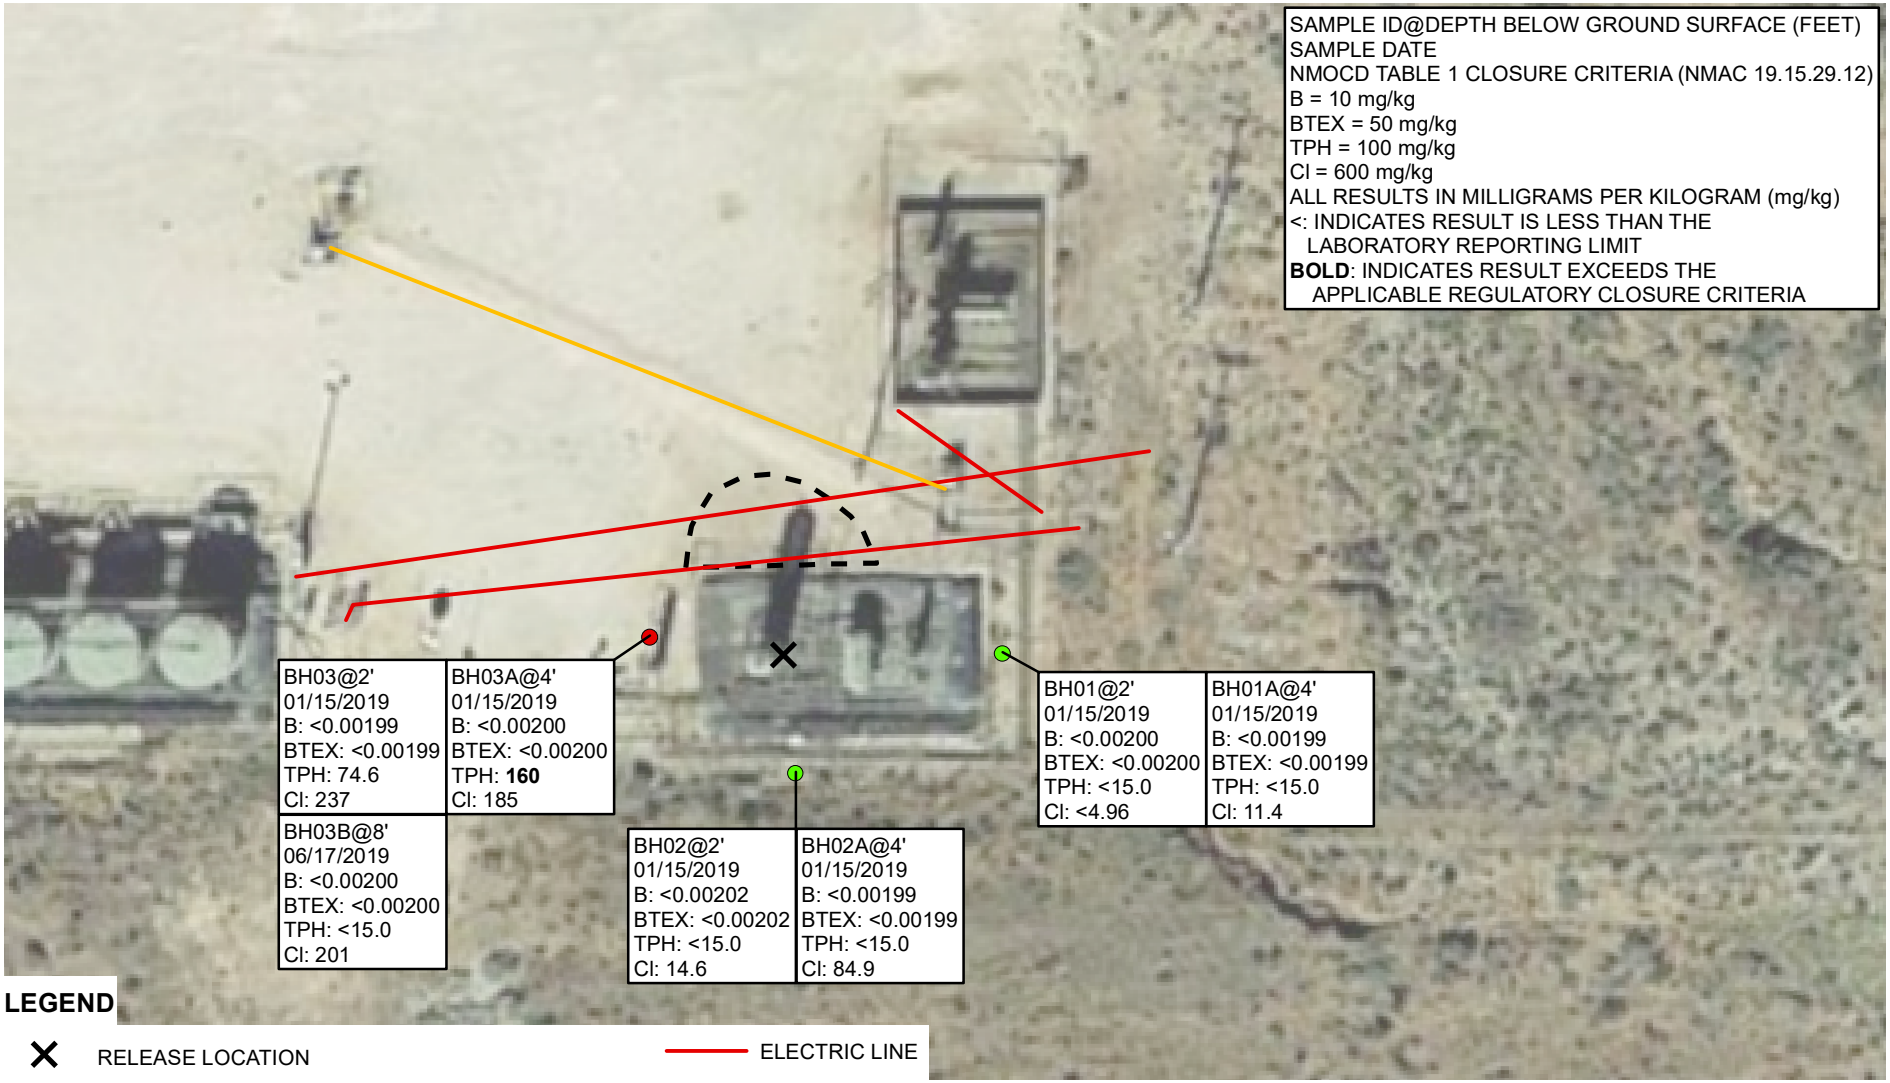
FIGURE 2
SOIL SAMPLE LOCATIONS
PLU CVX JV PC 003H
UNIT P SEC 28 T24S R30E
EDDY COUNTY, NEW MEXICO
XTO ENERGY, INC.

On October 12, 2018, LTE personnel inspected the Site to evaluate the release extent. Five preliminary soil samples (SS01 through SS05) were collected within and around the release area to assess the lateral extent of impacted soil. The soil sample locations, depicted on Figure 2, were selected based on information provided on the initial Form C-141 and field observations. To eliminate the effects from weathering and natural degradation of contaminants at the ground surface, the soil samples were collected from each sample location from a depth of 0.5 feet bgs.
