Following the recent spill at the Greenwood 4 Battery, Chevron has decided to abandon the facility and remediate the site in accordance with BLM objectives. Several historical spill sites have been identified and will be addressed as well. Based on depth to ground water maps, the depth to groundwater at the Greenwood 4 Battery is approximately 250 feet. The following plan details how Chevron will execute the spill remediation and site reclamation.

Battery Spill Remediation:

RE: GREENWOOD PGU #4 BATTERY

RE: GREENWOOD PGU #4

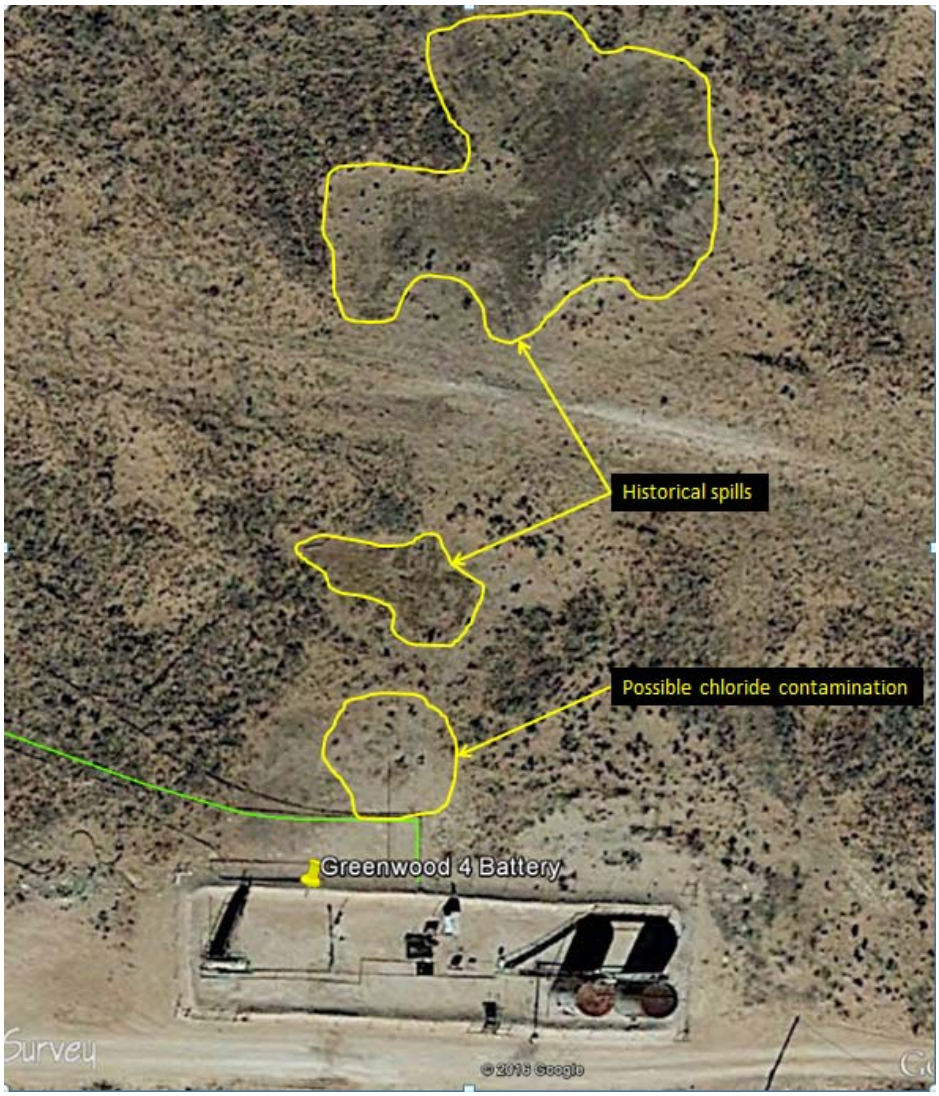
Figure 3: Historical Spills (0.36 acres)

Several historical spills were identified while scoping the location for abandonment. There were three (3) larger areas to the north of the Greenwood 4 battery and seven (7) smaller spills along the greenwood #4 flowline. One of the three contaminated areas was identified as a possible produced water spill and having possible chloride contamination. This area has been sampled and the results (Appendix 2) indicate relatively low chloride levels. These historical spill sites identified in the following figures (3-7) will be addressed as follows:

- Native uncontaminated soil lying underneath the contamination will be brought to the surface and used to cover the contaminated soil.
- The existing vegetation within the spill area will be excavated around as to minimize the impact to active plant growth.
- Area will be tilled to blend native soil evenly and a nitrogen fertilizer will be applied
- Area will then be seed drilled with BLM seed mix #2
- Note: Excavation will not occur within 10 ft. of any buried lines. Any spill area which falls within 10 ft. of a buried line will be addressed by covering the area with 1 ft. of topsoil and then the area will be broadcast seeded.
