May 31, 2019

RE: Deferral Request
Poker Lake Unit 052 Battery
Remediation Permit Number 2RP-5314
Eddy County, New Mexico

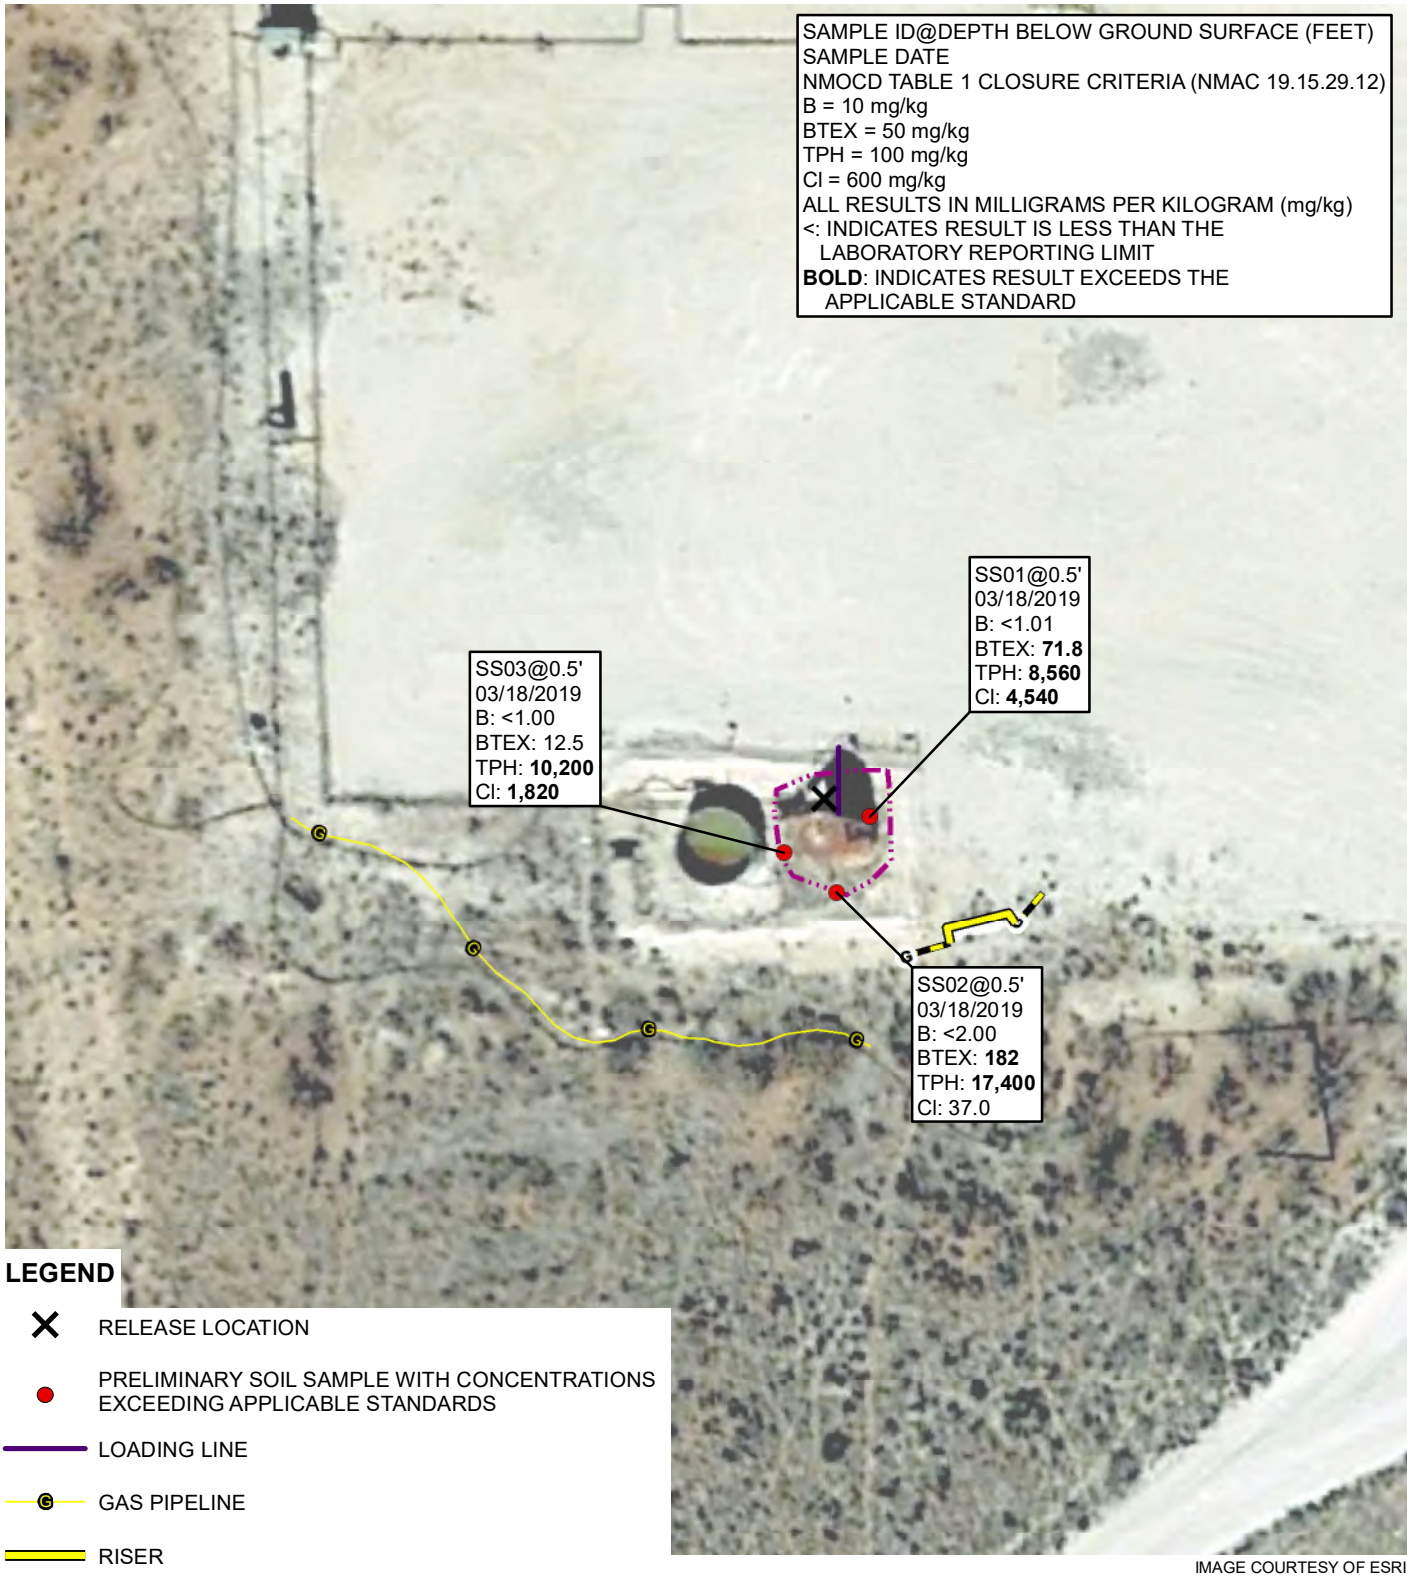
FIGURE 2
PRELIMINARY SOIL SAMPLE LOCATIONS
POKER LAKE UNIT 052 BATTERY
UNIT C SEC 33 T25S R31E
EDDY COUNTY, NEW MEXICO
XTO ENERGY, INC.

On March 18, 2019, LTE personnel inspected the Site to evaluate the release extent. Surface hydrocarbon staining was observed in the release area. The release extent was mapped using a handheld Global Positing System (GPS) unit and is depicted on Figure 2. LTE personnel collected three preliminary soil samples (SS01 through SS03) within the release area from a depth of 0.5 feet bgs to assess the lateral extent of soil impacts. The soil samples were screened for volatile aromatic hydrocarbons and chlorides using a photo-ionization detector (PID) and Hach® chloride QuanTab® test strips. The soil samples were placed directly into pre-cleaned glass jars, labeled with location, date, time, sampler, and method of analysis, and immediately placed on ice. The samples were shipped to Xenco Laboratories (Xenco) in Midland, Texas, at 4 degrees Celsius (°C) under strict chain-of-custody procedures for analysis of BTEX by United States Environmental Protection Agency (EPA) Method 8021B, TPH-gasoline range organics (GRO), TPH-diesel range organics (DRO), and TPH-oil range organics (ORO) by EPA Method 8015M/D, and chloride by EPA Method 300.0. The soil sample locations are presented on Figure 2.

Laboratory analytical results indicated that TPH concentrations exceeded the NMOCD Table 1 closure criteria in preliminary soil samples SS01 through SS03; BTEX concentrations exceeded the NMOCD Table 1 closure criteria in preliminary soil samples SS01 and SS02; and chloride concentrations exceeded the NMOCD Table 1 closure criteria in preliminary soil samples SS01 and SS03. Based on the laboratory analytical results, potholing was scheduled to delineate the lateral and vertical extent of impacted soil and direct excavation activities. Laboratory analytical results are presented on Figure 2 and summarized in Table 1, and the laboratory analytical report is included in Attachment 2.

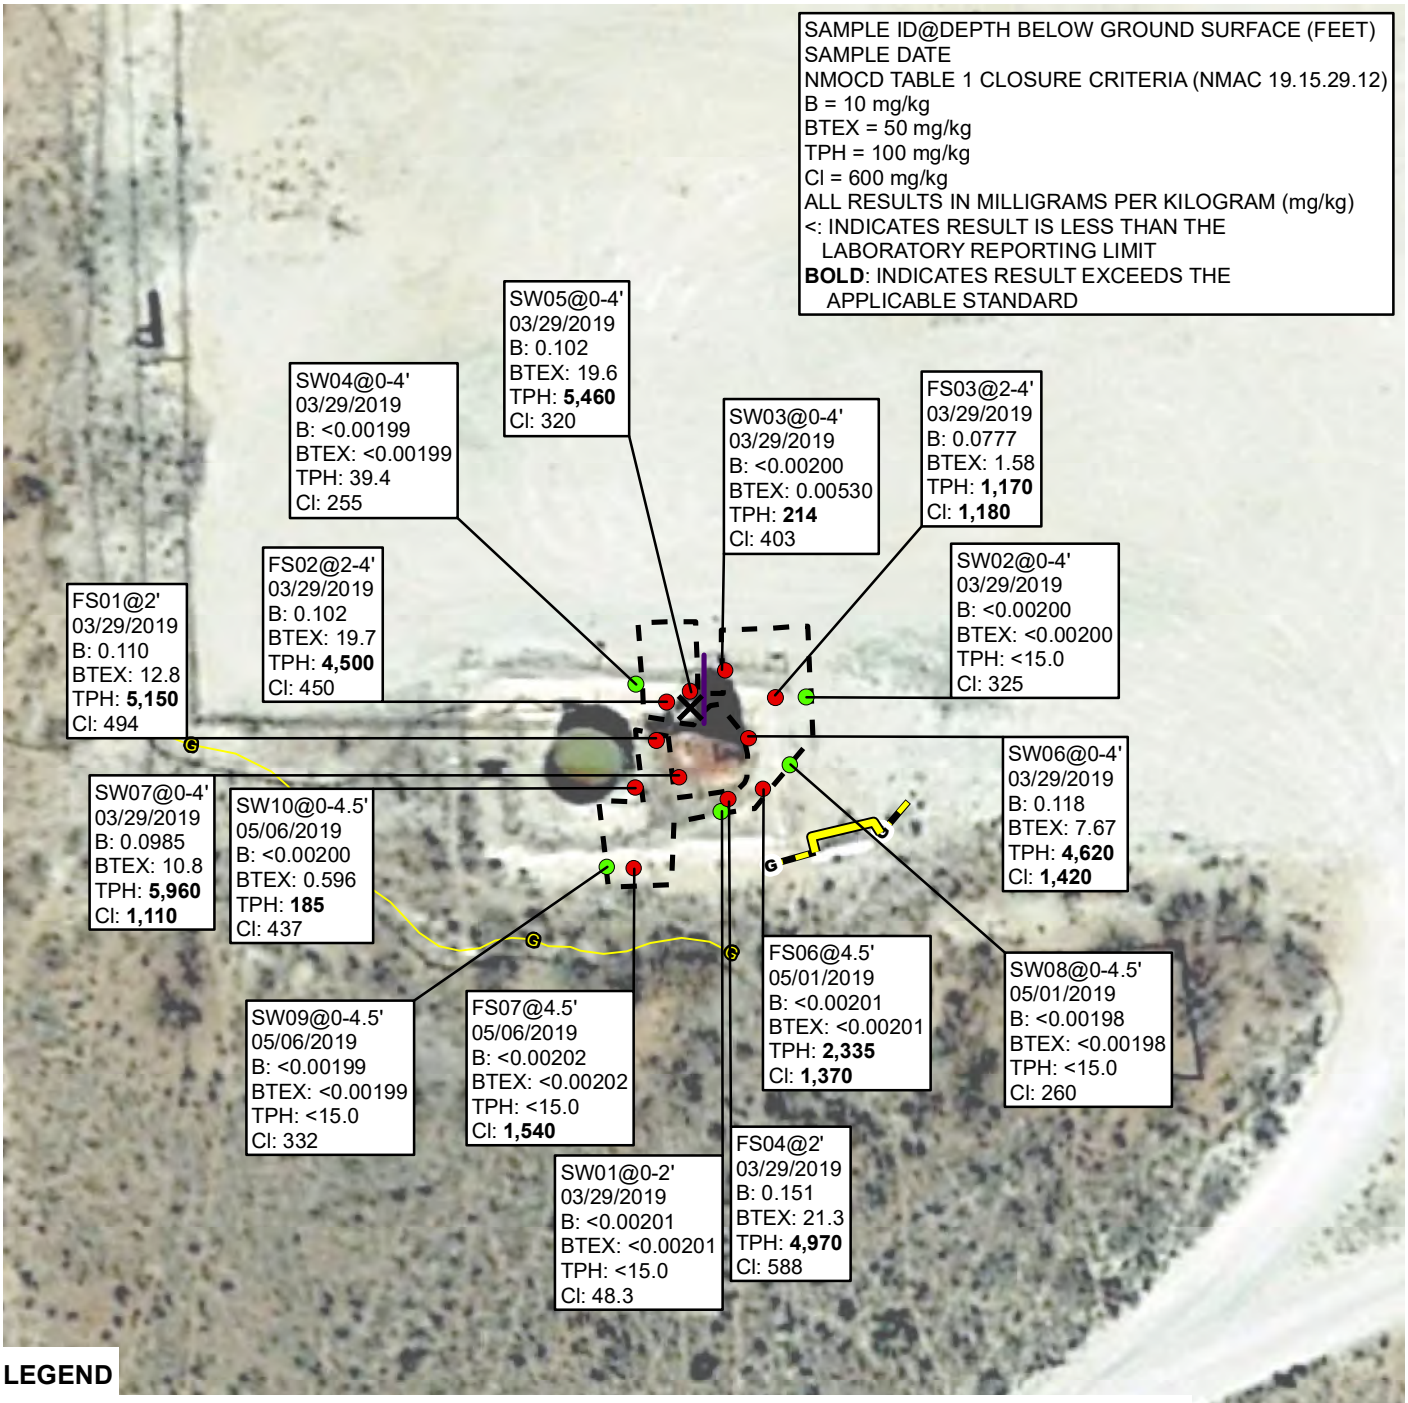
FIGURE 4
EXCAVATION SOIL SAMPLE LOCATIONS
POKER LAKE UNIT 052 BATTERY
UNIT C SEC 33 T25S R31E
EDDY COUNTY, NEW MEXICO
XTO ENERGY, INC.

Further excavation of impacted soil beyond excavation sidewall samples SW03, SW05, SW06, SW07, SW10 and excavation floor samples FS01 through FS07 was limited by the presence of active production equipment and pipelines. XTO safety policy restricts soil disturbing activities to a 2 foot radius of any on-site production equipment and pipelines. This XTO safety policy is established to protect workers and reduce the likelihood of compromising the foundation of the production equipment or pipelines. This policy was enforced where impacted soil was identified within 2 feet of active production equipment or pipelines. Laboratory analytical results are summarized in Table 1 and the complete laboratory analytical reports are included as Attachment 2.

XTO requests to backfill the existing excavation and complete remediation during any future major construction/alteration or final plugging and abandonment, whichever occurs first. LTE and XTO do not believe deferment will result in imminent risk to human health, the environment, or groundwater. XTO requests deferral of final remediation for RP Number 2RP-5314. Upon approval of this deferral request, XTO will backfill the excavation with material purchased locally and recontour the Site to match pre-existing site conditions. An updated NMOCD Form C-141 is included as Attachment 1. A photographic log of the Site is included as Attachment 4.
