Report Type: Closure Report 1RP-5632

General Site Information:						
Site:	**Fascinator Fed Com #703H**					
Company:	**COG Operating LLC**					
Section, Township and Range	**Unit L**	**Sec. 29**	**T 24S**	**R 35E**		
Lease Number:	**API No.**					
County:	**Lea County**					
GPS:	**32.18807**			**-103.39778**		
Surface Owner:	**Private**					
Directions:	From intersection of HWY 18 and HWY 28 in Jal, travel west on HWY 128for approximately 13.4 miles, turn north onto lease road for 0.45 mile to the location on the west side of the lease road.

Release Data:	
Date Released:	7/11/2019
Type Release:	Recycled Produced Water
Source of Contamination:	Layflat Line
Fluid Released:	66 bbls
Fluids Recovered:	60 bbls

Re: Closure Report for the COG Operating, LLC, Fascinator Fed Com #703H, Unit L, Section 29, Township 24 South, Range 35 East, Lea County, New Mexico.
1RP-5632

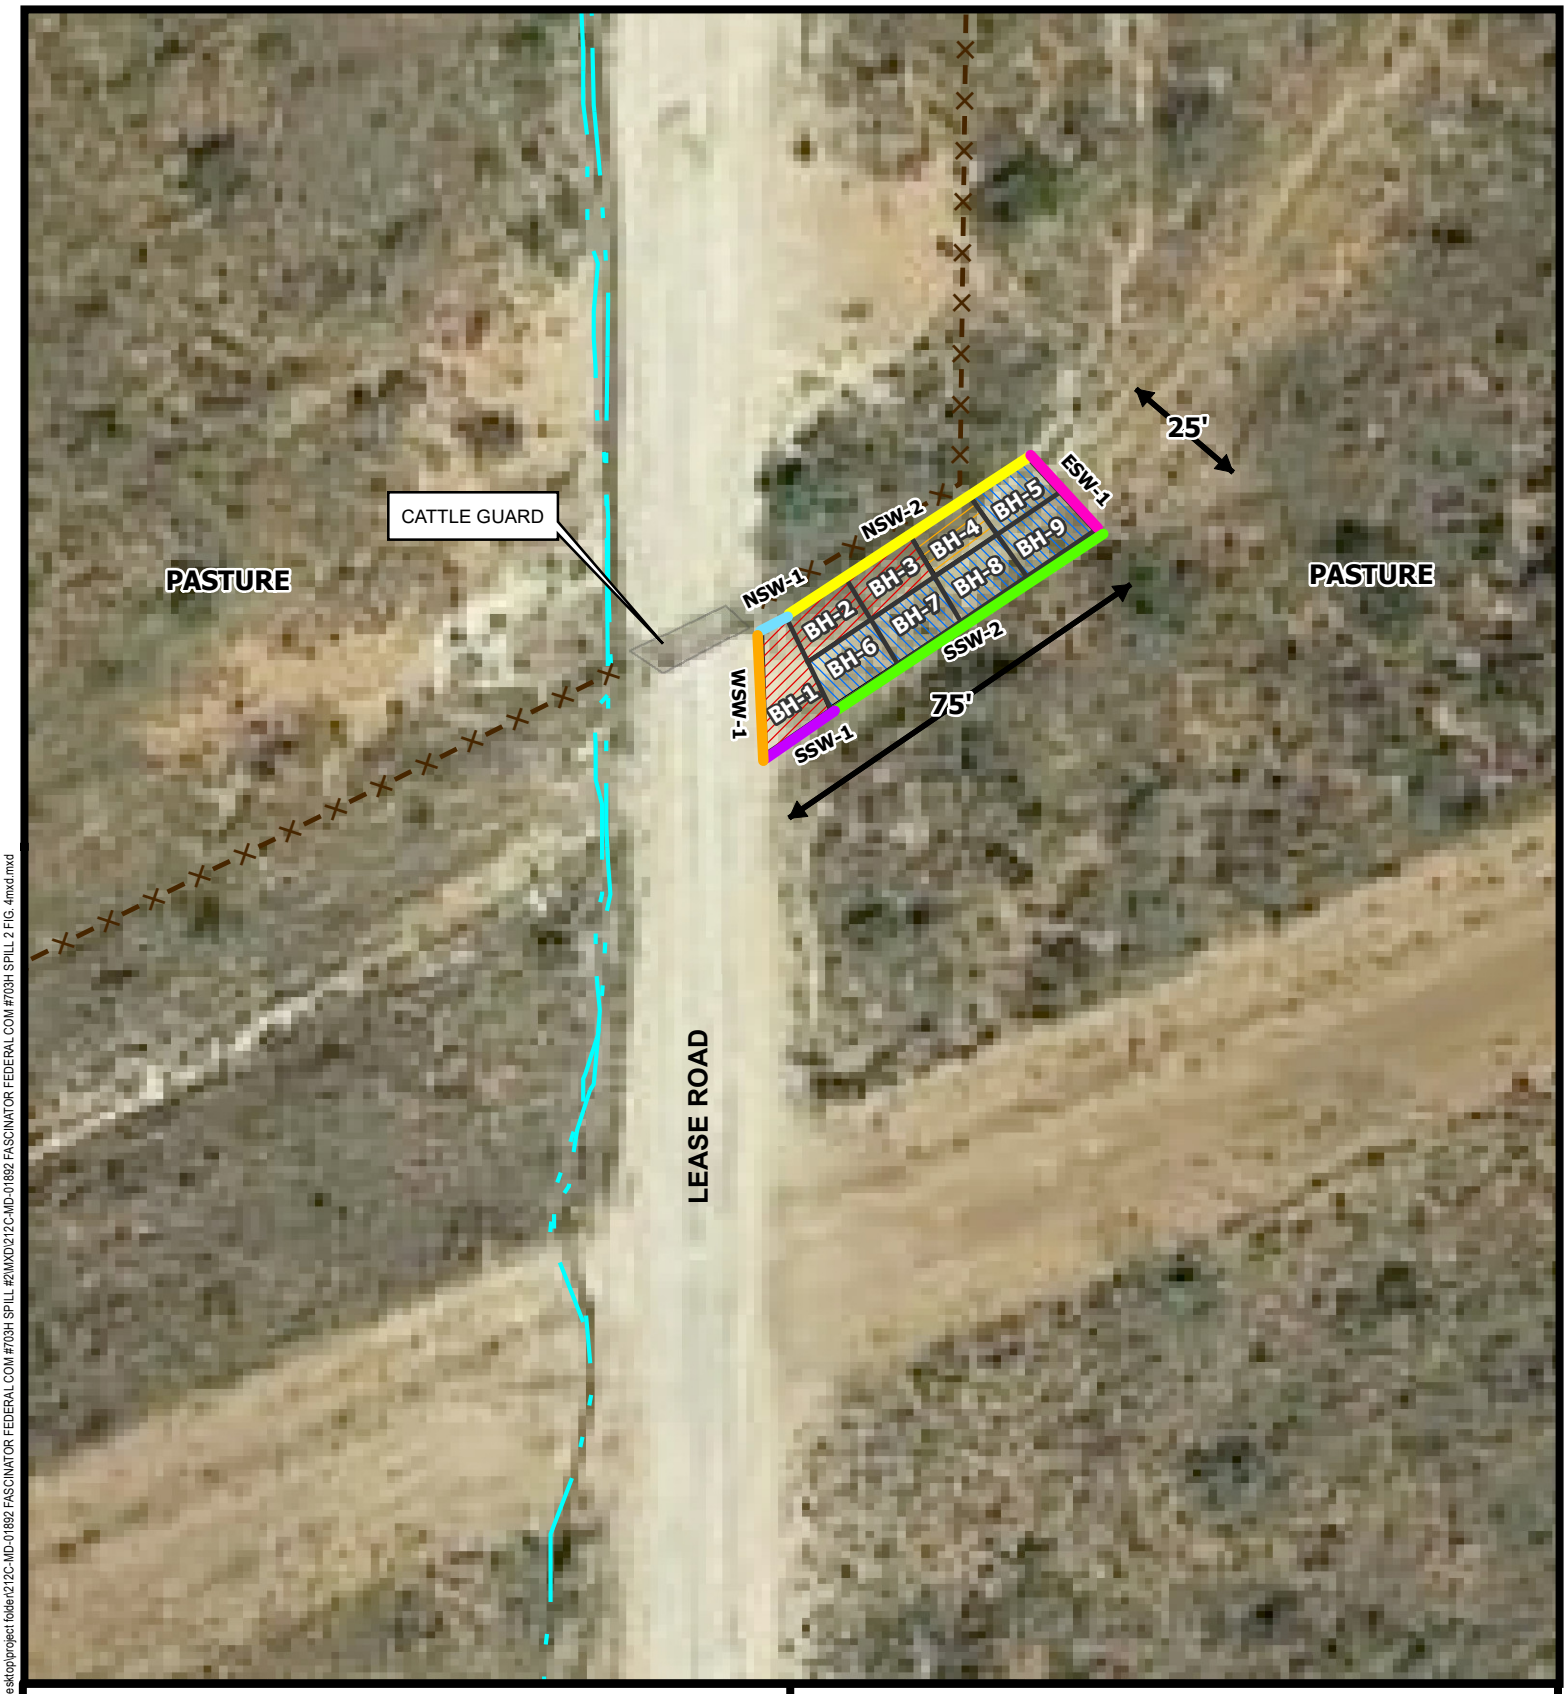
FIGURE
4

Tetra Tech personnel were onsite from September 3-6, 2019 to supervise the remediation activities. The release area was excavated to total depths between 2.0' to 6.0' below surface. Nine (9) bottom hole composite samples (Bottom Hole 1 through Bottom Hole 9) and six (6) sidewall composite samples (NSW-1, NSW-2, SSW-1, SSW-2, ESW-1, and WSW-1) were collected every 200 square feet to ensure proper removal of the impacted soils.

Additionally, two auger holes (AH-1 and AH-2) were installed along the lease road and cattle guard to total depths ranging from 3'-3.5' and 5'-5.5' below surface. Selected samples were submitted to the laboratory to be analyzed for TPH method 8015 extended, BTEX method 8021B, and Chloride by method SM4500. The sampling results are summarized in Table 1. The excavation depths and sample locations are shown in Figure 4.

Approximately 280 cubic yards of material were excavated and transported offsite for proper disposal. The area was then backfilled with clean material to surface grade.
