Pit, Closed-Loop System, Below-Grade Tank, or Proposed Alternative Method Permit or Closure Plan Application

Waste Excavation and Removal Closure Plan

BEPCO, L.P.
dba Bass Enterprises Production Co.
Poker Lake Unit #274
Section 12, T-24-S, R-29-E
Eddy County, New Mexico

Poker Lake Unit #274

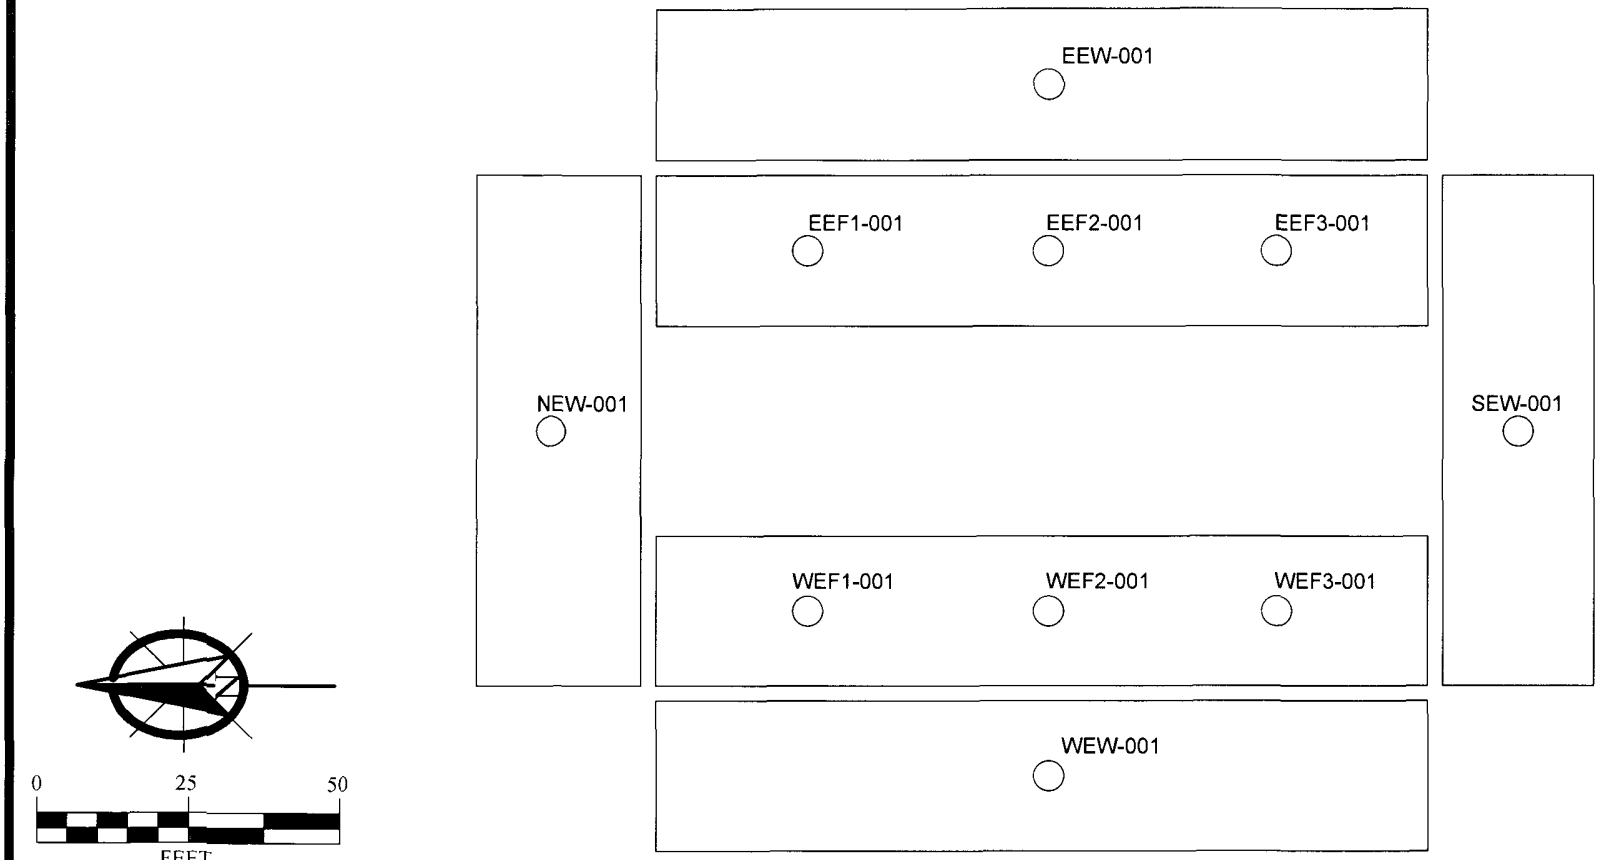
SITE PLAN DENOTING
PIT CLOSURE SAMPLING LOCATIONS

Note All wall samples were composite samples. Initial round of sampling methods SW8015 Mod and EPA 418.1 for TPH, EPA 300/300.1 for chlorides and 8021B/5030 for BTEX were run during the analysis. Chlorides were the only ones that came back above the required limits. All analysis shown were mg/Kg Chlorides.

Round One Samples - 08-27-08
Round Two Samples - 09-02-08
Round Three Samples - 09-05-08
Round Four Samples - 09-22-08
