PIT REMEDIATION AND CLOSURE REPORT

Facility or Well Name: GCU # 250

BLOW PIT B1138

FIELD REPORT: PIT CLOSURE VERIFICATION

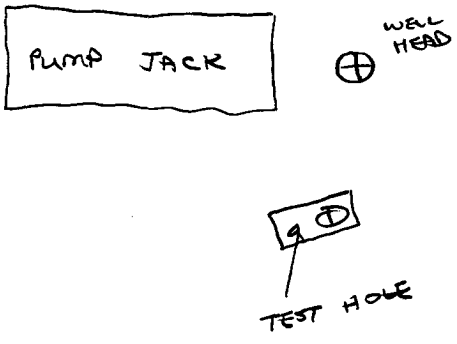
PIT PERIMETER

FIELD NOTES & REMARKS: PIT LOCATED APPROXIMATELY 30 FT. S7E FROM WELLHEAD.
DEPTH TO GROUNDWATER: >100' NEAREST WATER SOURCE: >1000' NEAREST SURFACE WATER: —
NMOCD RANKING SCORE: 0 NMOCD TPH CLOSURE STD: 5000 PPM

SAMPLE ID	FIELD HEADSPACE (ppm)
1 @ 9.5'	0.0
2 @	
3 @	
4 @	
5 @
