PIT REMEDIATION AND CLOSURE REPORT

Facility or Well Name: Kutz Deep GC D #1E

FIELD REPORT: PIT CLOSURE VERIFICATION

LOCATION: NAME: KUTZ DEEP G.C. D WELL #: 1E TYPE: BLOW

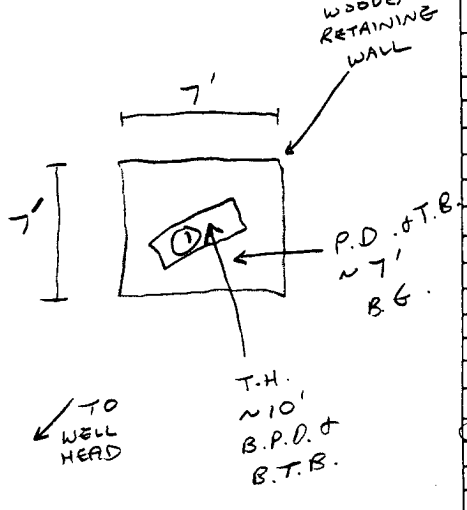
PIT PERIMETER

FIELD NOTES & REMARKS: PIT LOCATED APPROXIMATELY 180 FT. N27E FROM WELLHEAD.

SOIL COLOR: MED. GRAY TO BLACK (BETWEEN 7 - 17 FT. BELOW GRADE).

DISCOLORATION/STAINING OBSERVED: (YES) NO EXPLANATION - NOTED ABOVE

HC ODOR DETECTED: (YES) NO EXPLANATION - TEST HOLE & OVM SAMPLE.

SAMPLE ID	FIELD HEADSPACE (ppm)
1 @ 16'	774
2 @	
3 @	
4 @	
5 @

ADDITIONAL COMMENTS: INSTRUCTED OPERATOR TO DILUTE/AERATE CONTAMINATED SOIL DOWN TO BACKHOE/EXTENDAHOE MAX. DEPTH (~17 FT. BELOW GRADE) & LEAVE IN PIT AREA.
