State of New Mexico
Energy, Minerals and Natural Resources Department

PIT REMEDIATION AND CLOSURE REPORT

Facility or Well Name: Florance D LS #16

FIELD REPORT: PIT CLOSURE VERIFICATION

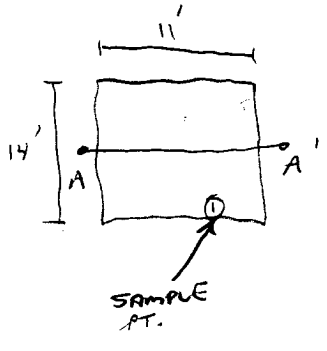
PIT PERIMETER

FIELD NOTES & REMARKS: PIT LOCATED APPROXIMATELY 25 FT. N70W FROM WELLHEAD.
DEPTH TO GROUNDWATER: >100' NEAREST WATER SOURCE: >1000' NEAREST SURFACE WATER: >1000'
NMOCD RANKING SCORE: 0 NMOCD TPH CLOSURE STD: 5000 PPM

BEDROCK BOTTOM

SOIL TYPE: (SAND) / SILTY SAND / SILT / SILTY CLAY / CLAY / GRAVEL / OTHER BEDROCK (SANDSTONE)
SOIL COLOR: DK. YELL. ORANGE BEDROCK - DK. GRAY
COHESION (ALL OTHERS): (NON COHESIVE) / SLIGHTLY COHESIVE / COHESIVE / HIGHLY COHESIVE
CONSISTENCY (NON COHESIVE SOILS): (LOOSE) / (FIRM) / DENSE / VERY DENSE
PLASTICITY (CLAYS): NON PLASTIC / SLIGHTLY PLASTIC / COHESIVE / MEDIUM PLASTIC / HIGHLY PLASTIC
DENSITY (COHESIVE CLAYS & SILTS): SOFT / FIRM / STIFF / VERY STIFF / HARD
MOISTURE: DRY (SLIGHTLY MOIST) / MOIST / WET / SATURATED / SUPER SATURATED
DISCOLORATION/STAINING OBSERVED: (YES) / NO EXPLANATION - BEDROCK
HC ODOR DETECTED: YES / NO EXPLANATION - BEDROCK & OVM SAMPLE
SAMPLE TYPE: (GRAB) / COMPOSITE - # OF PTS. —
ADDITIONAL COMMENTS: COLLECTED SAMPLE FROM BEDROCK - VERY HARD, COMPETENT. INSTRUCTED OPERATOR TO DILUTE/AERATE EXCAVATED SOIL & PLACE BACK INTO PIT.

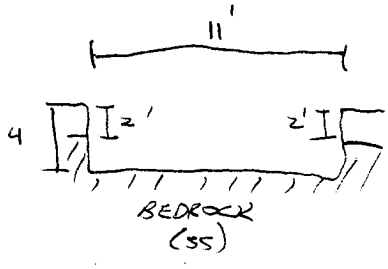
PIT PROFILE

SAMPLE ID	FIELD HEADSPACE PID (ppm)
1 @ 4'	448
2 @	
3 @	
4 @	
5 @

BOTH PASSED
