Pit, Closed-Loop System, Below-Grade Tank, or Proposed Alternative Method Permit or Closure Plan Application

1
Operator: **Burlington Resources Oil & Gas Company, LP** OGRID#: **14538**
Address: **P.O. Box 4289, Farmington, NM 87499**
Facility or well name: **SAN JUAN 29-7 UNIT 53M**
API Number **30-039-30801** OCD Permit Number
U/L or Qtr/Qtr **F(SE/NW)** Section: **27** Township: **29N** Range: **7W** County: **Rio Arriba**
Center of Proposed Design. Latitude. **36.699702** °N Longitude: **107.560037** °W NAD: [ ] 1927 [X] 1983
Surface Owner [X] Federal [ ] State [ ] Private [ ] Tribal Trust or Indian Allotment

Burlington Resources Oil Gas Company, LP
San Juan Basin
Closure Report

Lease Name: SAN JUAN 29-7 UNIT 53M
API No.: 30-039-30801

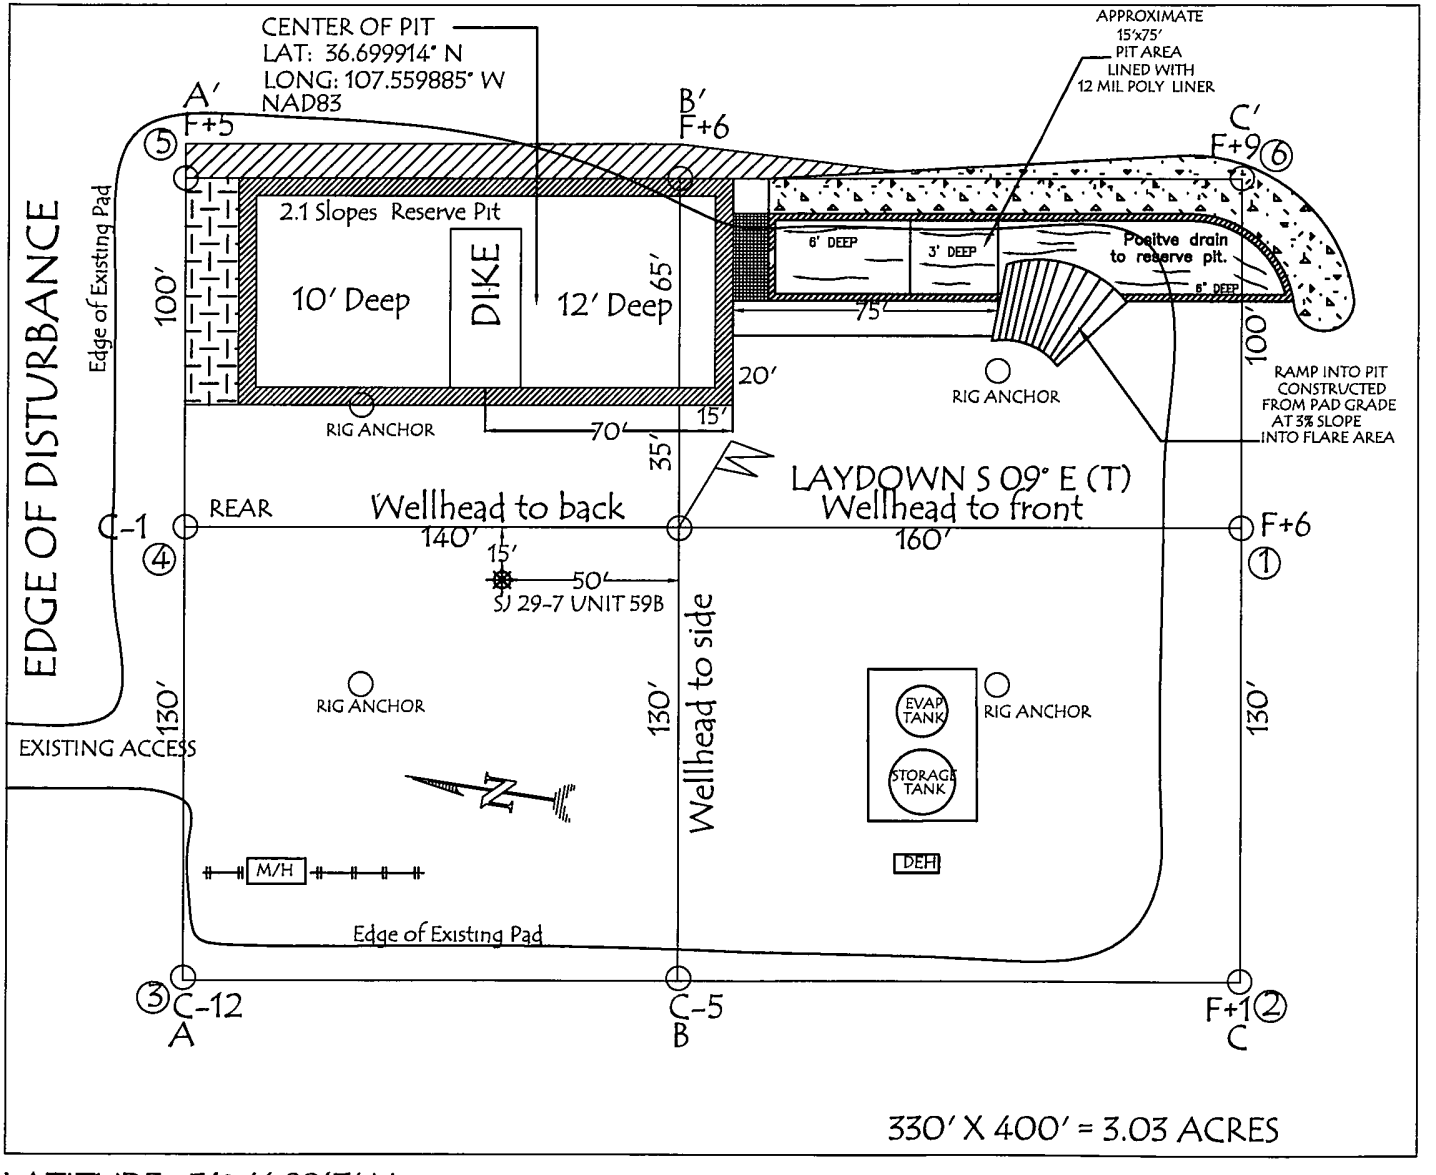
RESERVE PIT DIKE TO BE 8' ABOVE DEEP SIDE (OVERFLOW - 3' WIDE AND 1' ABOVE SHALLOW SIDE).
