Release Notification and Corrective Action

Name of Company	Dugan Production Corp.	Contact	Kurt Fagrelius
Address	P.O. Box 420	Telephone No.	505-325-1821
Facility Name	Champ #9	Facility Type	Permanent Pit

Champ #9
Seperator Pit

Permanent pit: Champ #9
API number: 30-045-29287

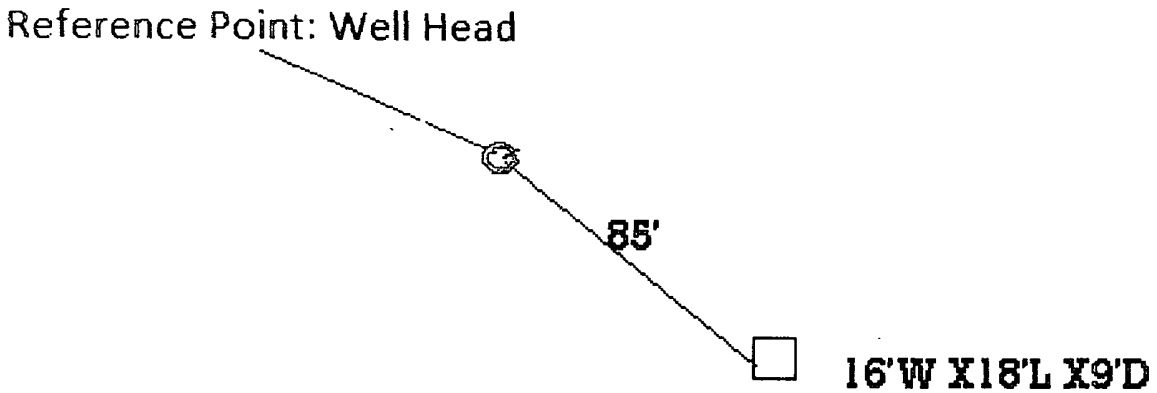
From Reference Point Go N.35 Degrees NE. For a Distance of 85' to Center of Pit.

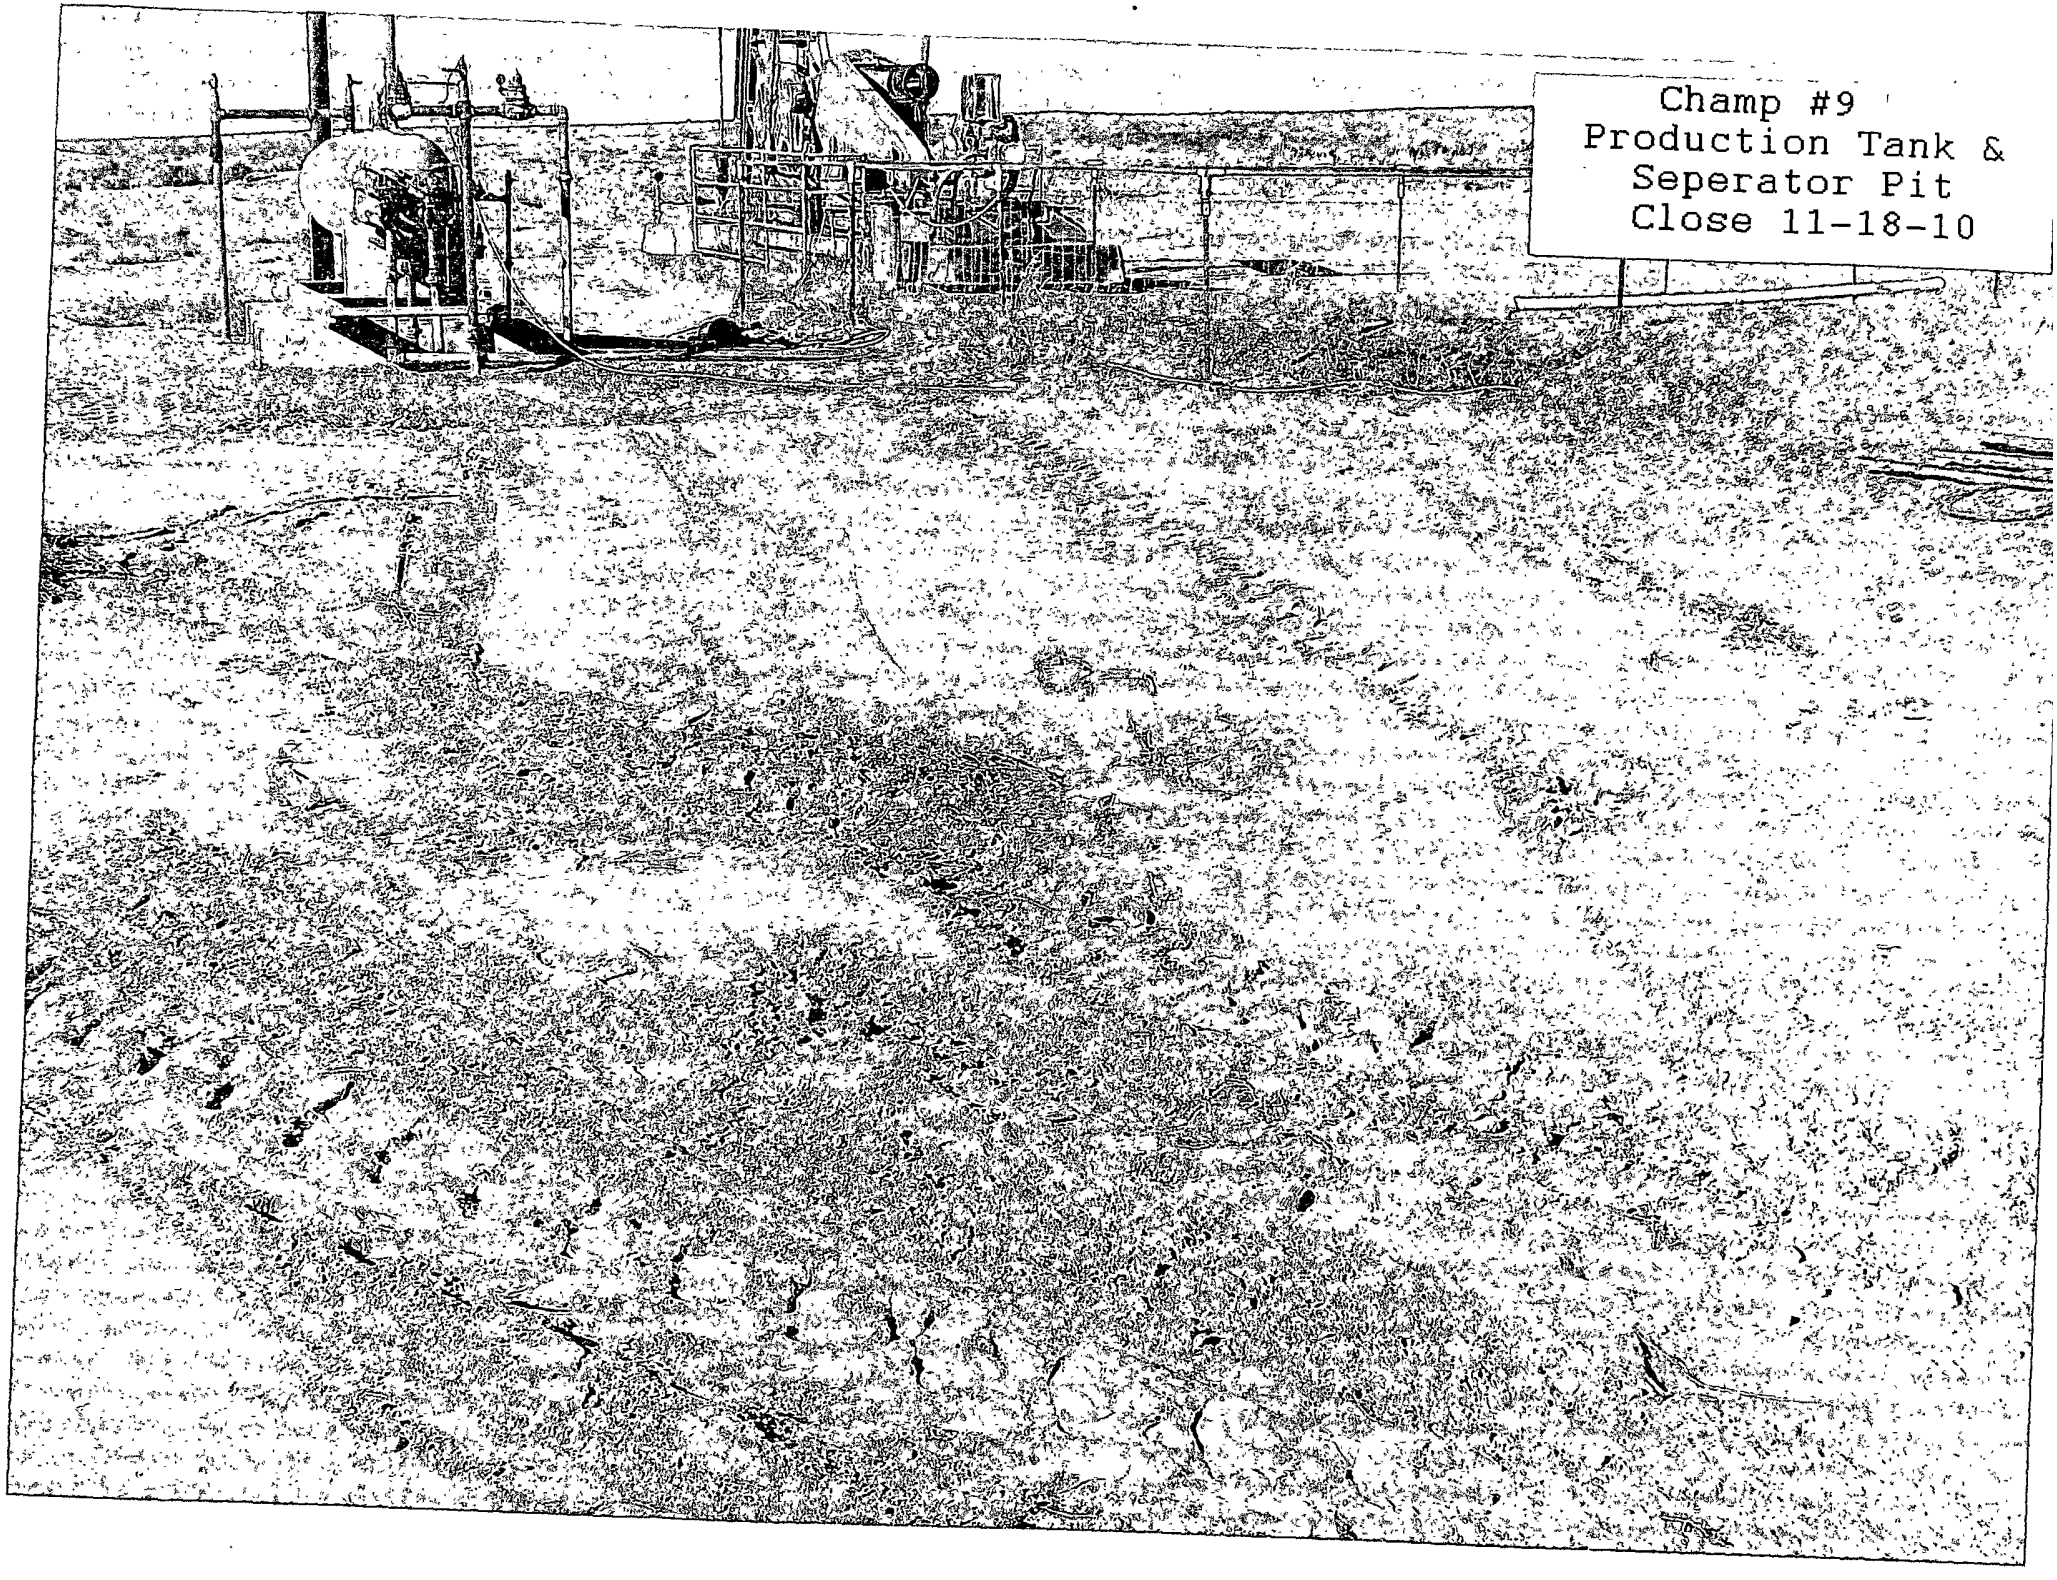
Champ #9
Production Tank &
Seperator Pit
Close 11-18-10

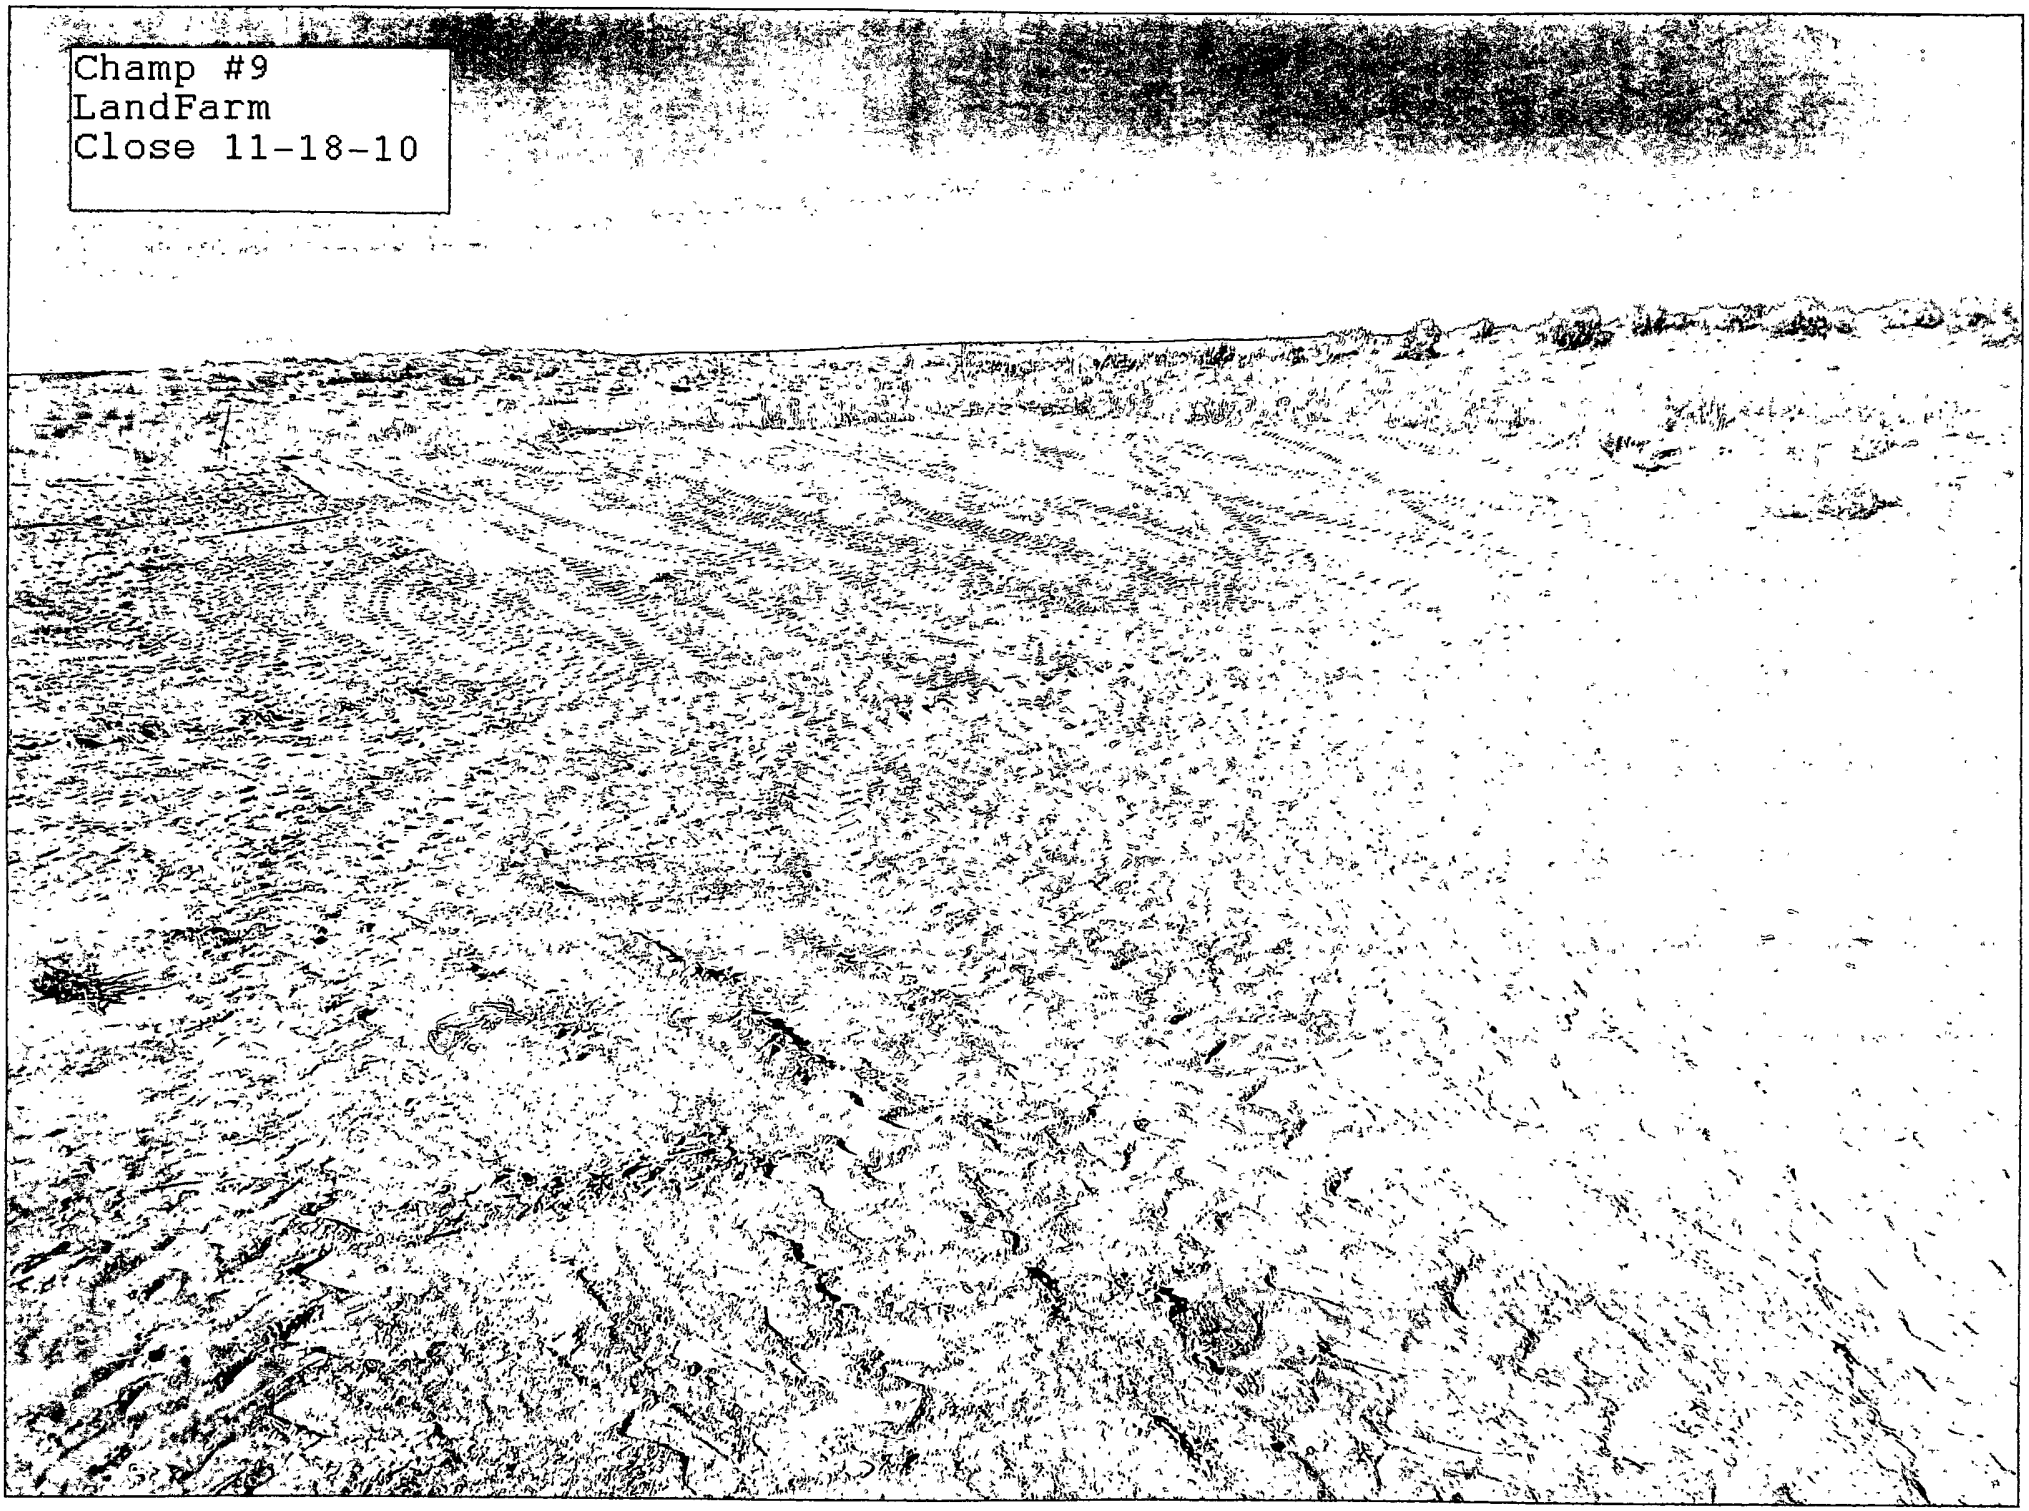
Champ #9
LandFarm
Close 11-18-10
