Pit or Below-Grade Tank Registration or Closure

Operator: Dugan Production Corp Telephone: (505)325-1821 e-mail address:
Address: P.O. Box 420, Farmington, New Mexico 87401
Facility or well name: Dorsey 1 API #: 30-045-29909 U/L or Qtr/Qtr E Sec 26 T 22N R 8W
County: San Juan Latitude 36.11308 Longitude 107.65794 NAD: 1927 ☐ 1983 ☐ Surface Owner Federal ☒ State ☐ Private ☐ Indian ☐

FIELD REPORT: PIT CLOSURE VERIFICATION

LOCATION: NAME: DORSEY WELL #: 1 TYPE: SEP
QUAD/UNIT: E SEC: 26 TWP: 22N RNG: 8W PM: NM CNTY: SJ ST: NM
QTR/FOOTAGE: 1720 FNL x 790 FWL CONTRACTOR: DPC

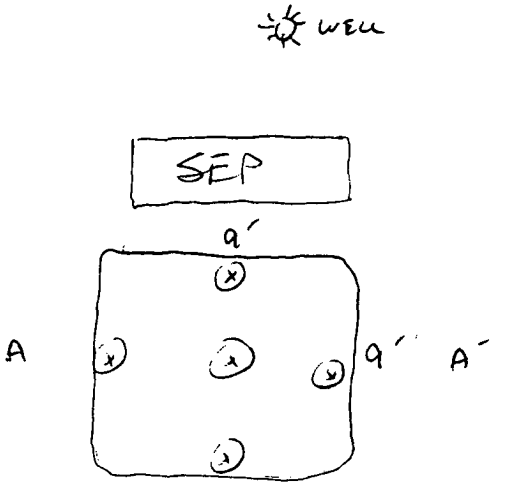
PIT PERIMETER

FIELD NOTES & REMARKS: PIT LOCATED APPROXIMATELY 33 FT. S 18 W FROM WELLHEAD.
DEPTH TO GROUNDWATER: >100 NEAREST WATER SOURCE: >1000 NEAREST SURFACE WATER: >1000
NMOCD RANKING SCORE: 0 NMOCD TPH CLOSURE STD: 5000 PPM

SOIL TYPE: SAND / SILTY SAND / SILT / SILTY CLAY / CLAY / GRAVEL / OTHER SLTY clayey Sand
SOIL COLOR: DARK BROWN
COHESION (ALL OTHERS): NON COHESIVE / (SLIGHTLY COHESIVE) COHESIVE / HIGHLY COHESIVE
CONSISTENCY (NON COHESIVE SOILS): LOOSE / (FIRM) / DENSE / VERY DENSE
PLASTICITY (CLAYS): NON PLASTIC / SLIGHTLY PLASTIC / COHESIVE / MEDIUM PLASTIC / HIGHLY PLASTIC
DENSITY (COHESIVE CLAYS & SILTS): SOFT / (FIRM) / STIFF / VERY STIFF / HARD
MOISTURE: DRY / (SLIGHTLY MOIST) / MOIST / WET / SATURATED / SUPER SATURATED
DISCOLORATION/STAINING OBSERVED: YES / (NO) EXPLANATION -
HC ODOR DETECTED: YES / (NO) EXPLANATION -
SAMPLE TYPE: GRAB / (COMPOSITE) # OF PTS. 5
ADDITIONAL COMMENTS: 9'x9'x4' Deep Earthen Pit. Use Backhoe to Dig into Pit for Samples

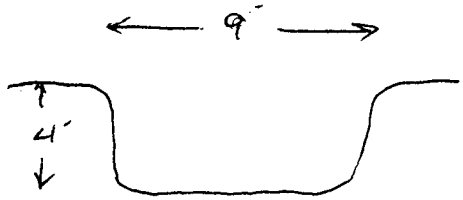
PIT PROFILE

SAMPLE ID	FIELD HEADSPACE (ppm)
1 @	
2 @	
3 @	
4 @	
5 @	
5-Point Composite @ 7'	0.0
