Pit or Below-Grade Tank Registration or Closure

Operator: Redwolf Production, Inc. Telephone: (505) 326-4125 e-mail address: ddelventhal@qwest.net
Address: P. O. Box 5382 Farmington, NM 87499
Facility or well name: C. E. No. 1 API #: 30-045-29471 U/L or Qtr/Qtr K Sec 6 T 25N R 11W
County: San Juan Latitude _____ Longitude _____ NAD: 1927 ☐ 1983 ☐
Surface Owner: Federal ☐ State ☐ Private ☐ Indian ☒

FIELD REPORT: PIT CLOSURE VERIFICATION

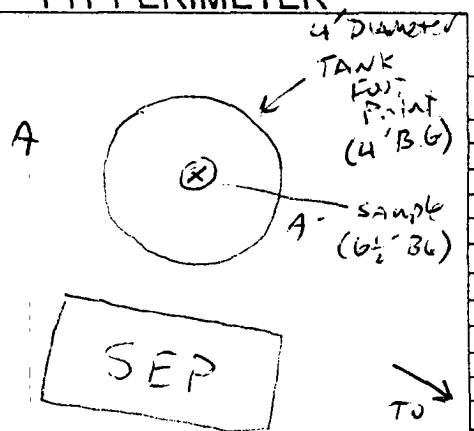
PIT PERIMETER

FIELD NOTES & REMARKS: PIT LOCATED APPROXIMATELY 120 FT. N79W FROM WELLHEAD.
DEPTH TO GROUNDWATER: >100 NEAREST WATER SOURCE: >1000 NEAREST SURFACE WATER: <200
NMOCD RANKING SCORE: 20 NMOCD TPH CLOSURE STD: 100 PPM

SOIL TYPE: SAND (SILTY SAND) / SILT / SILTY CLAY / CLAY / GRAVEL / OTHER
SOIL COLOR: Lite tan
COHESION (ALL OTHERS): (NON COHESIVE) / SLIGHTLY COHESIVE / COHESIVE / HIGHLY COHESIVE
CONSISTENCY (NON COHESIVE SOILS): (LOOSE) / FIRM / DENSE / VERY DENSE
PLASTICITY (CLAYS): NON PLASTIC / SLIGHTLY PLASTIC / COHESIVE / MEDIUM PLASTIC / HIGHLY PLASTIC
DENSITY (COHESIVE CLAYS & SILTS): SOFT / FIRM / STIFF / VERY STIFF / HARD
MOISTURE: (DRY / SLIGHTLY MOIST) MOIST / WET / SATURATED / SUPER SATURATED
DISCOLORATION/STAINING OBSERVED: YES (NO) EXPLANATION -
HC ODOR DETECTED: YES (NO) EXPLANATION -
SAMPLE TYPE: (GRAB) / COMPOSITE - # OF PTS.
ADDITIONAL COMMENTS: 7 Barrel Fiberglass tank set @ 4' Below Grade. Fill tank w/ Backhoe & Sample Below w/ Sample Shovel. No evidence of tank leak or spill

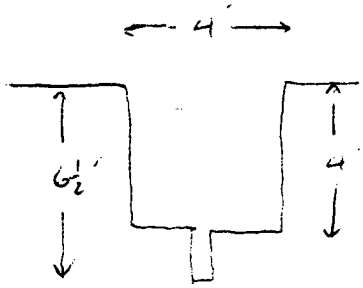
PIT PROFILE

SAMPLE ID	FIELD HEADSPACE (ppm)
1 @ 6½'	0.0
2 @	
3 @	
4 @	
5 @
