Release Notification and Corrective Action

Name of Company **Burlington Resources, a Wholly Owned Subsidiary of ConocoPhillips Company**	Contact **Lisa Hunter**
Address **3401 East 30th St, Farmington, NM**	Telephone No. **(505) 326-9786**
Facility Name: **San Juan 27-4 Unit 116**	Facility Type: **Gas Well**

Re: San Juan 27-4 Unit 116
Below Grade Tank Closure Sampling and Release Report

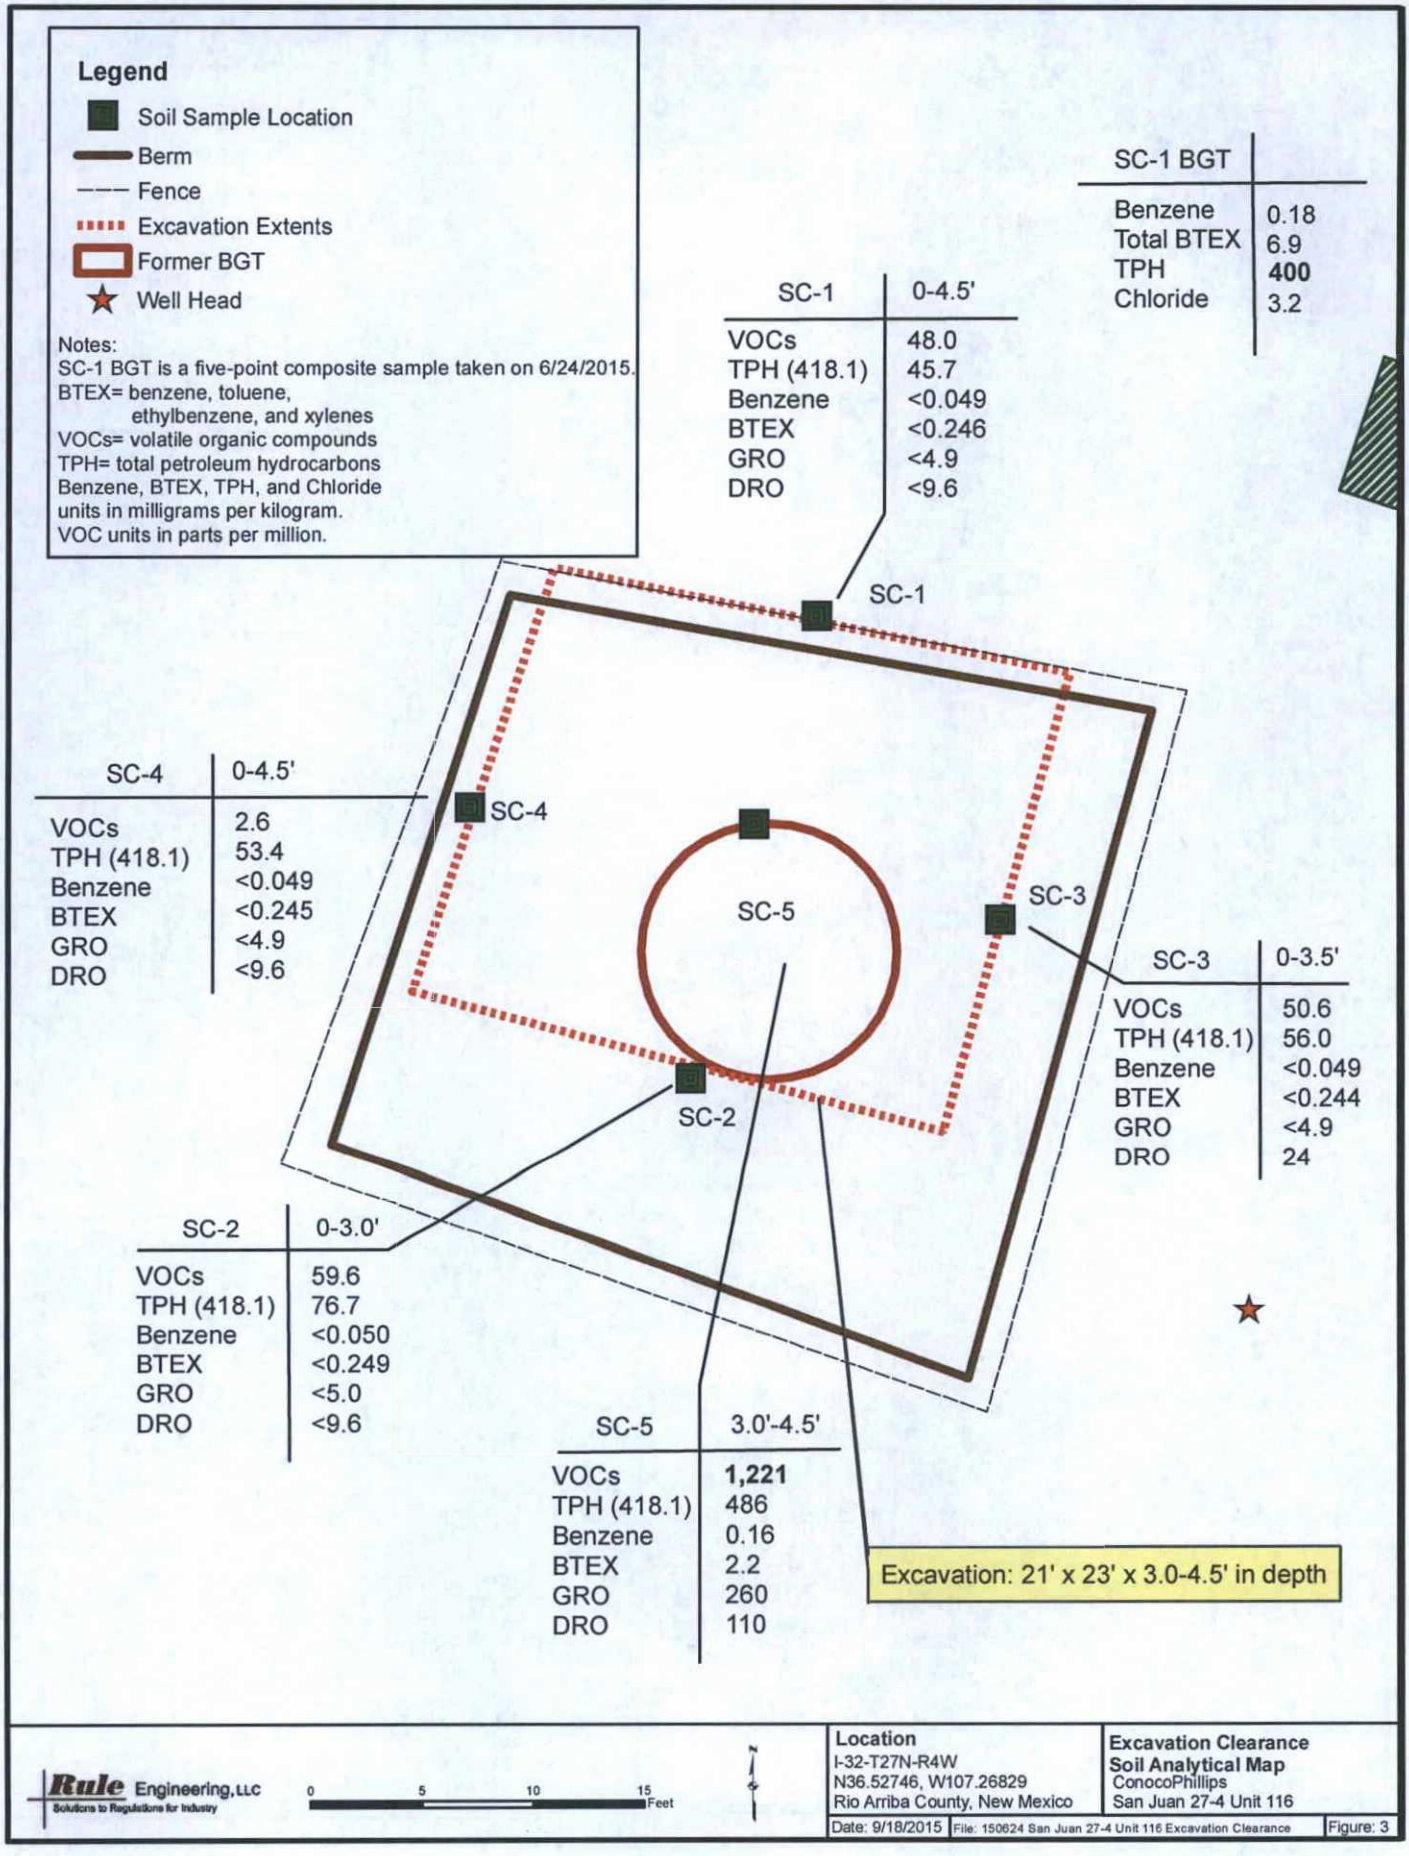
0 5 10 15 Feet
Location
I-32-T27N-R4W
N36.52746, W107.26829
Rio Arriba County, New Mexico
Excavation Clearance
Soil Analytical Map
ConocoPhillips
San Juan 27-4 Unit 116
Date: 9/18/2015
File: 150624 San Juan 27-4 Unit 116 Excavation Clearance
Figure: 3

Field results for soil confirmation samples reported VOC concentrations below the NMOCD action levels of 100 ppm in all samples, except SC-5 with 1,221 ppm. Samples SC-1 through SC-5 had TPH concentrations below the NMOCD action levels of 1,000 mg/kg. Laboratory analytical results for soil confirmation samples SC-1 through SC-5 reported benzene, total BTEX, and TPH (GRO/DRO) concentrations below the applicable NMOCD action levels. Field sampling and laboratory analytical results are summarized in Table 3 and presented on Figure 3. The analytical laboratory report is attached.

On June 24, 2015, approximately 60 cubic yards of hydrocarbon contaminated soils were removed from within the impacted area. The final excavation measured approximately 23 feet x 21 feet x 3 (to 4.5) feet in depth. Five confirmation soil samples were collected from the sidewalls and base of the final excavation on June 24, 2015.

Field VOCs from the excavation were reported below the NMOCD action level of 100 ppm in all samples, except SC-5 with 1,221 ppm. Laboratory analytical results for soil confirmation samples (SC-1 through SC-5) reported benzene and total BTEX concentrations below the NMOCD action levels of 10 mg/kg and 50 mg/kg, respectively. All soil confirmation samples reported field and laboratory TPH concentrations below the NMOCD action level of 1,000 mg/kg. Based on laboratory analytical results, no further work is recommended.

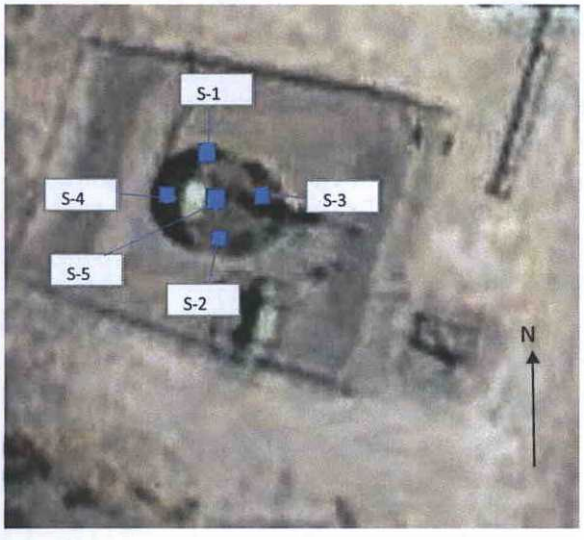
SC-1 is a 5-point composite of S-1 through S-5, collected 0.5 ft below tank liner.
Sample SC-1 was laboratory analyzed for TPH (418.1), BTEX (8021) and chlorides (300.0).
