Pit or Below-Grade Tank Registration or Closure

Operator: BP AMERICA PROD. CO. Telephone: (505-326-9200 e-mail address: _____
Address: 200 ENERGY COURT. FARMINGTON. NM 87410
Facility or well name: STOREY C #2M API #: 30-045- 25322 U/L or Qtr/Qtr E Sec 35 T 28N R 9W
County: SAN JUAN Latitude 36.62056 Longitude 107.76463 NAD: 1927 ☐ 1983 ☒ Surface Owner Federal ☒ State ☐ Private ☐ Indian ☐

FIELD REPORT: PIT CLOSURE VERIFICATION

LOCATION: NAME: STOREY C WELL #: 2M TYPE: SEP

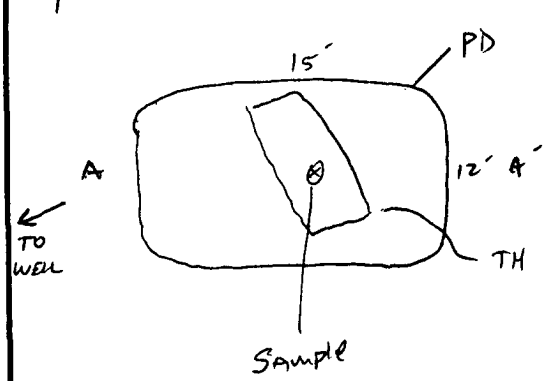
PIT PERIMETER

FIELD NOTES & REMARKS: PIT LOCATED APPROXIMATELY 114 FT. N72E FROM WELLHEAD.

ADDITIONAL COMMENTS: 15'x12'x3' Deep earthen Pit excavated into bedrock sandstone. Use backhoe to excavate into Sandstone & sample

BEDROCK BOTTOM

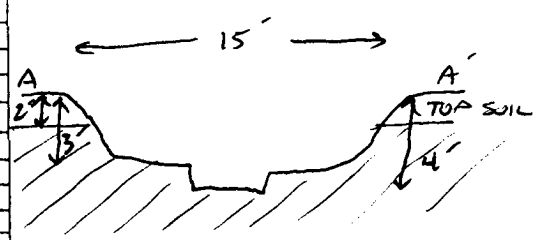
PIT PROFILE

DISCOLORATION/STAINING OBSERVED: (YES) / NO EXPLANATION - BROWN STAIN

HC ODOR DETECTED: (YES) / NO EXPLANATION - MODERATE

SAMPLE ID	FIELD HEADSPACE (ppm)
1 @ 4'	286
2 @	
3 @	
4 @	
5 @
