Pit or Below-Grade Tank Registration or Closure

Operator: BP AMERICA PROD. CO. Telephone: (505)-326-9200 e-mail address:
Address: 200 ENERGY COURT. FARMINGTON. NM 87410
Facility or well name: McCULLEY LS #5M API #: 30-045- 26544 U/L or Qtr/Qtr D Sec 24 T 28N R 9W
County: SAN JUAN Latitude 36.65130 Longitude 107.74466 NAD: 1927 ☐ 1983 ☒ Surface Owner Federal ☒ State ☐ Private ☐ Indian ☐

FIELD REPORT: PIT CLOSURE VERIFICATION

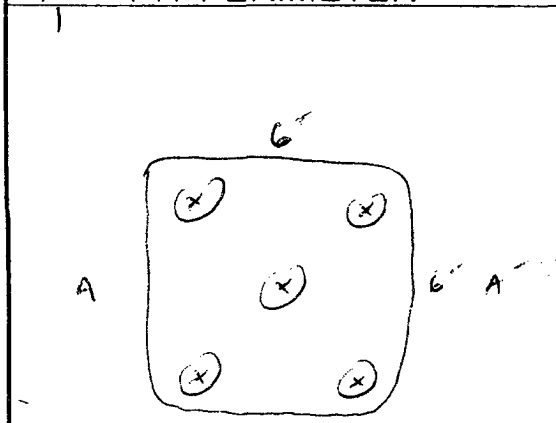
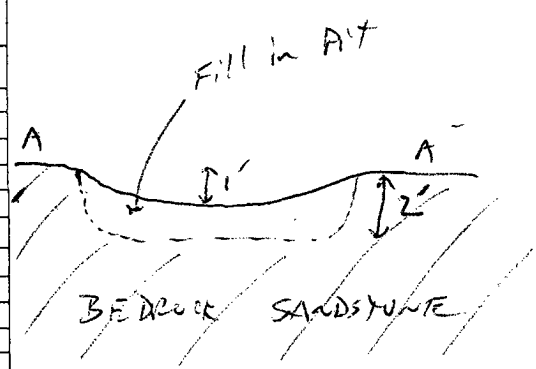
FIELD NOTES & REMARKS: PIT LOCATED APPROXIMATELY 51 FT. N45E FROM WELLHEAD.

SOIL TYPE: SAND / SILTY SAND / SILT / SILTY CLAY / CLAY / GRAVEL / (OTHER) BEDROCK @ G.L.
SOIL COLOR:
COHESION (ALL OTHERS): NON COHESIVE / SLIGHTLY COHESIVE / COHESIVE / (HIGHLY COHESIVE)
CONSISTENCY (NON COHESIVE SOILS): LOOSE / FIRM / DENSE / (VERY DENSE)
PLASTICITY (CLAYS): NON PLASTIC / SLIGHTLY PLASTIC / COHESIVE / MEDIUM PLASTIC / HIGHLY PLASTIC
DENSITY (COHESIVE CLAYS & SILTS): SOFT / FIRM / STIFF / VERY STIFF / HARD
MOISTURE: (DRY / SLIGHTLY MOIST) / MOIST / WET / SATURATED / SUPER SATURATED
DISCOLORATION/STAINING OBSERVED: YES (NO) EXPLANATION -
HC ODOR DETECTED: YES (NO) EXPLANATION -
SAMPLE TYPE: GRAB / (COMPOSITE) - # OF PTS. 5
ADDITIONAL COMMENTS: 6 x 6 x 1 Earthen Pit excavated into Bedrock Sandstone. Use Backhoe to Dig Into Pit x Sample.

SAMPLE ID	FIELD HEADSPACE (ppm)
1 @	
2 @	
3 @	
4 @	
5 @	
5-POINT COMPOSITE @ 2'	3.2

SAMPLE ID	ANALYSIS	TIME
5-POINT	TPH	~~0930~~
	BTEX	1050
	Cl-	
	PASSED

DISPOSAL FACILITY: NA REMEDIATION METHOD: CLOSE AS IS

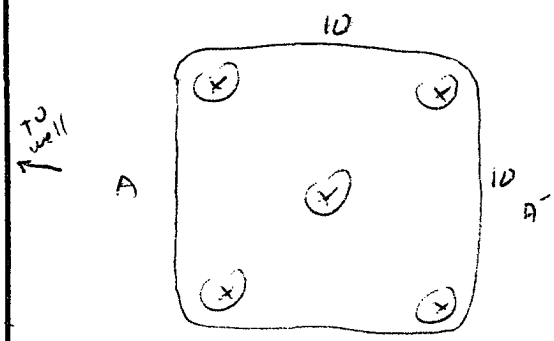
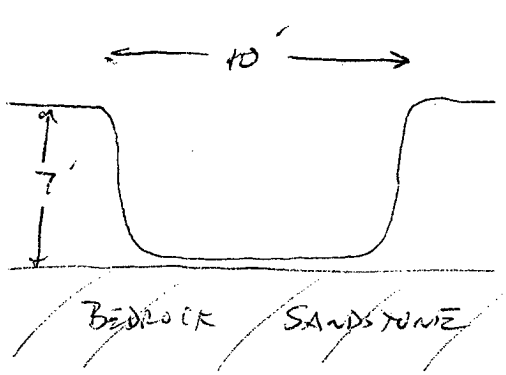
FIELD NOTES & REMARKS: PIT LOCATED APPROXIMATELY 129 FT. S 81 E FROM WELLHEAD.

SOIL TYPE: (SAND) / SILTY SAND / SILT / SILTY CLAY / CLAY / GRAVEL / OTHER BEDROCK SANDSTONE @ 7'
SOIL COLOR:
COHESION (ALL OTHERS): (NON COHESIVE) SLIGHTLY COHESIVE / COHESIVE / HIGHLY COHESIVE
CONSISTENCY (NON COHESIVE SOILS): (LOOSE) FIRM / DENSE / VERY DENSE
PLASTICITY (CLAYS): NON PLASTIC / SLIGHTLY PLASTIC / COHESIVE / MEDIUM PLASTIC / HIGHLY PLASTIC
DENSITY (COHESIVE CLAYS & SILTS): SOFT / FIRM / STIFF / VERY STIFF / HARD
MOISTURE: DRY (SLIGHTLY MOIST) / MOIST / WET / SATURATED / SUPER SATURATED
DISCOLORATION/STAINING OBSERVED: (YES) / NO EXPLANATION - GRAY/BLACK TO SANDSTONE @ 7'
HC ODOR DETECTED (YES) / NO EXPLANATION - STRONG
SAMPLE TYPE: GRAB / (COMPOSITE) # OF PTS. 5
ADDITIONAL COMMENTS: 9x9x2 EARTHEN PIT EXCAVATED ~~TO~~ DOWN TO BEDROCK SANDSTONE, USE BACKHOE. (Bedrock @ 7') BEDROCK BOTTOM

SAMPLE ID	FIELD HEADSPACE (ppm)
1 @	
2 @	
3 @	
4 @	
5 @	
5-POINT	161
COMPOSITE @ 7'

SAMPLE ID	ANALYSIS	TIME
5-POINT	TPH	1136
	BTEX	
	Cl-	
	PASSED

DISPOSAL FACILITY: BP CROUCH MESA L.F. REMEDIATION METHOD: EXCAVATE
LAND USE: RANGE - BLM LEASE: NM 004208 FORMATION: MV

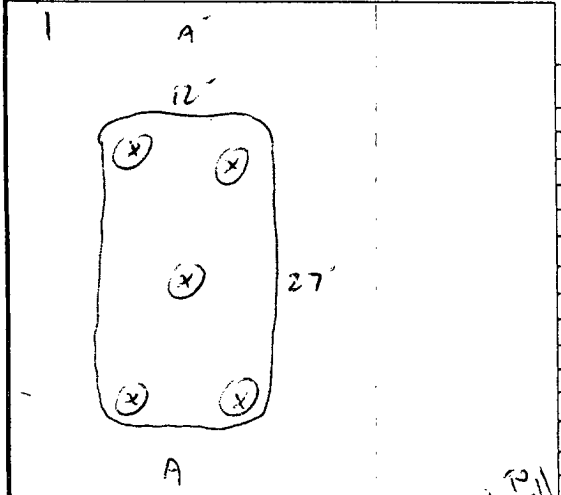
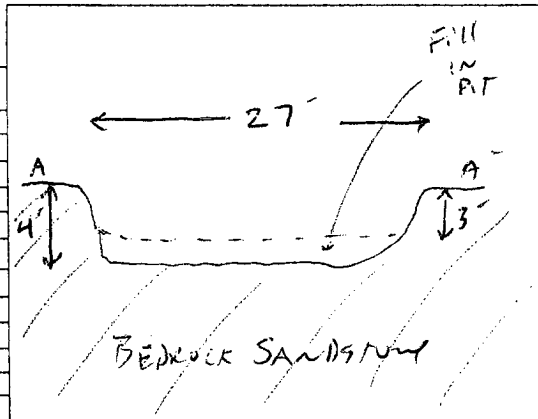
FIELD NOTES & REMARKS: PIT LOCATED APPROXIMATELY 93 FT. N41W FROM WELLHEAD.
DEPTH TO GROUNDWATER: >100 NEAREST WATER SOURCE: >1000 NEAREST SURFACE WATER: >1000
NMOCD RANKING SCORE: 0 NMOCD TPH CLOSURE STD: 5000 PPM

SOIL TYPE: SAND / SILTY SAND / SILT / SILTY CLAY / CLAY / GRAVEL / (OTHER) BEDROCK SANDSTONE
SOIL COLOR: YELLOW TAN
COHESION (ALL OTHERS): NON COHESIVE / SLIGHTLY COHESIVE / COHESIVE / (HIGHLY COHESIVE)
CONSISTENCY (NON COHESIVE SOILS): LOOSE / FIRM / DENSE / (VERY DENSE)
PLASTICITY (CLAYS): NON PLASTIC / SLIGHTLY PLASTIC / COHESIVE / MEDIUM PLASTIC / HIGHLY PLASTIC
DENSITY (COHESIVE CLAYS & SILTS): SOFT / FIRM / STIFF / VERY STIFF / HARD
MOISTURE: DRY / (SLIGHTLY MOIST) / MOIST / WET / SATURATED / SUPER SATURATED
DISCOLORATION/STAINING OBSERVED: YES / (NO) EXPLANATION -
HC ODOR DETECTED: YES / (NO) EXPLANATION -
SAMPLE TYPE: GRAB / (COMPOSITE) - # OF PTS. 5
ADDITIONAL COMMENTS: 27 x 12 x 3 Earthen Pit Excavated into Bedrock sandstone. Use Backhoe to Collect Samples.

SAMPLE ID	FIELD HEADSPACE (ppm)
1 @	
2 @	
3 @	
4 @	
5 @	
5-Point Composite @ 4'	7.1

SAMPLE ID	ANALYSIS	TIME
5-Point	TPH	1045
	BTEX	
	Cl-	
	PASSED

EXCAVATION APPROX. NA FT. x NA FT. x NA FT. DEEP. CUBIC YARDAGE: 0
DISPOSAL FACILITY: NA REMEDIATION METHOD: CLOSE AS IS
LAND USE: RANGE - BLM LEASE: NM 004208 FORMATION: MV

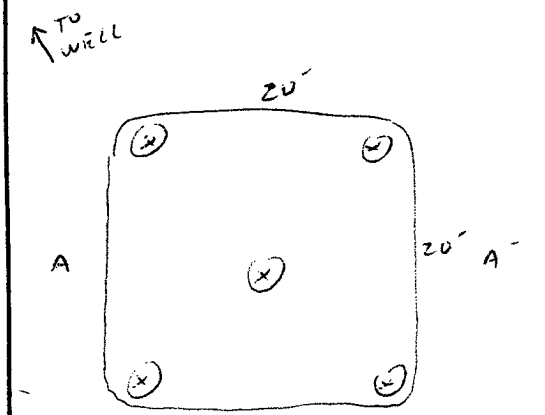
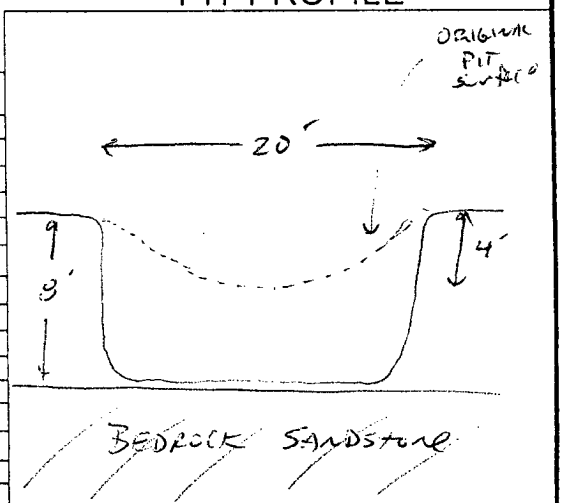
SOIL TYPE: (SAND) / SILTY SAND / SILT / SILTY CLAY / CLAY / GRAVEL / OTHER BEDROCK SANDSTONE @ 8'
SOIL COLOR:
COHESION (ALL OTHERS): (NON COHESIVE) SLIGHTLY COHESIVE / COHESIVE / HIGHLY COHESIVE
CONSISTENCY (NON COHESIVE SOILS): (LOOSE) / FIRM / DENSE / VERY DENSE
PLASTICITY (CLAYS): NON PLASTIC / SLIGHTLY PLASTIC / COHESIVE / MEDIUM PLASTIC / HIGHLY PLASTIC
DENSITY (COHESIVE CLAYS & SILTS): SOFT / FIRM / STIFF / VERY STIFF / HARD
MOISTURE: DRY / (SLIGHTLY MOIST) / MOIST / WET / SATURATED / SUPER SATURATED
DISCOLORATION/STAINING OBSERVED: (YES) NO EXPLANATION - Gray/Black in Removed Soils
HC ODOR DETECTED: (YES) NO EXPLANATION - Strong
SAMPLE TYPE: GRAB / (COMPOSITE) # OF PTS. 5
ADDITIONAL COMMENTS: 18 x 18 x 4' - Eastern Pit. Use Backhoe to Remove Gray/Black Soils to Bedrock Sandstone @ 8'

SAMPLE ID	FIELD HEADSPACE (ppm)
1 @	
2 @	
3 @	
4 @	
5 @	
5-POINT	211
COMPOSITE @ 8'

SAMPLE ID	ANALYSIS	TIME
5-POINT	TPH	1115
	BTEX	
	Cl-	
	PASSED

Additional Comments: PIT LOCATED APPROXIMATELY 90 FT. S41E FROM WELL HEAD.
PIT EXCAVATION: WIDTH 20 ft., LENGTH 20 ft., DEPTH 8 ft. .
PIT REMEDIATION: CLOSE AS IS: ☐, LANDFARM: ☐, COMPOST: ☐, STOCKPILE: ☐, OTHER ☒ EXCAVATE
Cubic yards: 70
BEDROCK BOTTOM
