Pit or Below-Grade Tank Registration or Closure

Operator: Dugan Production Corp Telephone: (505)325-1821 e-mail address: _____
Address: P.O. Box 420, Farmington, New Mexico 87401
Facility or well name: Dome State 32-22-6 #2 API #: 30-043-20470 U/L or Qtr/Qtr A Sec 32 T 22N R 6W
County: Sandoval Latitude 36.09930 Longitude 107.48649 NAD: 1927 ☐ 1983 ☐ Surface Owner Federal ☐ State ☒ Private ☐ Indian ☐

FIELD REPORT: PIT CLOSURE VERIFICATION

LOCATION: NAME: DOME STATE 32-22-6 WELL #: 2 TYPE: SEP

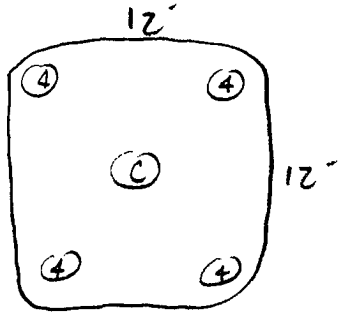
PIT PERIMETER

FIELD NOTES & REMARKS: PIT LOCATED APPROXIMATELY 78 FT. N42W FROM WELLHEAD.

SOIL TYPE: SAND / (SILTY SAND) / SILT / SILTY CLAY / CLAY / GRAVEL / (OTHER) BEDROCK SANDSTONE.
SOIL COLOR: TAN
COHESION (ALL OTHERS): NON COHESIVE / SLIGHTLY COHESIVE / COHESIVE / HIGHLY COHESIVE
CONSISTENCY (NON COHESIVE SOILS): (LOOSE) / FIRM / DENSE / VERY DENSE
PLASTICITY (CLAYS): NON PLASTIC / SLIGHTLY PLASTIC / COHESIVE / MEDIUM PLASTIC / HIGHLY PLASTIC
DENSITY (COHESIVE CLAYS & SILTS): SOFT / FIRM / STIFF / VERY STIFF / HARD
MOISTURE: (DRY / SLIGHTLY MOIST) / MOIST / WET / SATURATED / SUPER SATURATED
DISCOLORATION/STAINING OBSERVED: YES / (NO) EXPLANATION -
HC ODOR DETECTED: YES / (NO) EXPLANATION -
SAMPLE TYPE: GRAB / COMPOSITE - # OF PTS.
ADDITIONAL COMMENTS: 12'x12'x1' unlined Pit, constructed on Sandstone Surface By Piling Sand Around Pit. Use Backhoe to Dig to Sandstone - 0 Sample

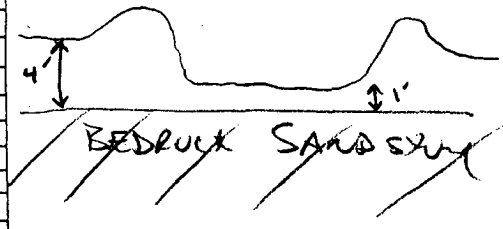
PIT PROFILE

12' x 12' x 1'± deep unlined production pit, center located 78 feet North 42° West of wellhead.

Use Backhoe to dig into pit and sample. Pit constructed on bedrock sandstone by piling sand to make containment walls.
