Pit or Below-Grade Tank Registration or Closure

FIELD REPORT: PIT CLOSURE VERIFICATION

LOCATION: NAME: DOME NAV. 33-22-6 WELL #: 1 TYPE: SEP
QUAD/UNIT: A SEC: 33 TWP: 22N RNG: 6W PM: NM CNTY: SN ST: NM
QTR/FOOTAGE: 790 FNL x 790 FEL CONTRACTOR: SIERRA - HARVEY

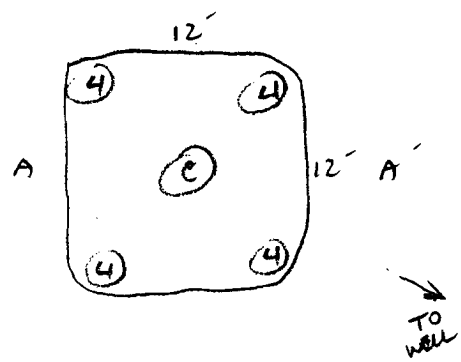
PIT PERIMETER

FIELD NOTES & REMARKS: PIT LOCATED APPROXIMATELY 54' FT. N86W FROM WELLHEAD.
DEPTH TO GROUNDWATER: >100 NEAREST WATER SOURCE: >1000 NEAREST SURFACE WATER: >1000
NMOCD RANKING SCORE: 0 NMOCD TPH CLOSURE STD: 5000 PPM

SOIL TYPE: SAND / (SILTY SAND) / SILT / SILTY CLAY / CLAY / GRAVEL / OTHER
SOIL COLOR: TAN
COHESION (ALL OTHERS): NON COHESIVE / (SLIGHTLY COHESIVE) / COHESIVE / HIGHLY COHESIVE
CONSISTENCY (NON COHESIVE SOILS): LOOSE / (FIRM) / DENSE / VERY DENSE
PLASTICITY (CLAYS): NON PLASTIC / SLIGHTLY PLASTIC / COHESIVE / MEDIUM PLASTIC / HIGHLY PLASTIC
DENSITY (COHESIVE CLAYS & SILTS): SOFT / FIRM / STIFF / VERY STIFF / HARD
MOISTURE: DRY / (SLIGHTLY MOIST) / MOIST / WET / SATURATED / SUPER SATURATED
DISCOLORATION/STAINING OBSERVED: YES / (NO) EXPLANATION -
HC ODOR DETECTED: YES / (NO) EXPLANATION -
SAMPLE TYPE: GRAB / COMPOSITE - # OF PTS.
ADDITIONAL COMMENTS: 12'x12'x2'± Deep Unlined Pit. USE BACKHOE TO DIG INTO PIT & SAMPLE
