Pit or Below-Grade Tank Registration or Closure

Operator: Dugan Production Corp Telephone: (505)325-1821 e-mail address:
Address: P.O. Box 420, Farmington, New Mexico 87401
Facility or well name: September No. 15 API #: 30-045-26518 U/L or Qtr/Qtr A Sec 24 T 24N R 10W
County: San Juan Latitude 36.30412 Longitude 107.84263 NAD: 1927 ☐ 1983 ☐ Surface Owner Federal ☒ State ☐ Private ☐ Indian ☐

FIELD REPORT: PIT CLOSURE VERIFICATION

LOCATION: NAME: SEPTEMBER WELL #: 15 TYPE: SEP
QUAD/UNIT: A SEC: 24 TWP: 24N RNG: 10W PM: NM CNTY: SJ ST: NM
QTR/FOOTAGE: 990 FNL x 990 FEL CONTRACTOR: DPC - TAYLOR

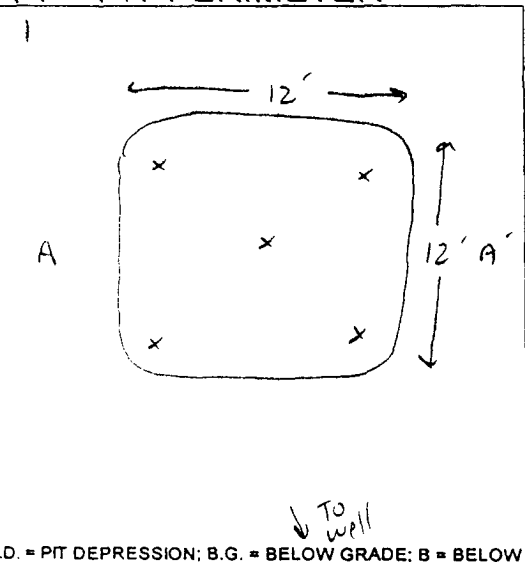
PIT PERIMETER

FIELD NOTES & REMARKS: PIT LOCATED APPROXIMATELY 69 FT. N23W FROM WELLHEAD.

SOIL TYPE: (SAND / SILTY SAND) SILT / SILTY CLAY / CLAY / GRAVEL / OTHER
SOIL COLOR:
COHESION (ALL OTHERS): (NON COHESIVE) / SLIGHTLY COHESIVE / COHESIVE / HIGHLY COHESIVE
CONSISTENCY (NON COHESIVE SOILS): (LOOSE) / FIRM / DENSE / VERY DENSE
PLASTICITY (CLAYS): NON PLASTIC / SLIGHTLY PLASTIC / COHESIVE / MEDIUM PLASTIC / HIGHLY PLASTIC
DENSITY (COHESIVE CLAYS & SILTS): SOFT / FIRM / STIFF / VERY STIFF / HARD
MOISTURE: DRY / SLIGHTLY MOIST / (MOIST) / WET / SATURATED / SUPER SATURATED
DISCOLORATION/STAINING OBSERVED: (YES) / NO EXPLANATION - BLACK FROM Pit Base (-3') TO 6'. Gray 6'-7'
HC ODOR DETECTED: (YES) / NO EXPLANATION -
SAMPLE TYPE: GRAB / (COMPOSITE) # OF PTS. 5
ADDITIONAL COMMENTS: 12'x12'x3'± Unlined PIT. USE Backhoe to DIG INTO PIT & SAMPLE. Collect Gray Stained Soils for LAB.

DISPOSAL FACILITY: NA REMEDIATION METHOD: CLOSE AS IS

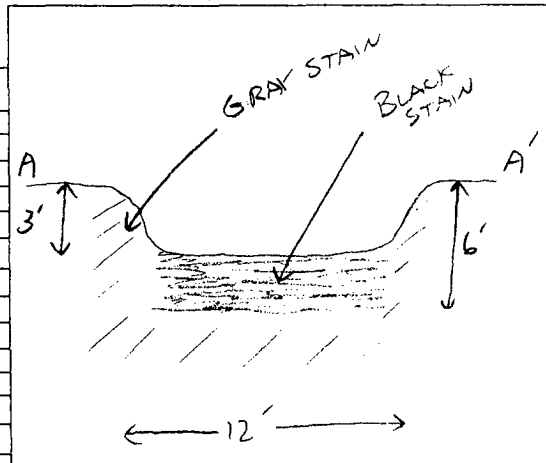
PIT PROFILE

SAMPLE ID	FIELD HEADSPACE (ppm)
1 @	
2 @	
3 @	
4 @	
5 @	
5-Pt @ 7'	0.0
