Pit or Below-Grade Tank Registration or Closure

Operator: Dugan Production Corp Telephone. (505)325-1821 e-mail address:
Address: P.O Box 420, Farmington, New Mexico 87401
Facility or well name: Turks Toast No. 3 API #: 30-045-27321 U/L or Qtr/Qtr D Sec 17 T 30N R 14W
County: San Juan Latitude 36.81867 Longitude 108 33849 NAD 1927 ☐ 1983 ☐ Surface Owner Federal ☒ State ☐ Private ☐ Indian ☐

FIELD REPORT: PIT CLOSURE VERIFICATION

LOCATION: NAME: TURRS TOAST WELL #: 3 TYPE: SEP.
QUAD/UNIT: D SEC: 17 TWP: 30N RNG: 14W PM: NM CNTY: SJ ST: NM
QTR/FOOTAGE: 950 FNL x 910 FWL CONTRACTOR: MJO

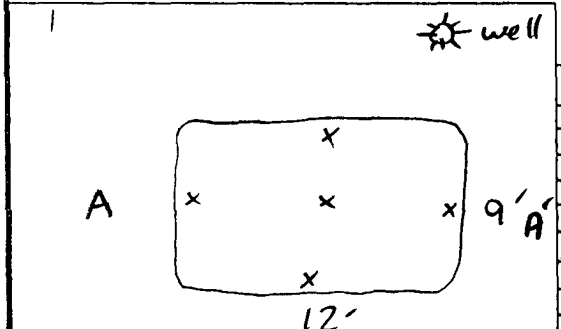
PIT PERIMETER

EXCAVATION APPROX. 12 FT. x 9' FT. x 5' FT. DEEP. CUBIC YARDAGE: 10 ±
DISPOSAL FACILITY: ONSITE REMEDIATION METHOD: LF
LAND USE: RANGE - BLM LEASE: NM-19163 FORMATION: DK

FIELD NOTES & REMARKS: PIT LOCATED APPROXIMATELY 20' FT. S 40 W FROM WELLHEAD.
DEPTH TO GROUNDWATER: >100 NEAREST WATER SOURCE: >1000 NEAREST SURFACE WATER: >200
NMOCD RANKING SCORE: 10 NMOCD TPH CLOSURE STD: 1000 PPM

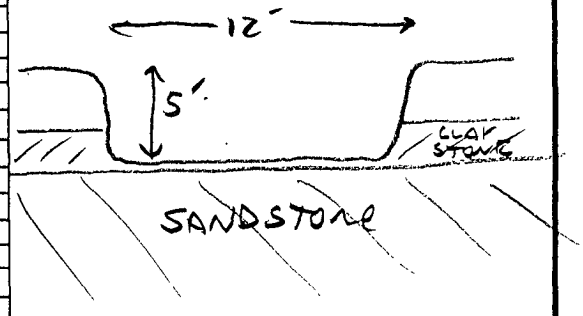
PIT PROFILE

SOIL TYPE: (SAND / SILTY SAND) SILT / SILTY CLAY / CLAY / GRAVEL (OTHER) Claystone 3'-5'; SANDSTONE @ 5'
SOIL COLOR:
COHESION (ALL OTHERS): NON COHESIVE / SLIGHTLY COHESIVE / COHESIVE / (HIGHLY COHESIVE)
CONSISTENCY (NON COHESIVE SOILS): LOOSE / FIRM / DENSE / (VERY DENSE)
PLASTICITY (CLAYS): NON PLASTIC / SLIGHTLY PLASTIC / COHESIVE / MEDIUM PLASTIC / HIGHLY PLASTIC
DENSITY (COHESIVE CLAYS & SILTS): SOFT / FIRM / STIFF / VERY STIFF / HARD
MOISTURE: DRY / (SLIGHTLY MOIST) / MOIST / WET / SATURATED / SUPER SATURATED
DISCOLORATION/STAINING OBSERVED: (YES) / NO EXPLANATION - Streaking
HC ODOR DETECTED: (YES) NO EXPLANATION - Moderate
SAMPLE TYPE: GRAB (COMPOSITE) # OF PTS. 5
ADDITIONAL COMMENTS: 10' x 8' x 3' ± Deep Unlined Pit. Use Backhoe to Dig to SANDSTONE @ 5'
