Pit or Below-Grade Tank Registration or Closure

Operator: Dugan Production Corp Telephone: (505)325-1821 e-mail address:
Address: P.O. Box 420, Farmington, New Mexico 87401
Facility or well name: Oktoberfest No. 1 API #: 30-045-26498 U/L or Qtr/Qtr A Sec 36 T 24N R 10W
County: San Juan Latitude 36.27536 Longitude 107.84176 NAD: 1927 ☐ 1983 ☐ Surface Owner Federal ☐ State ☐ Private ☐ Indian ☐

FIELD REPORT: PIT CLOSURE VERIFICATION

LOCATION: NAME: OKTOBERFEST WELL #: 1 TYPE: TANK
QUAD/UNIT A SEC: 36 TWP: 24N RNG: 10W PM: NM CNTY: SJ ST: NM
QTR/FOOTAGE: 900FN x 750 FE CONTRACTOR: DPC

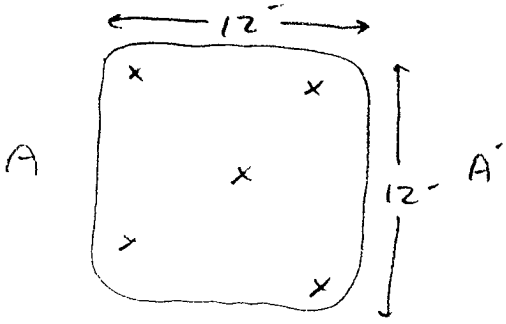
PIT PERIMETER

FIELD NOTES & REMARKS: PIT LOCATED APPROXIMATELY 90 FT. S46W FROM WELLHEAD.
DEPTH TO GROUNDWATER: >100 NEAREST WATER SOURCE: >1000 NEAREST SURFACE WATER >1000
NMOCD RANKING SCORE: 0 NMOCD TPH CLOSURE STD: 5000 PPM

SOIL TYPE: (SAND / SILTY SAND) / SILT / SILTY CLAY / CLAY / GRAVEL / OTHER
SOIL COLOR: TAN
COHESION (ALL OTHERS): (NON COHESIVE) / SLIGHTLY COHESIVE / COHESIVE / HIGHLY COHESIVE
CONSISTENCY (NON COHESIVE SOILS): (LOOSE) / FIRM / DENSE / VERY DENSE
PLASTICITY (CLAYS) NON PLASTIC / SLIGHTLY PLASTIC / COHESIVE / MEDIUM PLASTIC / HIGHLY PLASTIC
DENSITY (COHESIVE CLAYS & SILTS): SOFT / FIRM / STIFF / VERY STIFF / HARD
MOISTURE (DRY) / SLIGHTLY MOIST / MOIST / WET / SATURATED / SUPER SATURATED
DISCOLORATION/STAINING OBSERVED: YES / (NO) EXPLANATION -
HC ODOR DETECTED. YES / (NO) EXPLANATION -
SAMPLE TYPE GRAB / (COMPOSITE) # OF PTS.
ADDITIONAL COMMENTS 12'x12'x4' UNLINED PIT
USE BACKHOE TO SAMPLE

SAMPLE ID	FIELD HEADSPACE (ppm)
1 @	
2 @	
3 @	
4 @	
5 @	
5-Pt @ 7'	0.0
