PIT REMEDIATION AND CLOSURE REPORT

Operator: ConocoPhillips Company Telephone: (505) 599-3400

Facility Or: Krause Wn Fed #5E API # :30-045-24121
Well Name

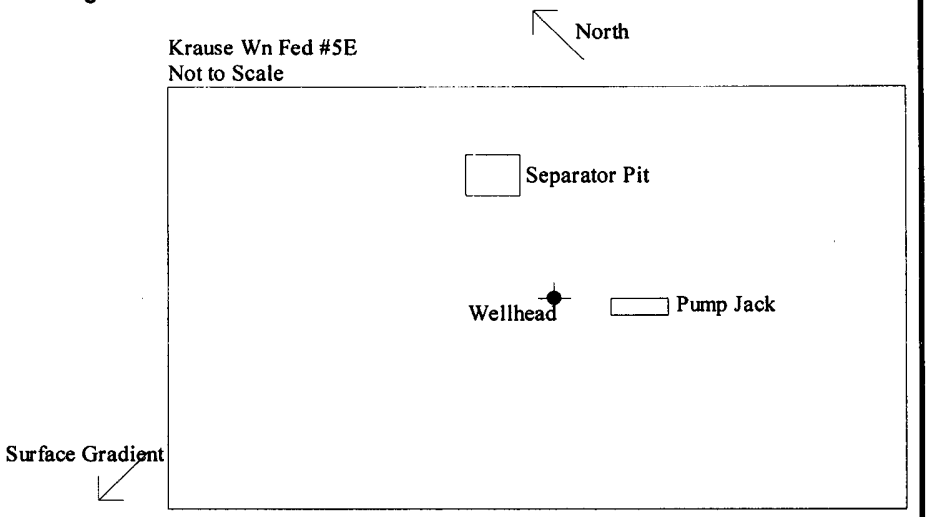
Site Diagram:

Comments:
Staining and odor from 1' to 3' below pit bottom
