PIT REMEDIATION AND CLOSURE REPORT

Operator: Caulkins Oil Company **Telephone:** (505) 632-1544

Facility or Well Name: Breech "B" 172-E

Wellname Breech B 172-E

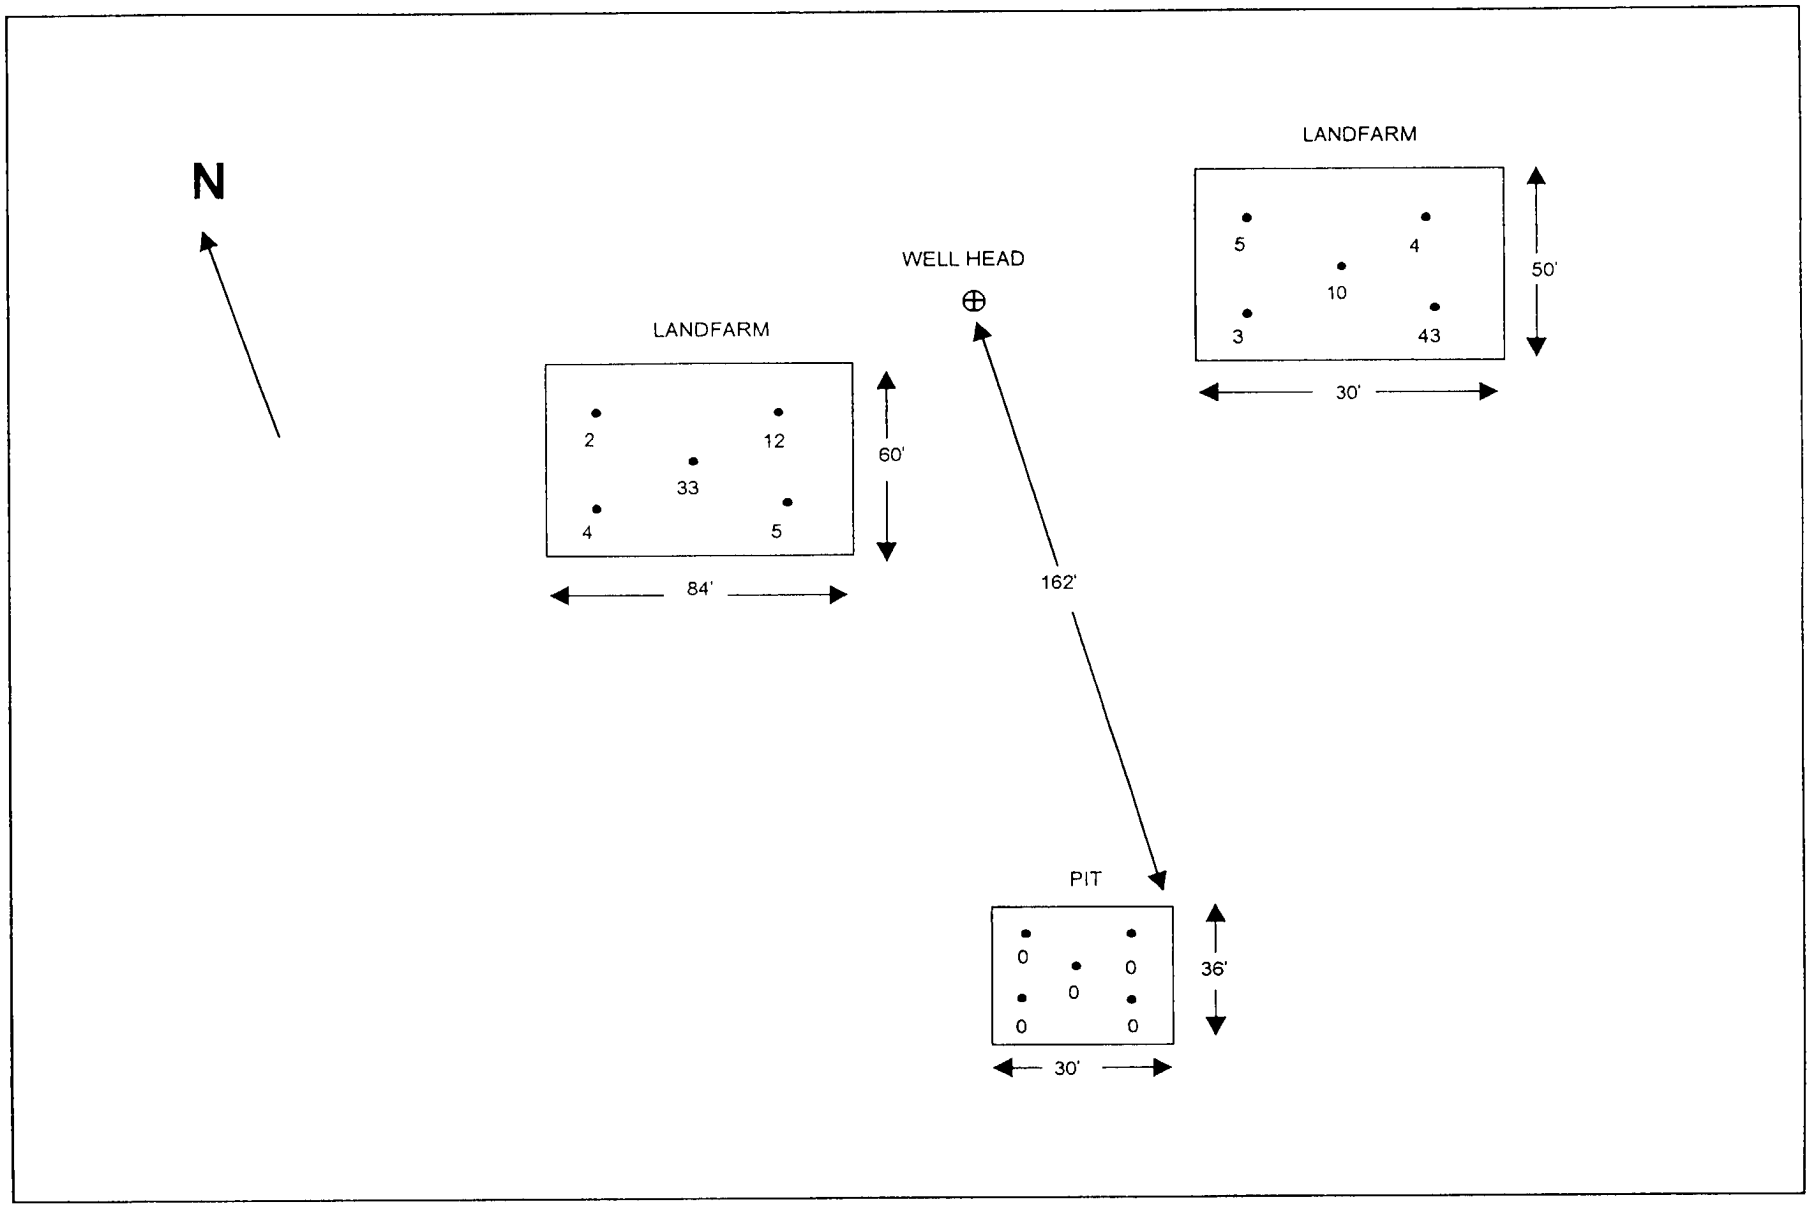
Pit Location: (Attach diagram)
Pit dimensions: length 36', width 30', depth 12'

Footage from reference: 165'

Direction from reference: 200 Degrees ____ East ___ North of
X West ___ South X
