PIT REMEDIATION AND CLOSURE REPORT

Facility Or: Well Name: FLORANCE #82

FIELD REPORT: CLOSURE VERIFICATION

Well Name:	**Florance #82**
Well Site location:	Unit O, Sec. 22, T29N, R9W
Pit Type:	Abandoned Blow Pit
Producing Formation:	Pictured Cliffs
Pit Category:	Non Vulnerable
Horizontal Distance to Surface Water:	> 1000 ft.
Vicinity Groundwater Depth:	> 100 ft.

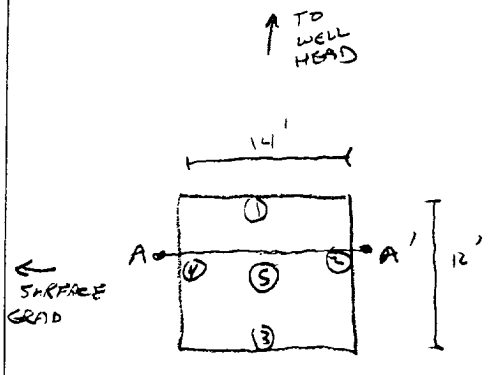
PIT PERIMETER

PALE YELL. BROWN SAND, NON COHESIVE, SLIGHTLY MOIST TO MOIST, FIRM TO LOOSE, NO APPARENT DISCOLORATION OBSERVED OR HC ODOR DETECTED.

BOTTOM - BEDROCK (SANDSTONE), MED. LT. GRAY, VERY HARD, HC ODOR DETECTED IN OVM SAMPLE.

BEDROCK BOTTOM (5')

SAMPLE ID	FIELD HEADSPACE PID (ppm)
1 @ 3'	0.0
2 @ 3'	278
3 @ 3'	0.0
4 @ 3'	0.0
5 @ 5'	697

RISK ASSESSED
