RATIONALE FOR RISK-BASED CLOSURE OF PRODUCTION PITS LOCATED OUTSIDE OF THE VULNERABLE ZONE IN THE SAN JUAN BASIN

FIELD PIT SITE ASSESSMENT FORM

FIELD PIT REMEDIATION/CLOSURE FORM

FIELD SERVICES LABORATORY
ANALYTICAL REPORT
PIT CLOSURE PROJECT - Soil Samples Outside the GWV Zone

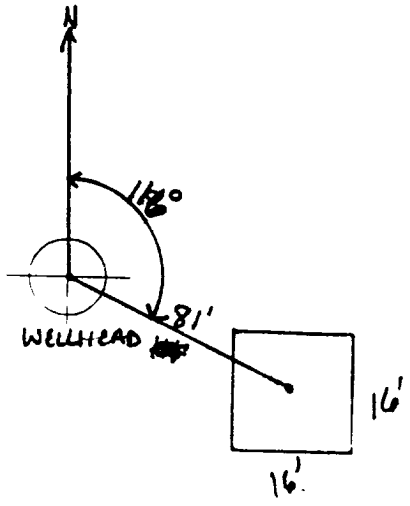
Remarks : REDLINE & TOPO SHOW LOCATION IS OUTSIDE V.2. TWO PITS ON LOCATION. ONE BELONGS TO OPERATOR. WILL CLOSE EPNG'S LOCATION DRIP.

Original Pit : a) Degrees from North 116° Footage from Wellhead 81'

b) Length : 16' Width : 16' Depth : 3'
