Meter Number:90473 90474
Location Name:MADDOX MARK #1A
Location:TN-32 RG-11
SC-15 UL-J
4 - Fee
NMOCD Zone:OUTSIDE
Hazard Ranking Score:00

RATIONALE FOR RISK-BASED CLOSURE OF PRODUCTION PITS LOCATED OUTSIDE OF THE VULNERABLE ZONE IN THE SAN JUAN BASIN

FIELD PIT SITE ASSESSMENT FORM

FIELD PIT REMEDIATION/CLOSURE FORM

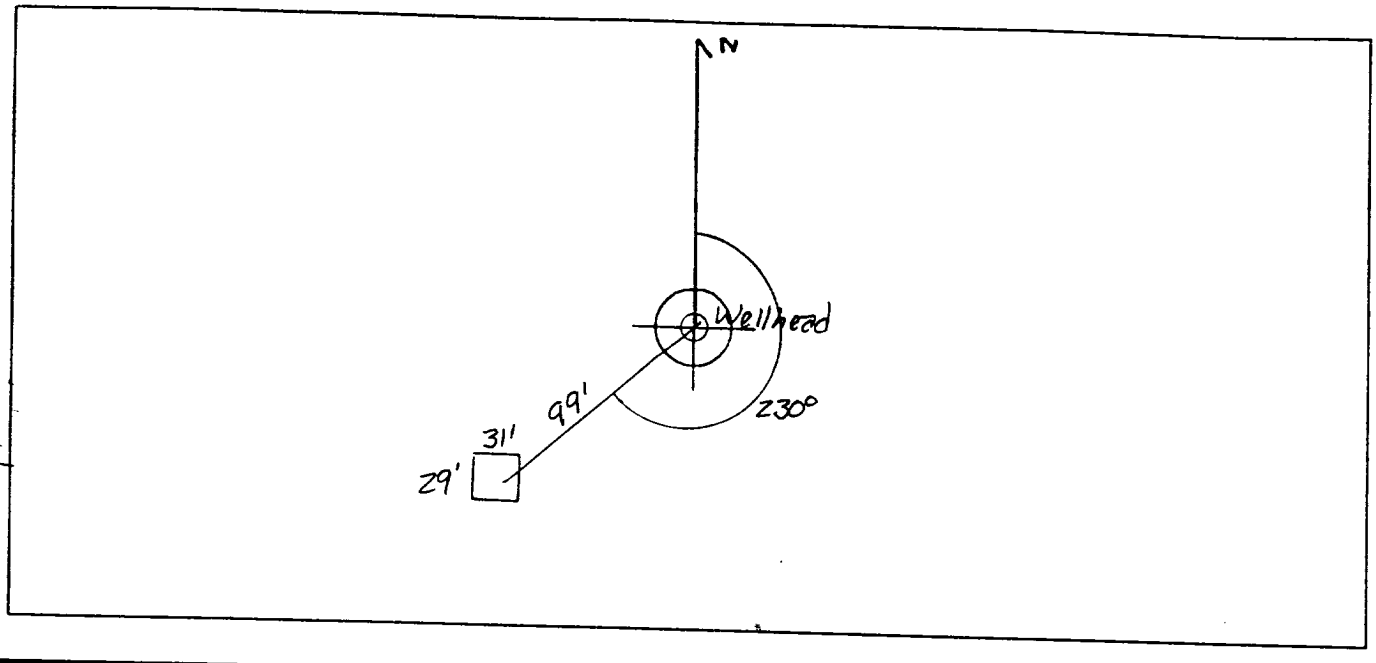
Remarks : Redline Book - Outside Vulnerable Zone Topo - Outside
Three pits onsite, location drip pit is dry. Will close one pit.

Original Pit : a) Degrees from North 230° Footage from Wellhead 99'

b) Length : 29' Width : 31' Depth : 4'
