Pit or Below-Grade Tank Registration or Closure

Operator: Saber Resources, Inc. Telephone: (432) 685-0169 e-mail address: Doug@SaberResources.com
Address: 400 W. Illinois, Suite 950 Midland, TX 79701
Facility or well name: T.D. Pope 26 #17 #: 30-025-05150 U/L or Qtr/Qtr I Sec 26 T 14S R 37E
County: Lea Latitude N 33 deg 04.413' Longitude W 103 deg 09.865' NAD: 1927 ☒ 1983 ☐
Surface Owner: Federal ☐ State ☐ Private ☒ Indian ☐

TD Pope 26 #17

Site Drawing
(Not to Scale)

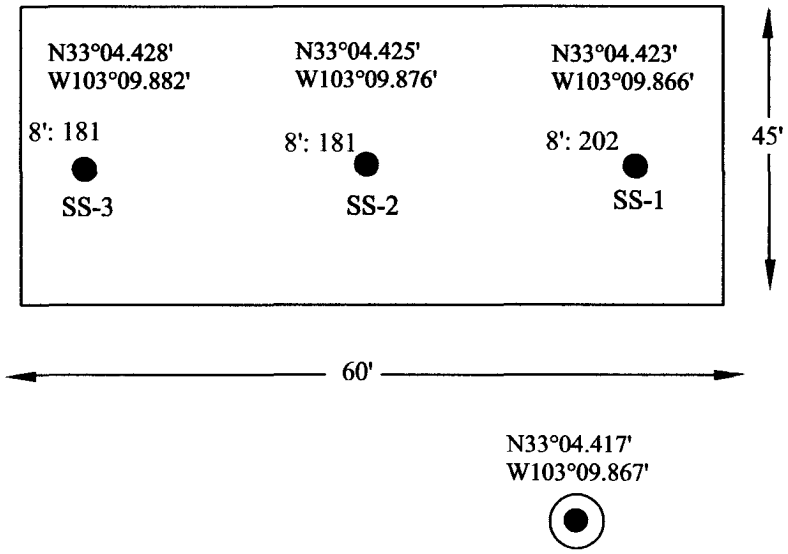
FIGURE # 1

8': 202
SS-1 — Soil sample location taken on 04/09/07, at a depth (feet), with chloride concentration (mg/kg).

Additional Comments: All fluids were removed from the pit. The burial pit was constructed adjacent to the drilling pit and lined with a 12 ml liner.
The liner and impacted material were placed in the burial pit, completely encapsulated and capped with a 20 ml liner, and covered with 3 feet of topsoil to grade.
Any hydrocarbon impacted material was disposed at an NMOCD approved facility.
Samples were collected below the liner and results are attached to this final C144 form.
