November 13, 2020 Vertex Project #: 20E-00141-013

Spill Closure Report: Todd 13 Battery
Unit P, Section 17, Township 23 South, Range 32 East
County: Lea
API: N/A
Tracking Number: NRM2003154559

Prepared For: Devon Energy Production Company
6488 Seven Rivers Highway
Artesia, New Mexico 88210

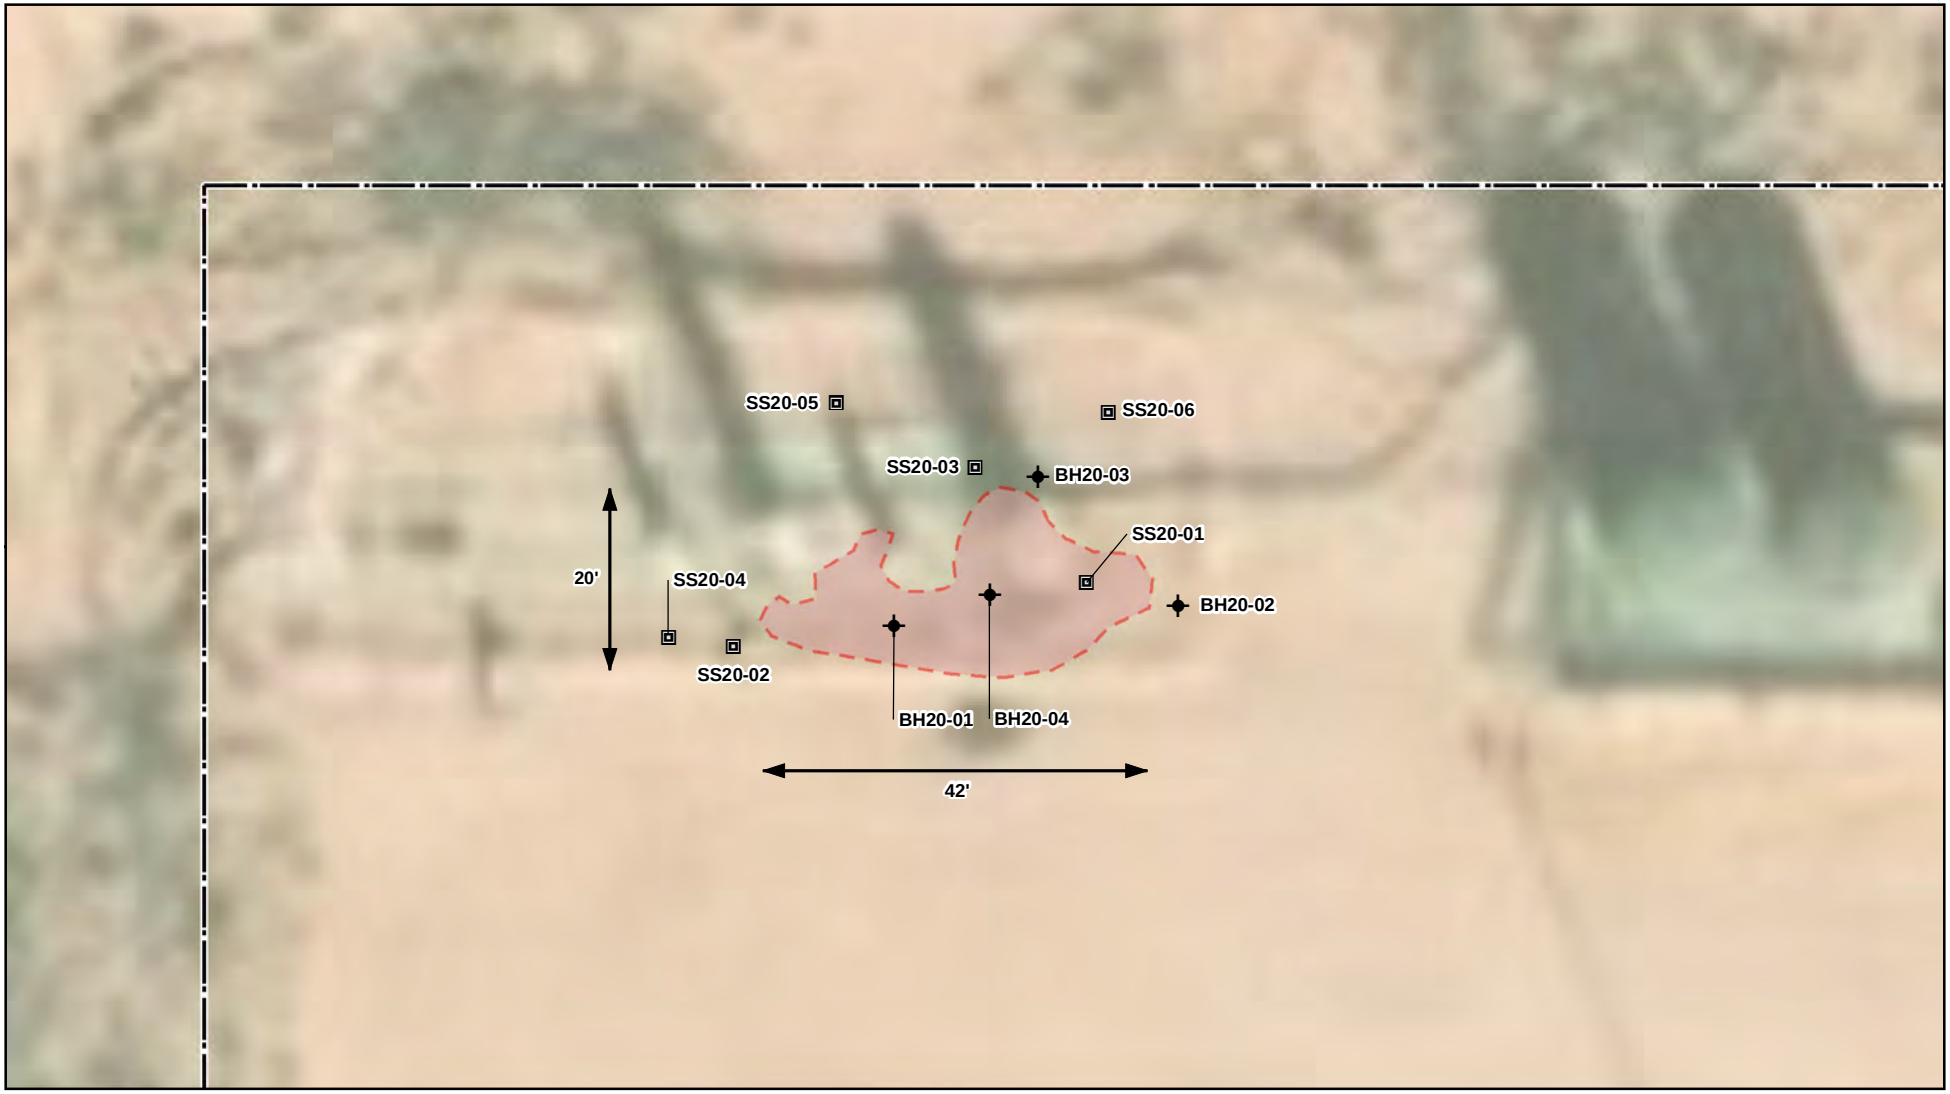
The release at Todd 13 occurred on federally owned land, N 32.297371, W 103.689202, approximately 30 miles east of Carlsbad, New Mexico. The legal description for the site is Unit P, Section 17, Township 23 South, Range 32 East, Lea County, New Mexico. This location is within the Permian Basin in southeast New Mexico and has historically been used for oil and gas exploration and production, and rangeland. An aerial photograph and site schematic are included in Attachment 2.

Borehole
Surface Sample
Approximate Lease Boundary
Approximate Spill Area (~ 476 sq. ft.)

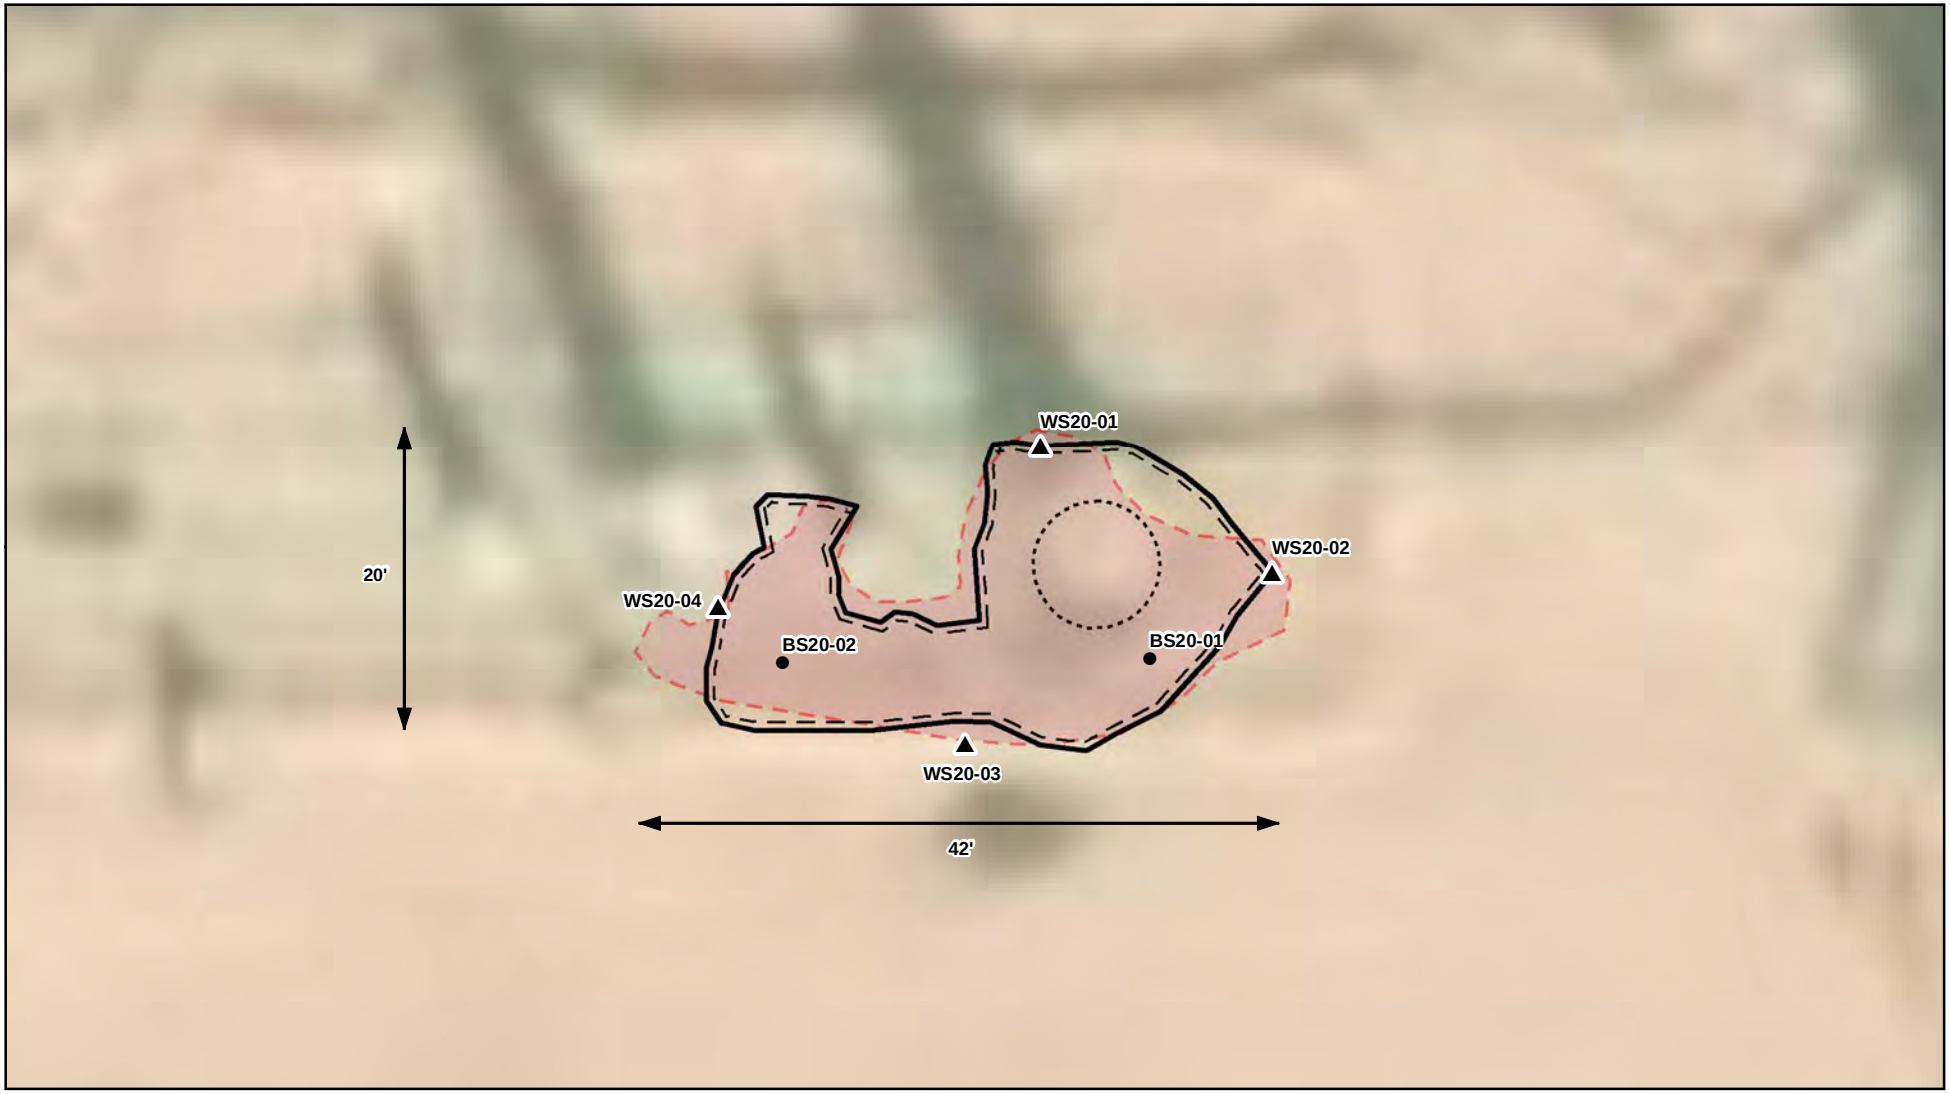
The additional confirmatory sample locations were marked using GPS and are shown on Figure 2 (Attachment 2). The final laboratory results for the confirmatory samples are presented in Table 2 (Attachment 6). Laboratory data reports and chain of custody forms are included in Attachment 7.

A GeoExplorer 7000 Series Trimble GPS unit, or equivalent, was used to map the additional confirmatory wall samples. The new wall samples are presented along with the original confirmatory base and side wall samples on Figure 3 (Attachment 2).

● Base Sample
▲ Wall Sample
Approximate Spill Area (~ 476 sq. ft.)
Excavated Area
Heater Treater Area (Not Excavated)
