Closure

Closure of Release Investigation and Remedial Action Plan

General Site Information:
Caza Eagle Claw Line (NMOCD Reference #: 1RP-5609)

December 18, 2020
Terracon Project No. AR197234

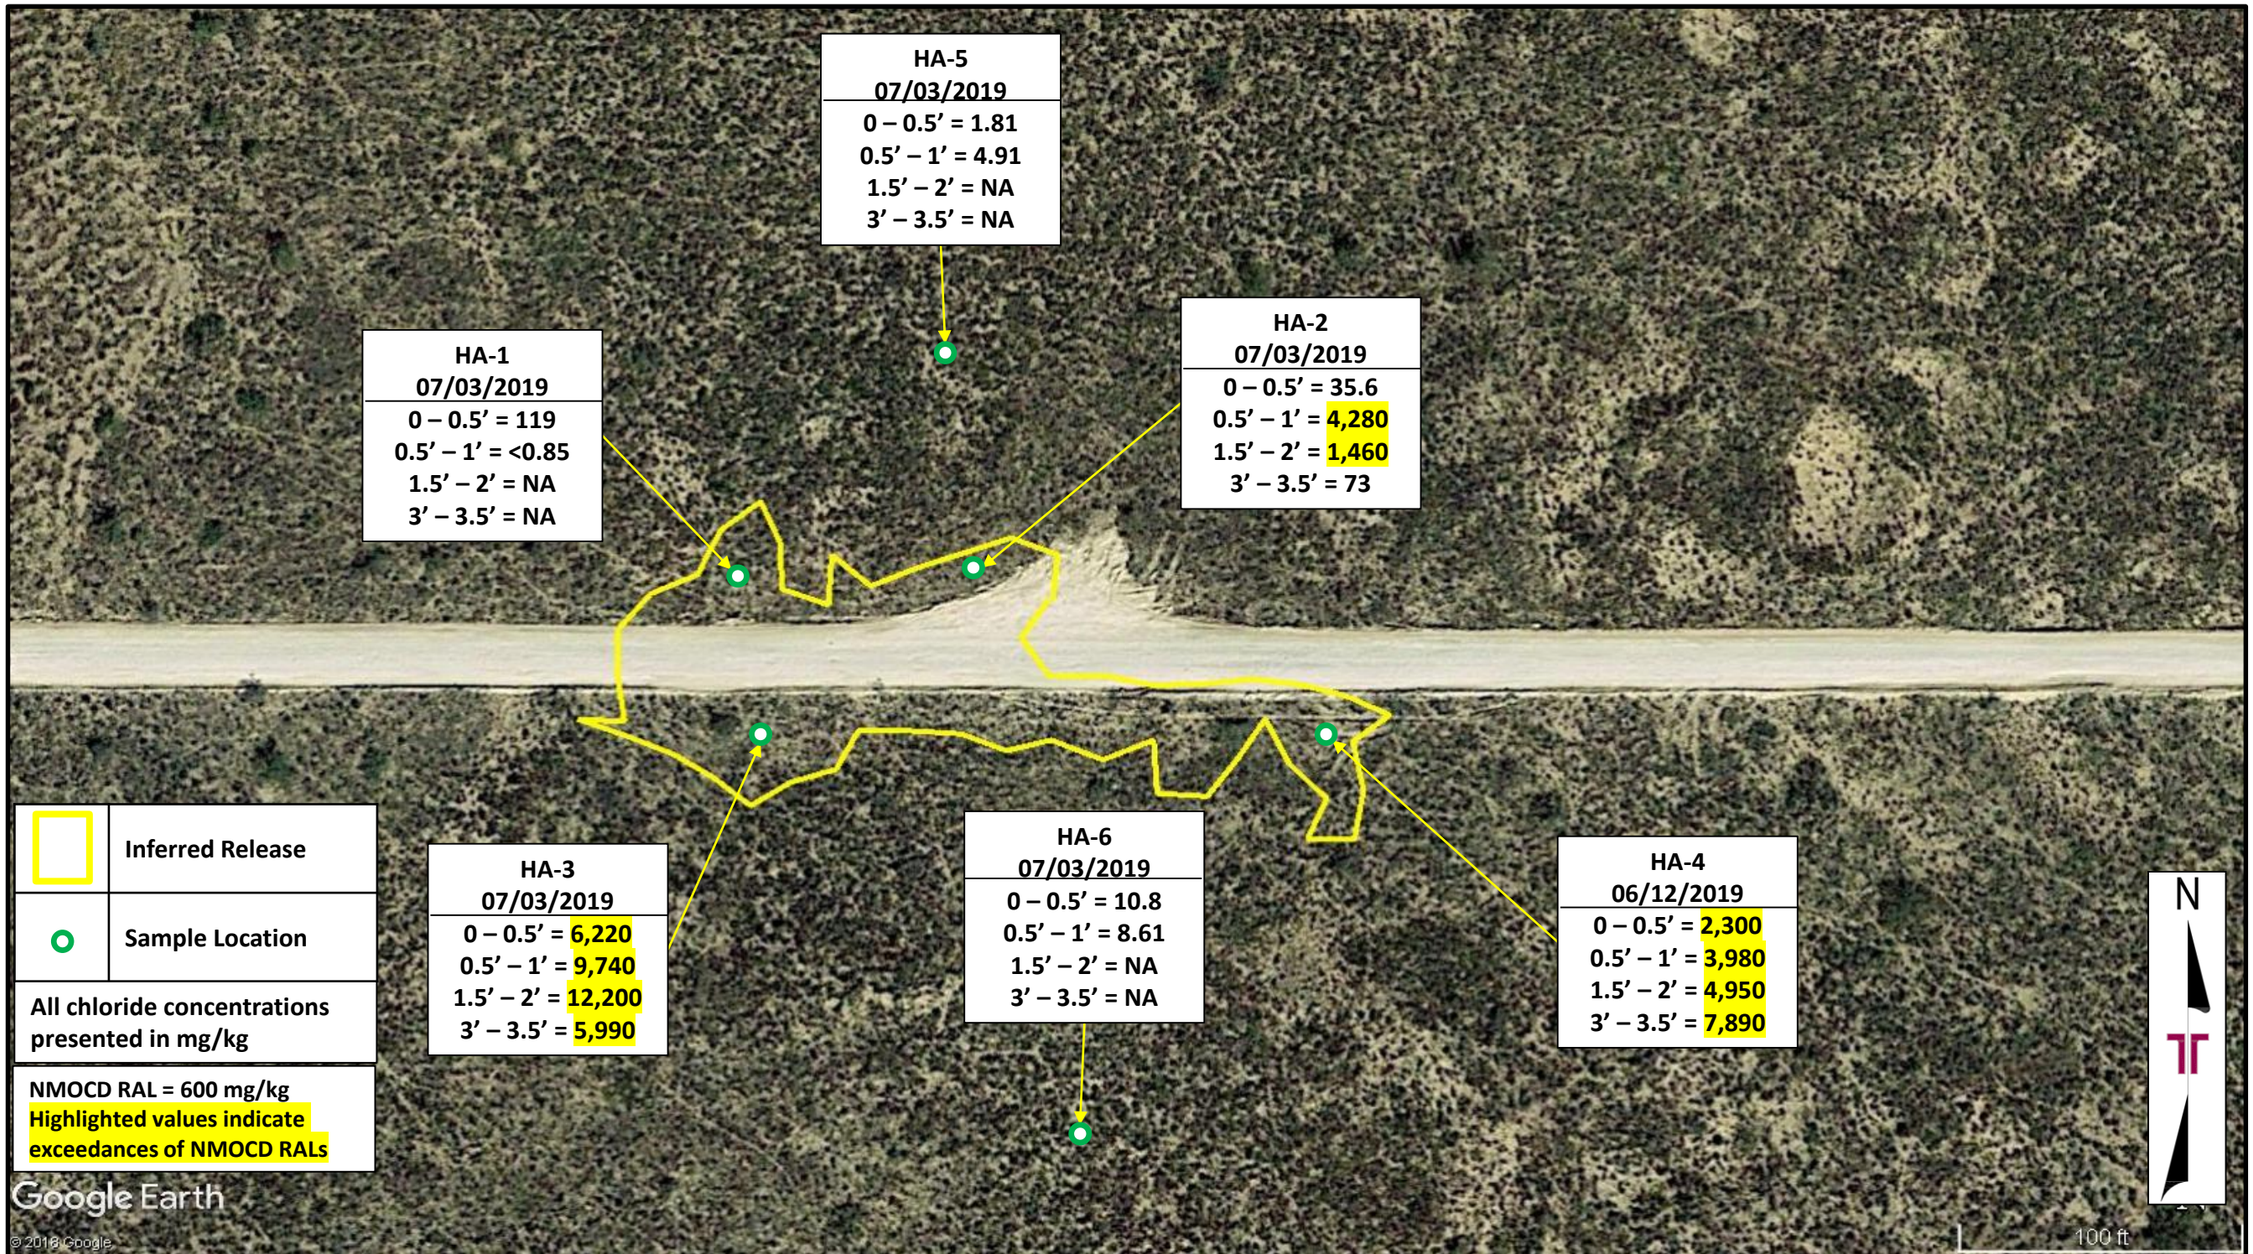
Figure 2 – Chloride Concentration Map (Soils within Reclamation Depths)

ft. bgs to 5 ft. bgs) at 10,400 mg/kg. as summarized in, Table 2. The dispersion of chloride concentrations can be observed in the HA-8 and HA-9 (5.5 ft bgs to 6 ft bgs) soil samples at 6,910 mg/kg and 3,900 mg/kg respectively, and GP-2 (8 ft bgs to 9 ft bgs) at 2,600 mg/kg.

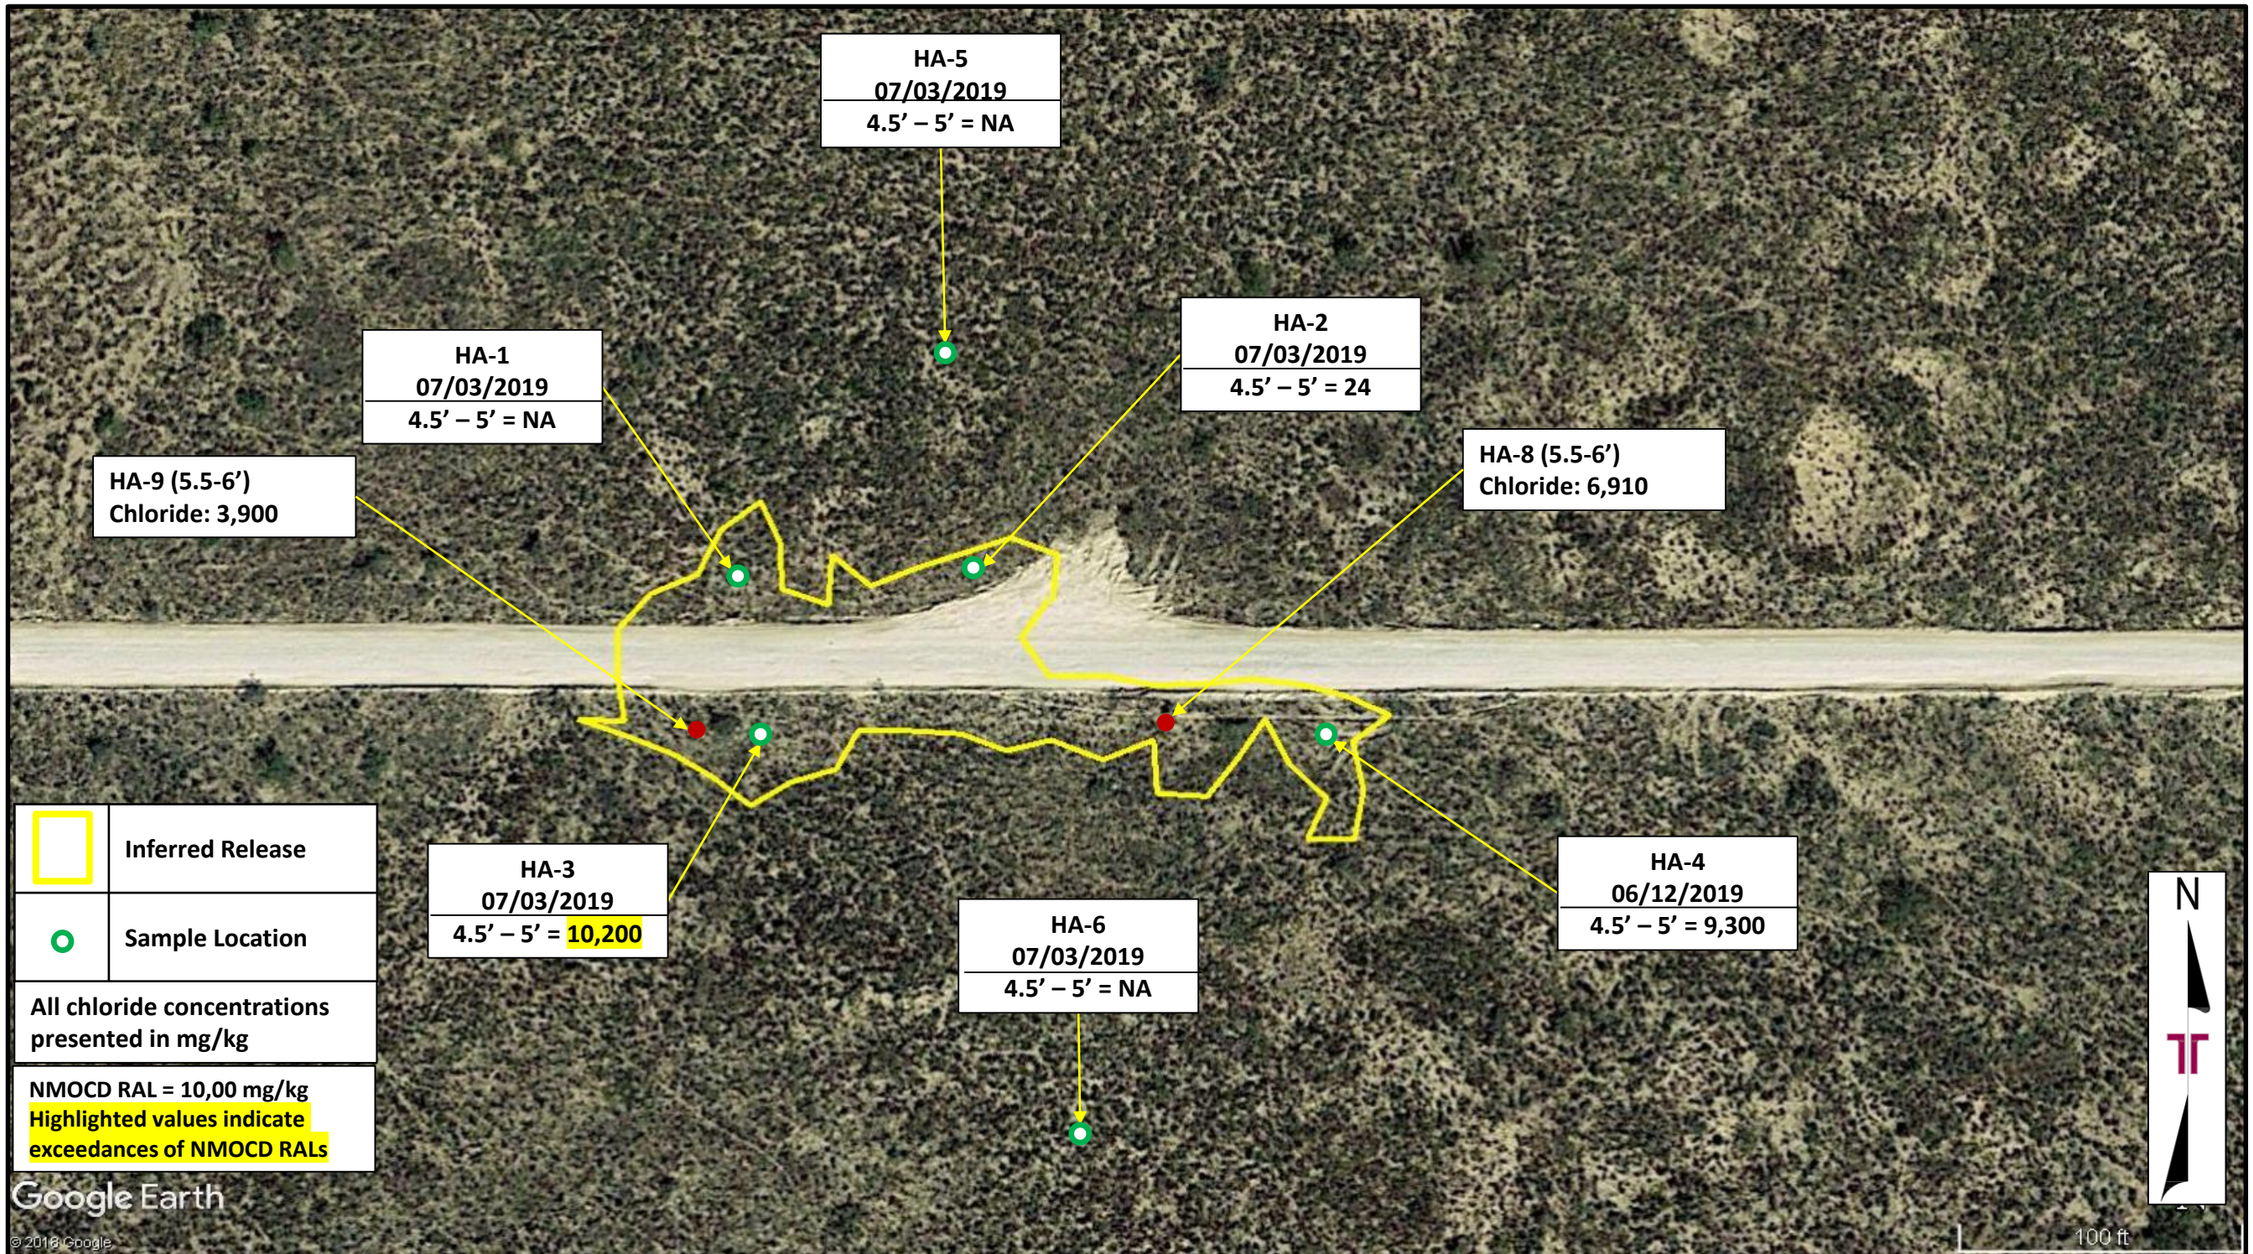
Figure 4 – Chloride Concentration Map (Soils >4 ft bgs.)

It should be noted that soil borings advanced within the release margins were terminated due to auger refusal upon encountering a cemented caliche layer at approximately 7 ft bgs, with the sole exception being GP-2 (8 ft bgs to 9 ft bgs).

Based on the anticipated depth to groundwater and confirmed vertical delineation, a remedial response was not warranted within the soils at depths greater than 4 ft. bgs with the exception of areas in the vicinity of soil boring HA-3 and GP-2. Excavation of areas proximate to soil boring HA-3 and GP-2 were recommended based on the apparent extent of impacts to depth. Confirmation sampling of excavation activities was conducted to ensure the extent of the impacts have been mitigated to below NMOCD Remediation Action Limits.

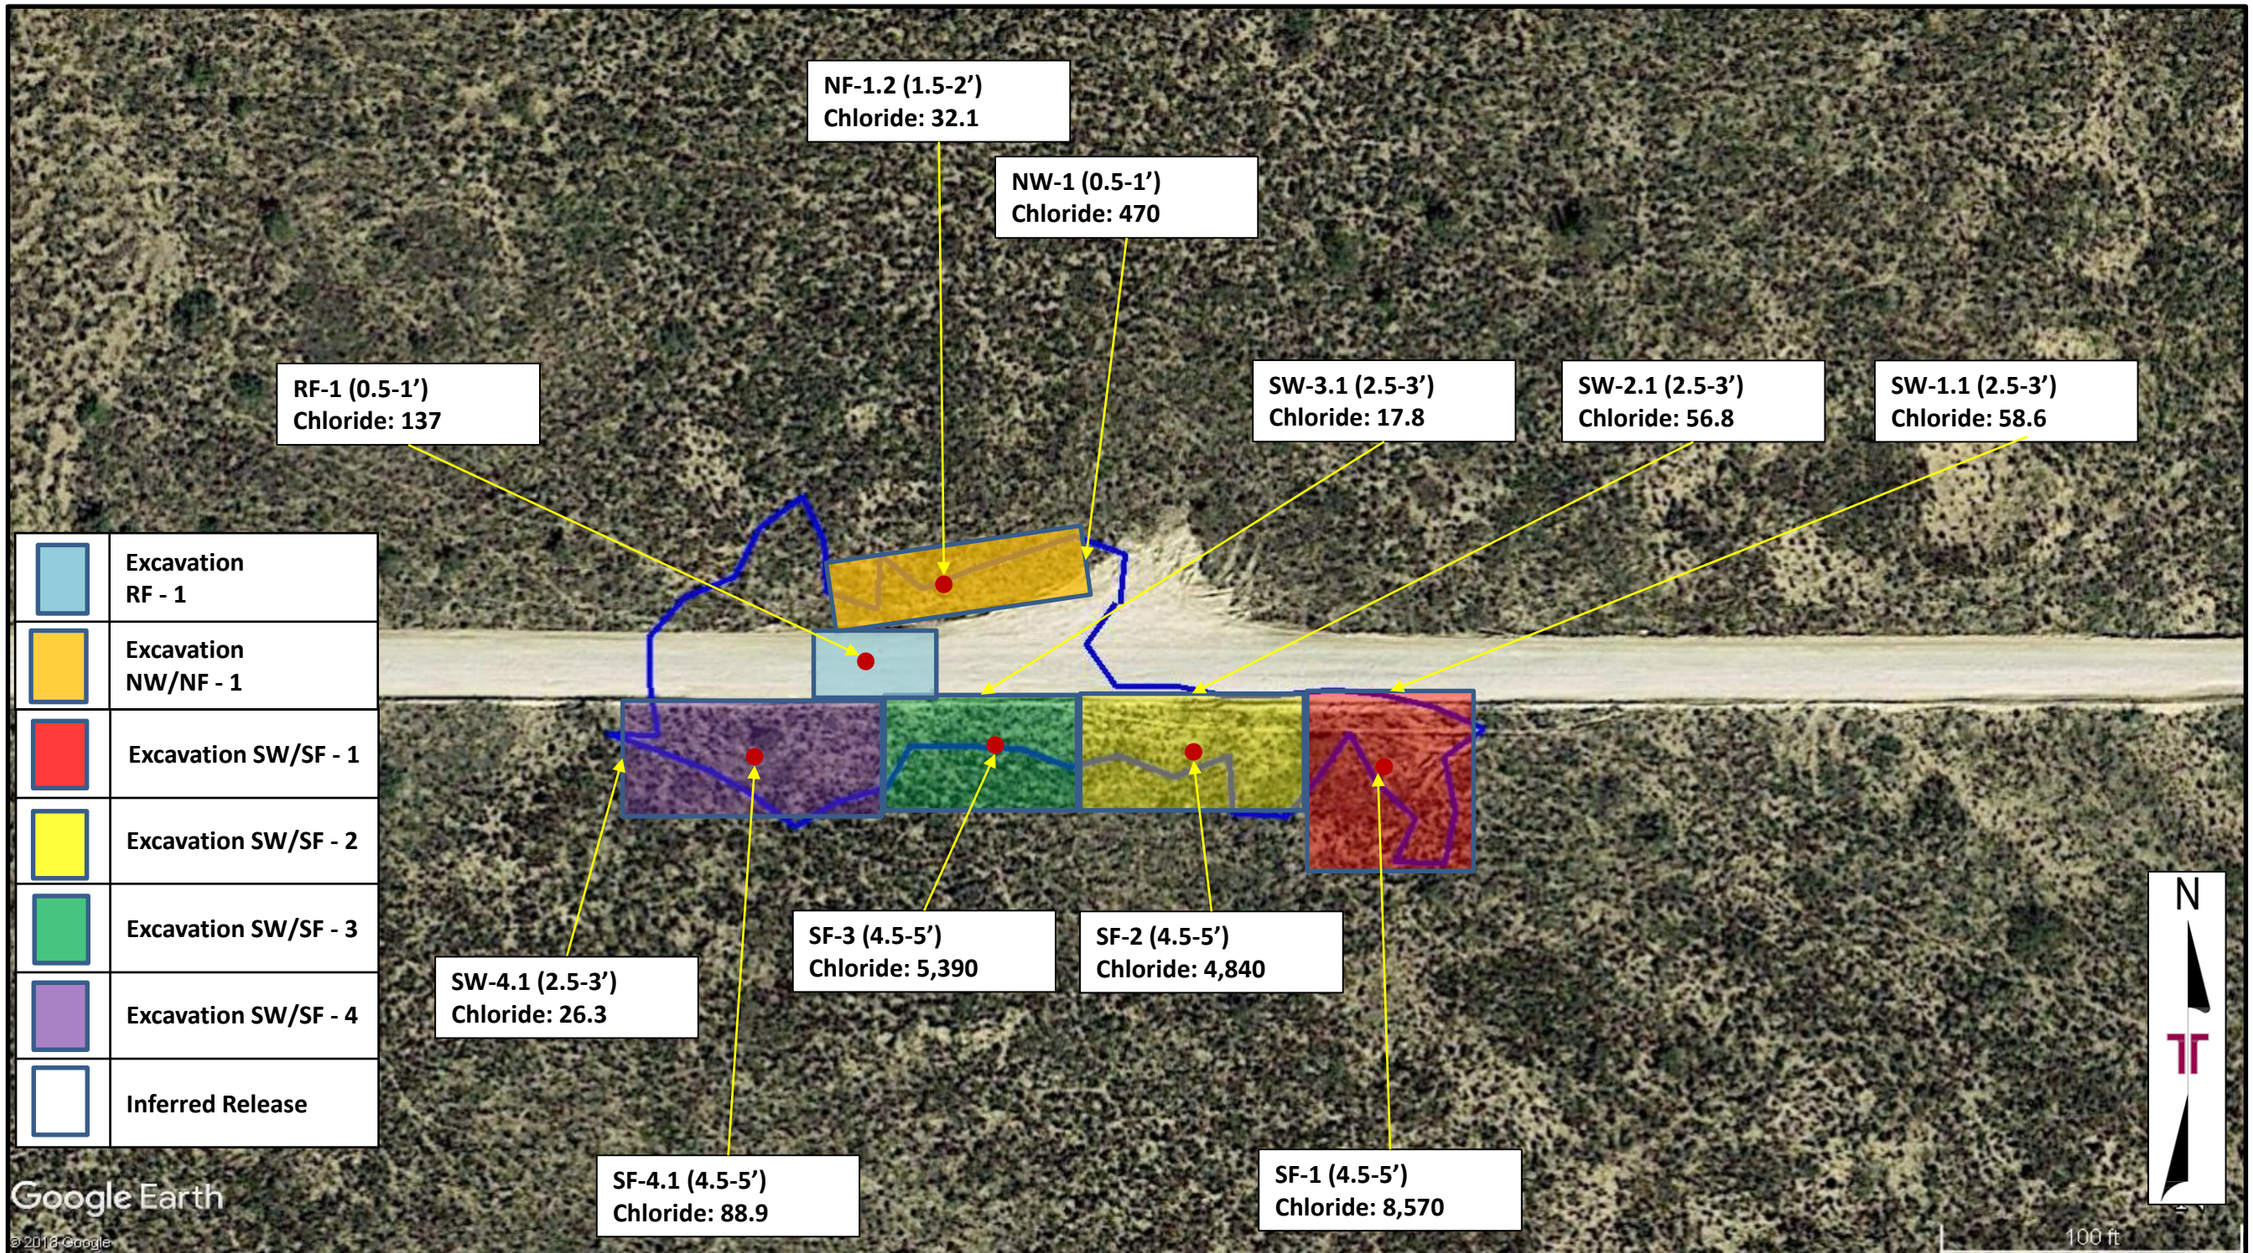
Figure 6 – Confirmation Concentration Map

Based on a review of the above confirmation analytical results, the areas surrounding the remediation margins do not exhibit concentrations above NMOCD RAl for benzene, Total BTEX, chloride and Total TPH. Based on these results below NMOCD RALs, Sections 9.0 and subsequent detail recommended closure of response actions were implemented at the site. Terracon recommends the restoration of the above mentioned site on August 15, 2020.
