Souder, Miller & Associates♦201 S. Halagueno St.♦Carlsbad, NM 88220
(575) 689-8801

January 11, 2021

#5E29133-BG20

SUBJECT: Remediation Closure Report for the Salado Draw 6 Fed #001H Release (NRM2012242719), Lea, New Mexico

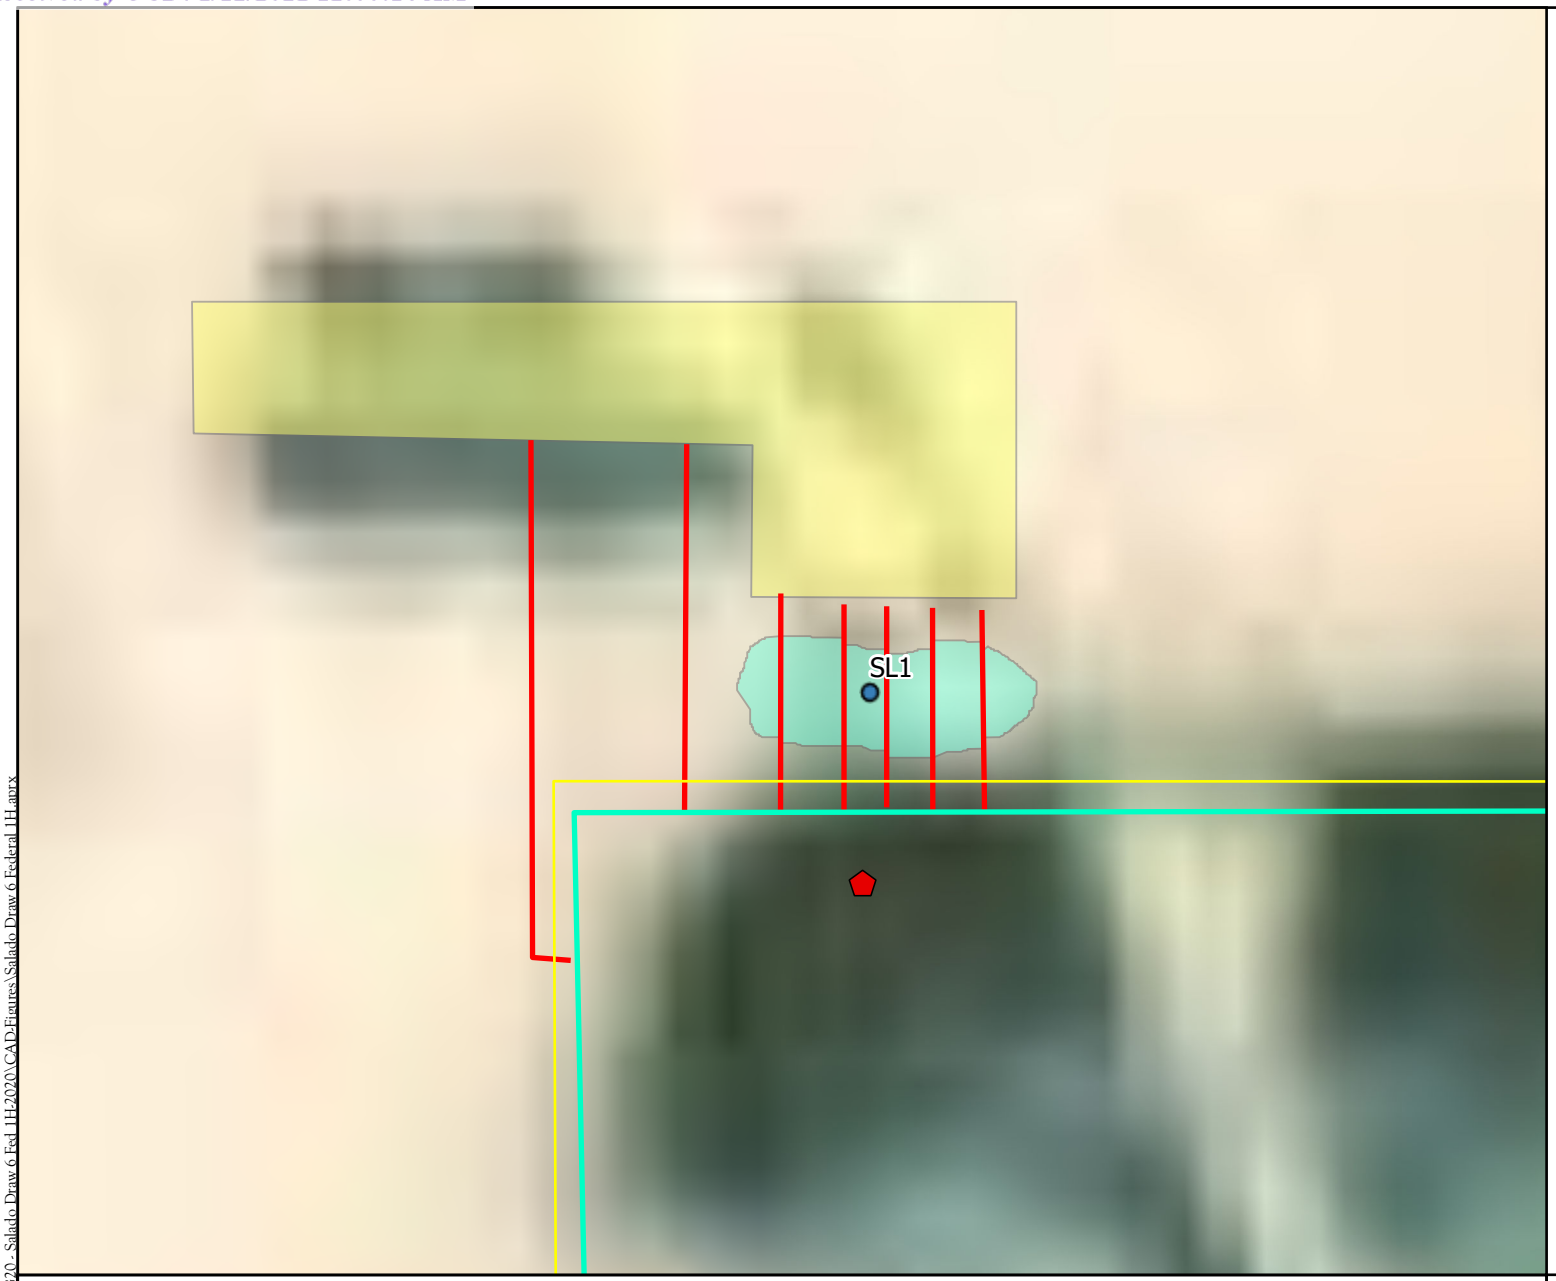
Figure 3

One sample location (SL1) was investigated within the visually impacted area outside of the secondary containment and within associated aboveground electrical lines using a hand-auger, to a depth of two (2) feet bgs. A background sample was also collected at 2 feet bgs, for analysis of chloride only. A total of five (5) samples were collected for laboratory analysis for total chloride using EPA Method 300.0; benzene, toluene, ethylbenzene and total xylenes (BTEX) using EPA Method 8021B; and motor, diesel and gasoline range organics (MRO, DRO, and GRO) by EPA Method 8015D. On July 2, 2020 SMA returned to further delineate sample location (SL1). As summarized in Table 3, initial sample results indicated that the area around SL1 required excavation due to high levels of chlorides that exceed the NMOCD Closure Criteria applicable to the Salado Draw 6 Federal #001H site. The site and initial sample locations are shown on Figure 3.
