RE: 1RP-4516 Warn State AC Battery

1RP-4516
DELINEATION AND DEFERRAL REPORT
Warn State AC Battery
Crude Oil and Produced Water Release
Lea County, New Mexico

LAI Project No. 19-0112-47

September 27, 2019

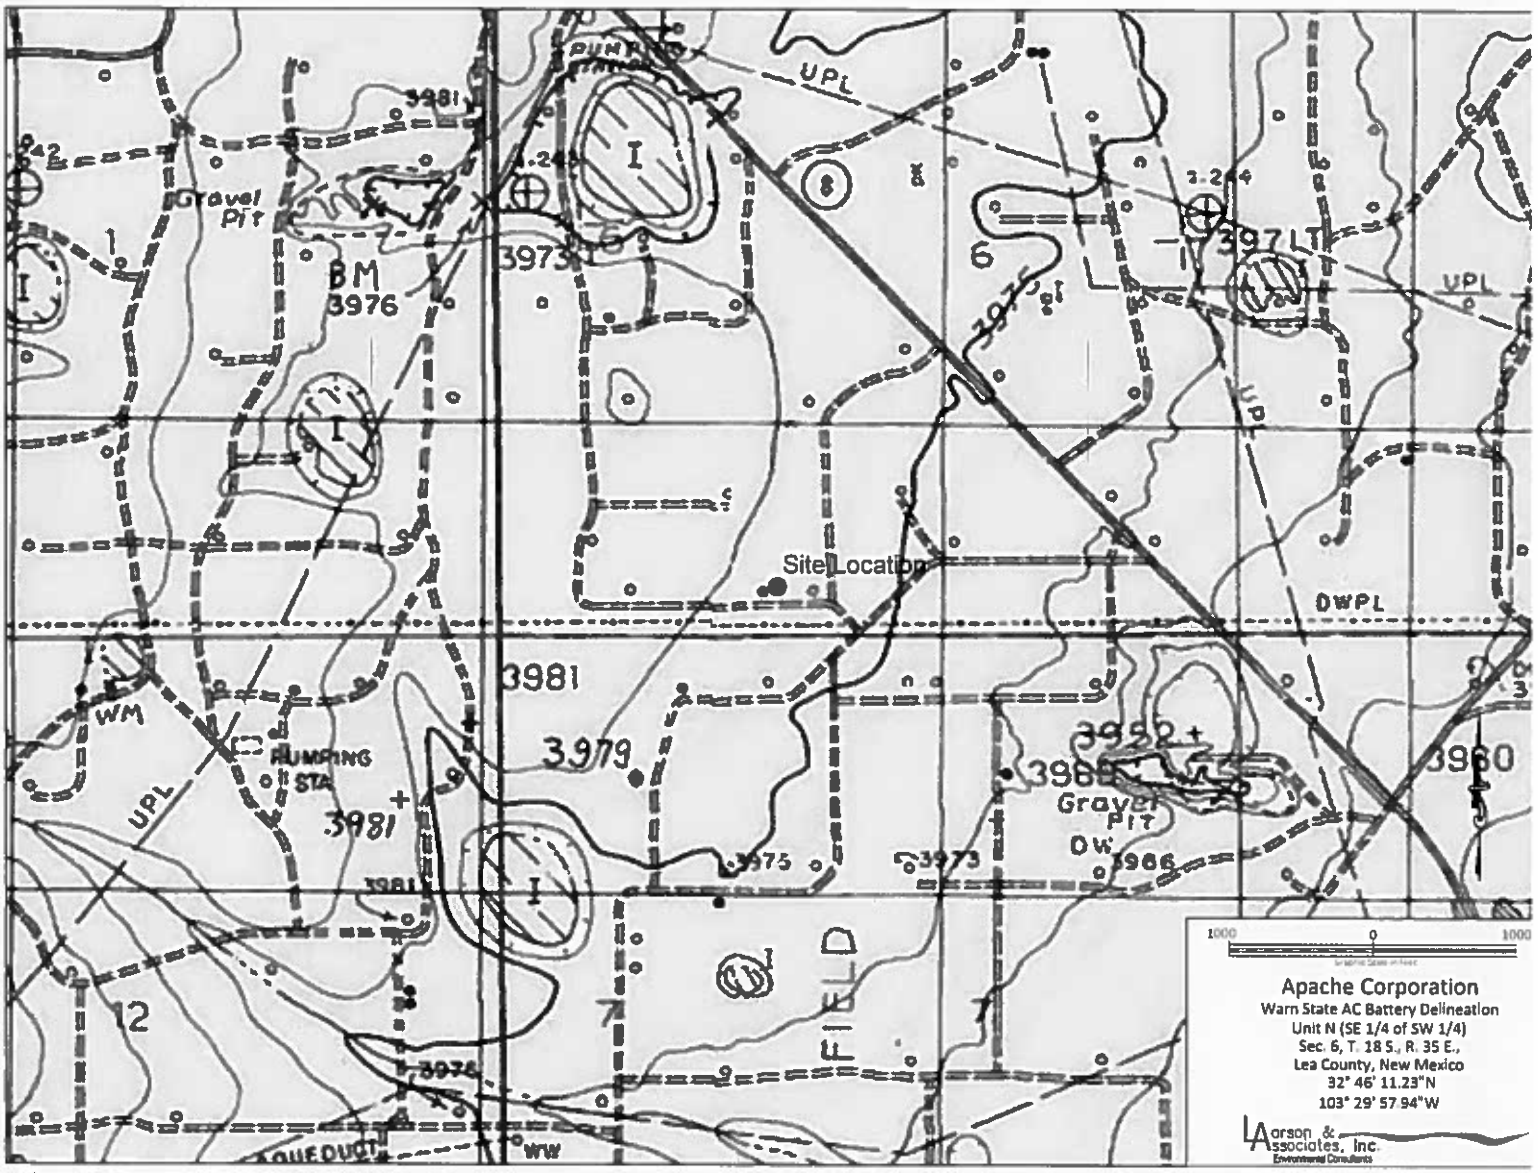
Figure 2 - Aerial Map Showing Soil Sample Locations and Proposed Microblazed Area

Figure 2 presents the soil sampling location. Appendix D presents the PBEL laboratory data. Appendix E presents photographs.

Apache has delineated BTEX, TPH and chloride below the remediation limits of 50 mg/Kg, 2,500 mg/Kg and 10,000 mg/Kg, respectively. Apache proposes to apply a 6% solution of Microblaze® microbial amendment and water to the affected soil and vegetation in the overspray area northeast of the facility to remediate DRO concentrations in the upper foot of soil. The overspray area measures approximately 8,450 square feet. Due to the spill area being in close proximity to production equipment and underground lines, Apache respectfully requests a deferral to complete delineation on the caliche road and remediation of the Warn State AC Battery (1RP-4516) until abandonment.

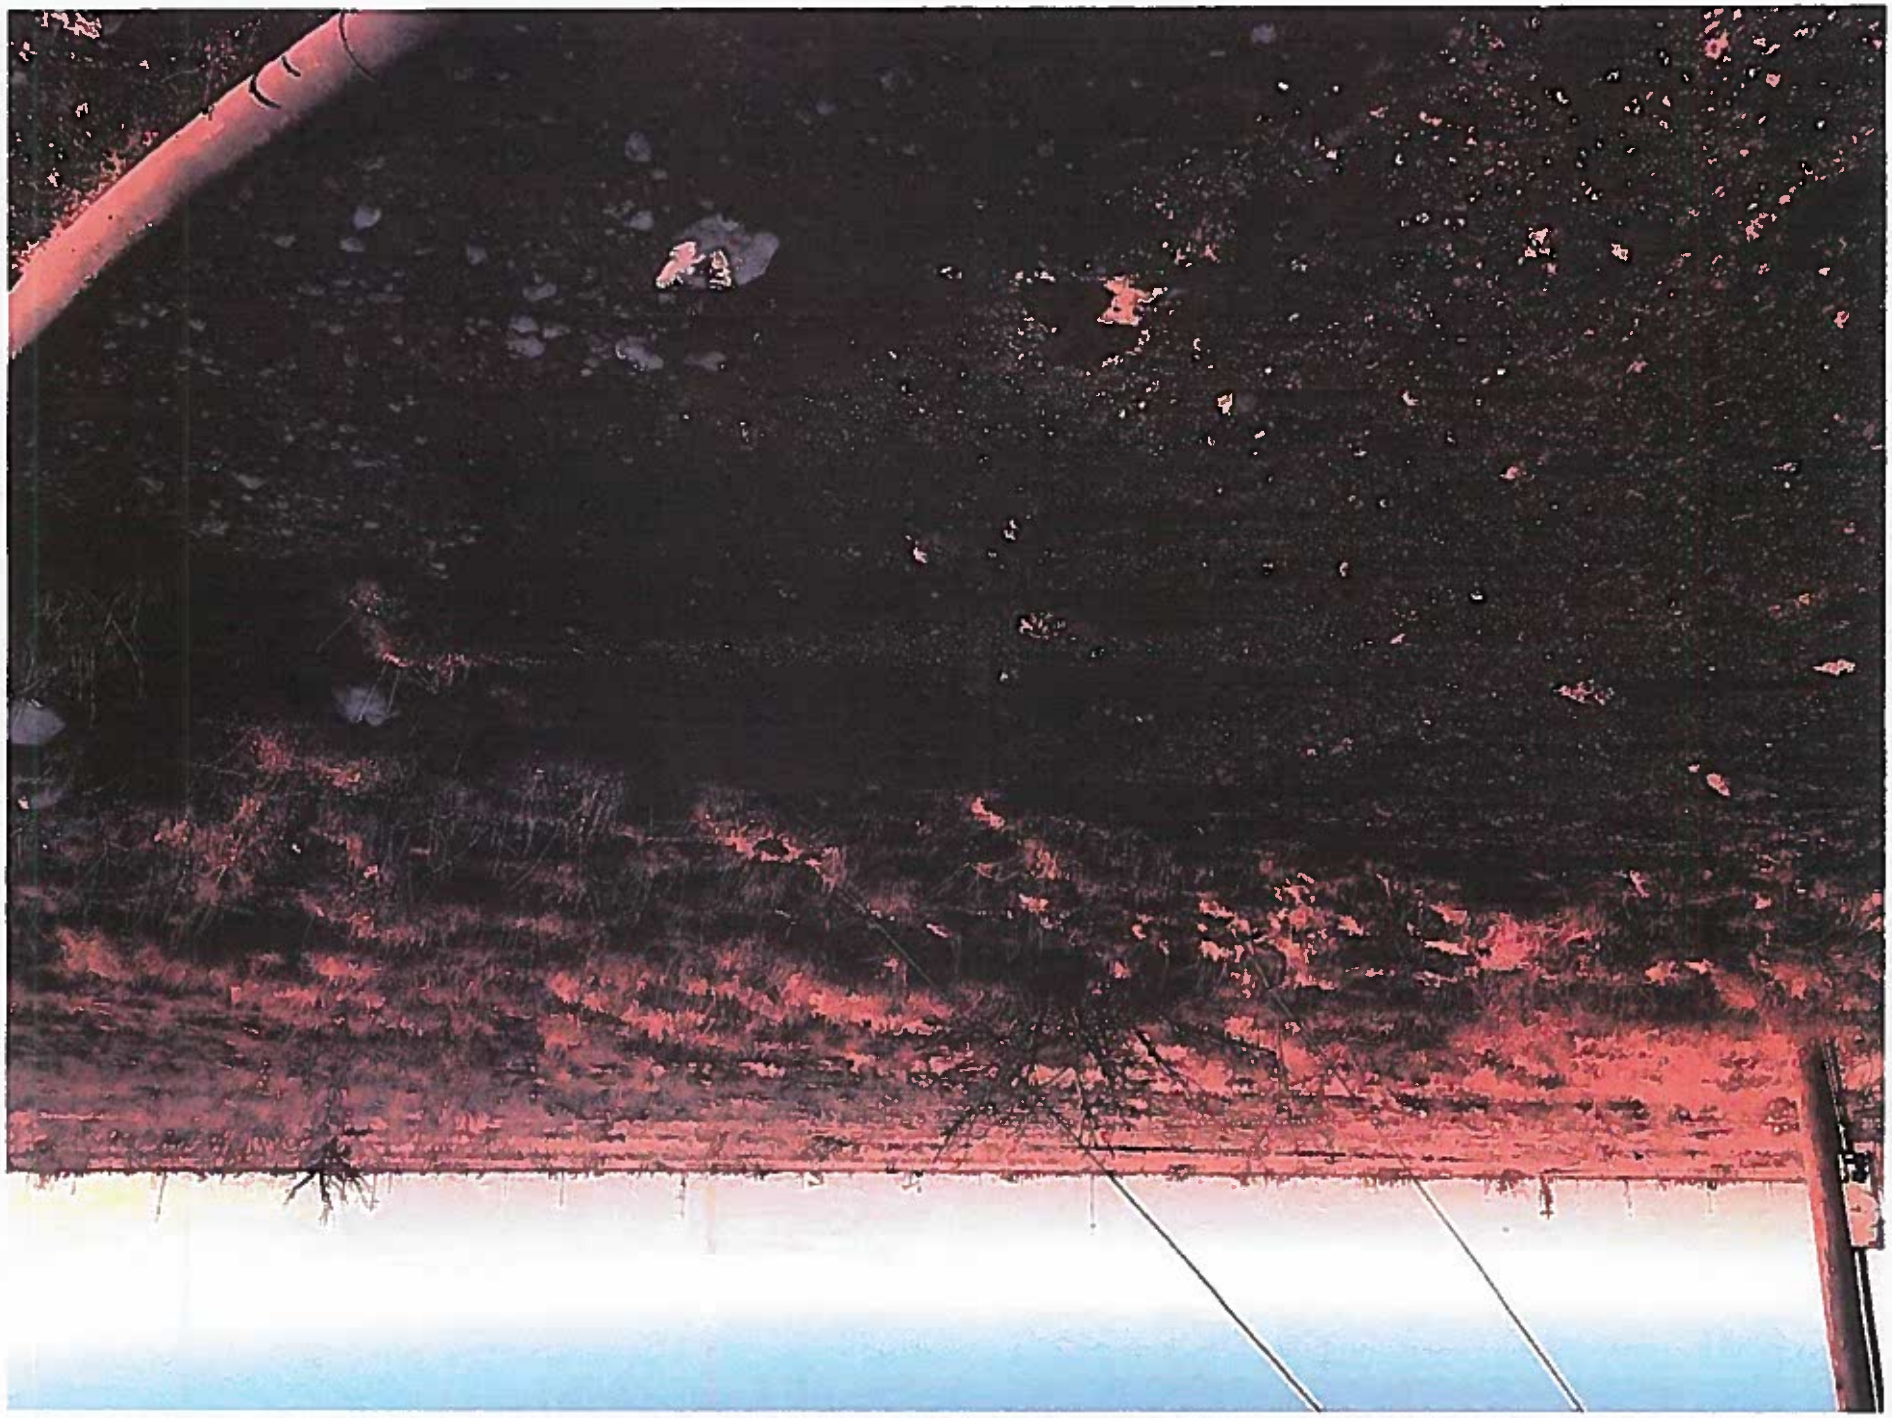
Attached, please see a photo taken this morning in the overspray area of product on the ground. NMSLO is in agreement with the conditions set forth by NMOCD and would like to request representative soil sampling in the overspray area. Please run for CL, TPH and BTEX.

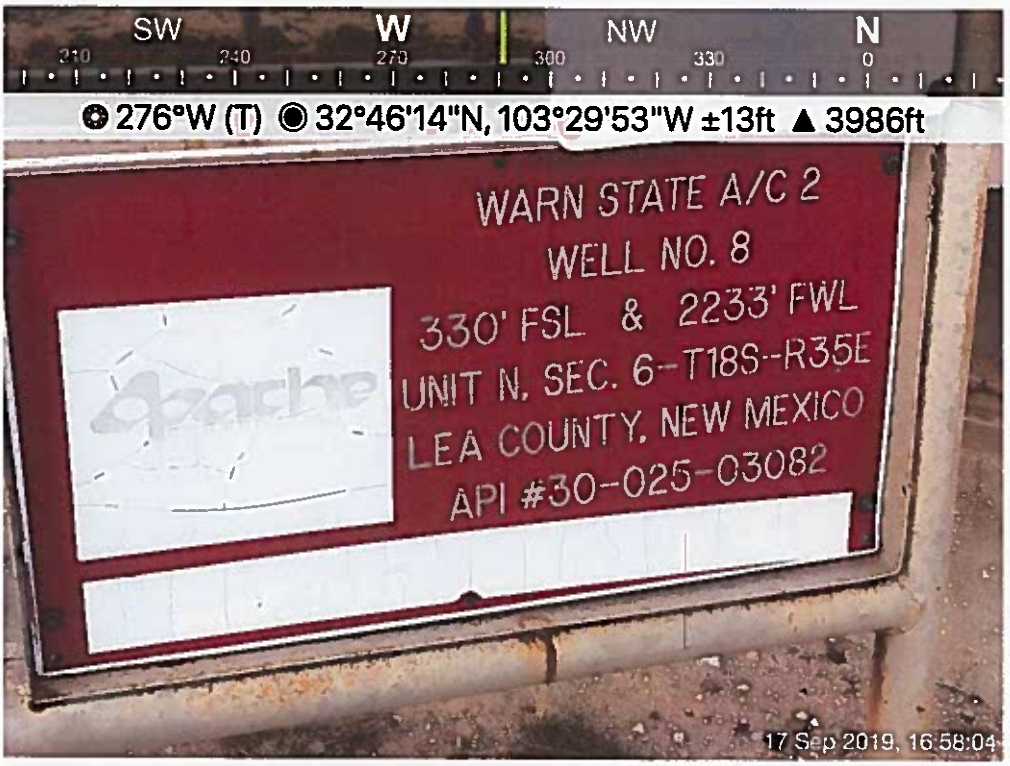
Warn State AC Facility Location, September 17, 2019

Site Viewing Southwest, September 17, 2019

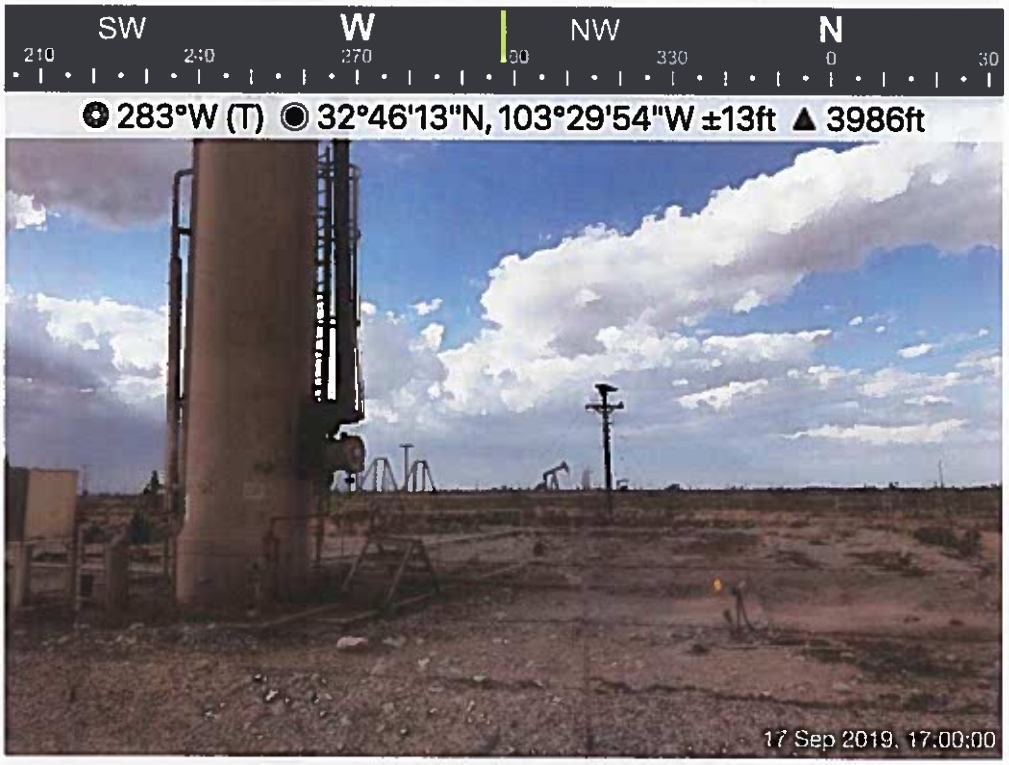
Site Viewing Northwest, September 17, 2019

SP 5 sample point Viewing Southwest, September 17, 2019
