Re: Central Vacuum Unit #96
Site Closure Report
Case No. 1RP-3247 & 1RP-2763
Lea County, New Mexico

- Central Vacuum Unit #96 – Site Closure Report

Release Notification and Corrective Action

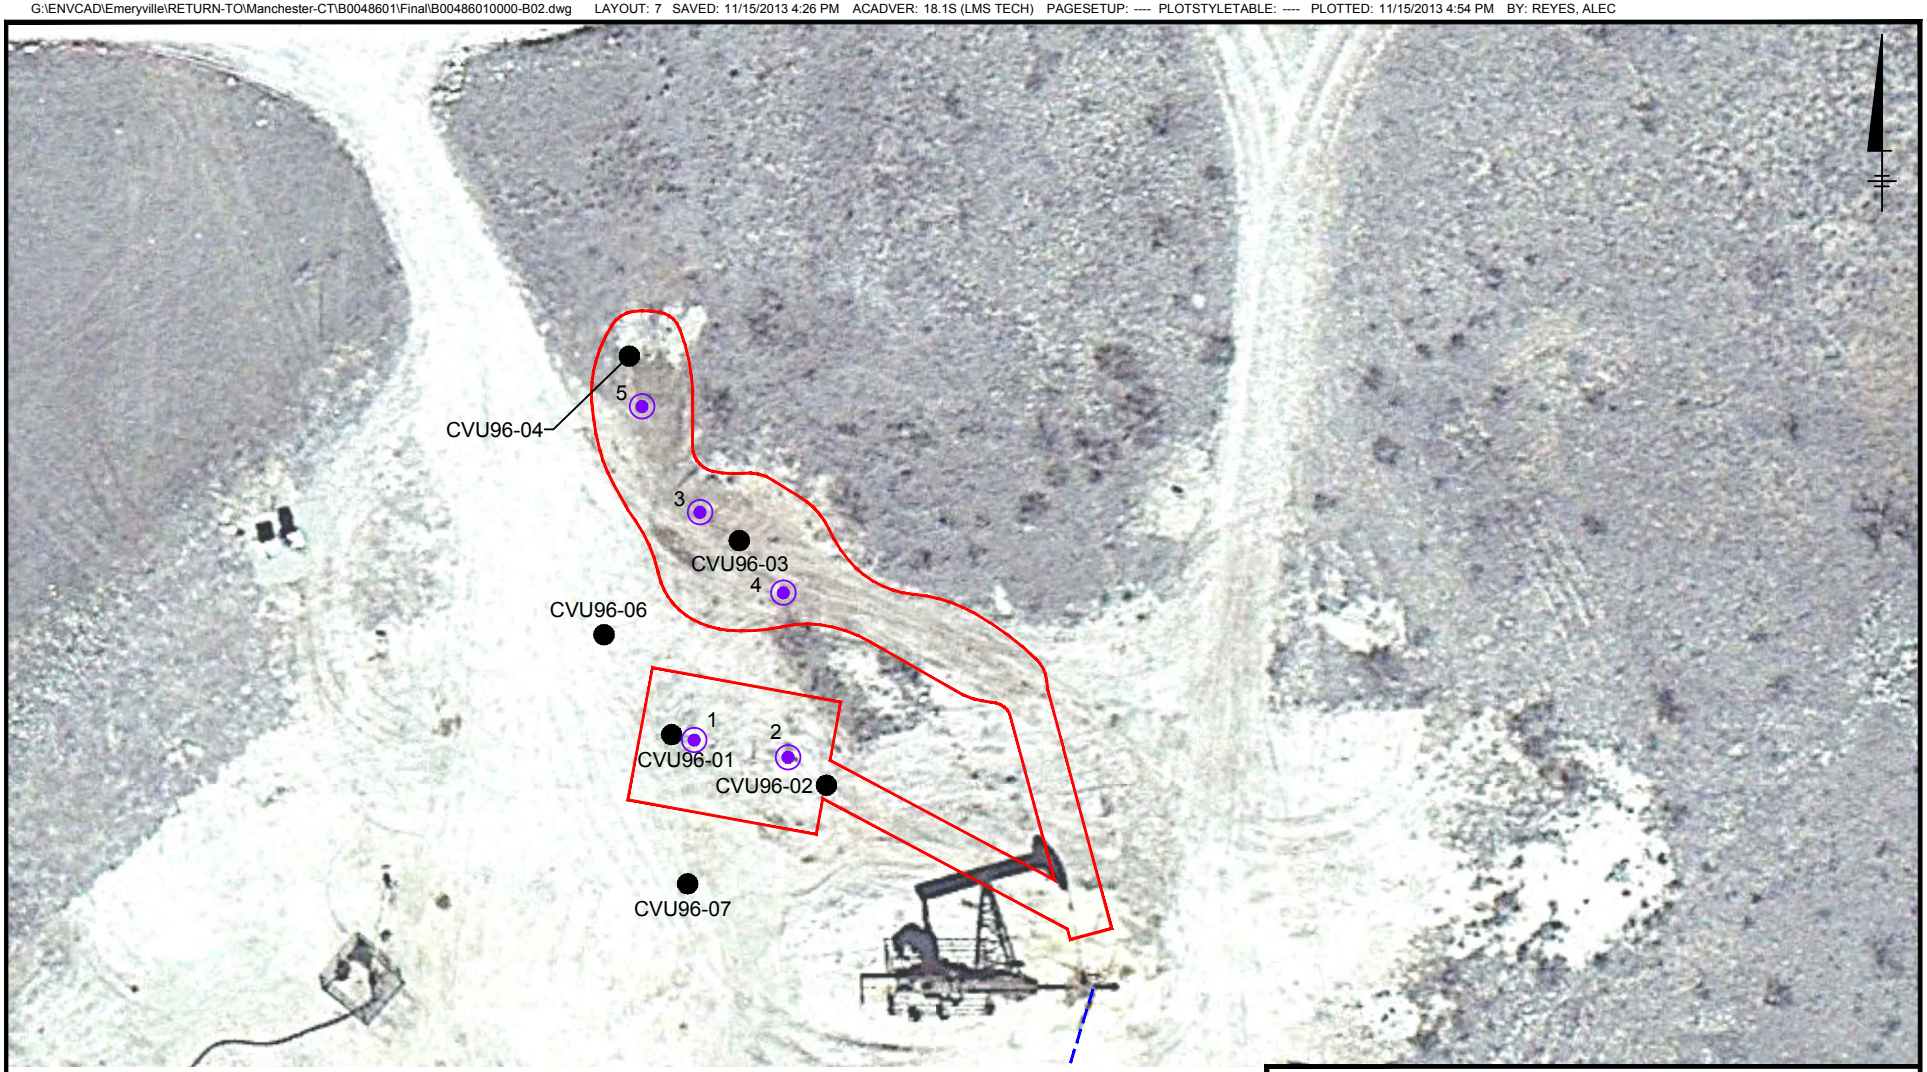
- MAY 2013 DISCRETE SOIL SAMPLING LOCATION
- 1 NOVEMBER 2011 DISCRETE SOIL SAMPLING LOCATION
- ABOVE GROUND UTILITY LINE
- APPROXIMATE EXTENT OF SPILL

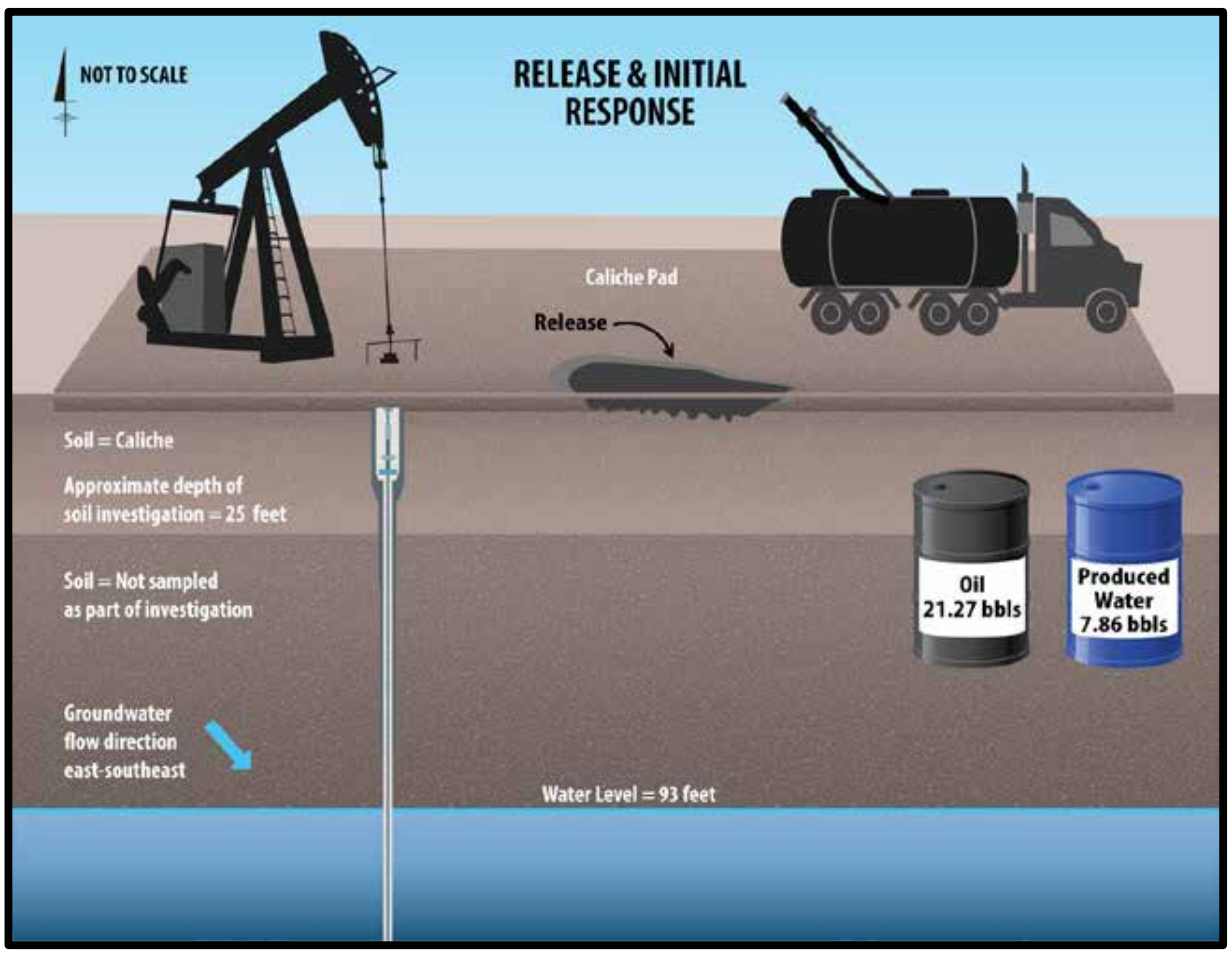
A release of approximately 7.86 bbls of produced water and 21.27 bbls of oil occurred at the site on November 5, 2011 due to the failure of a stuffing box. Chevron personnel from the MidContinent Business Unit (MCBU) stopped the release and recovered an approximately 20 bbls of fluids consisting mostly of oil using a vacuum truck. Chevron MCBU personnel excavated visually impacted soil in the area to a depth of approximately 2 feet bgs and collected five discrete confirmation soil samples from the base of the excavation. Analyte concentrations in one or more confirmation soil samples were above regulatory criteria, which prompted additional site assessment activities.

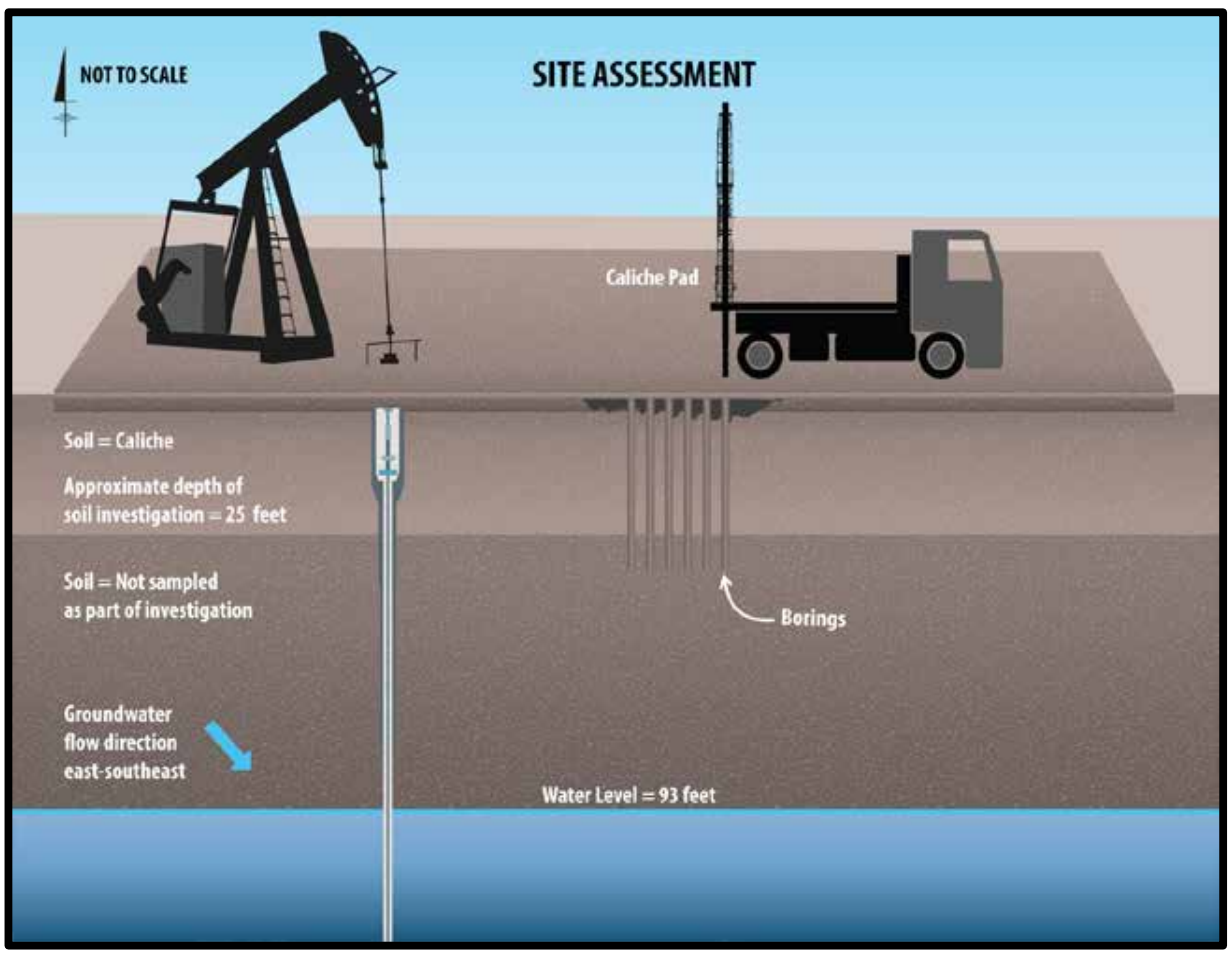
In May 2013, ARCADIS conducted site assessment activities to characterize the lateral and vertical extents of soil impacts at the site. Soil boring locations were selected based on the results of confirmation soil sampling completed at the site in November 2011, locations of pipelines and other equipment at the site, and the extent of the release as documented by Chevron MCBU personnel during the initial response activities. Analyte concentrations in samples collected during the 2013 assessment were reported below site-specific criteria. Site assessment activities demonstrate that remaining soil concentrations associated with the release do not pose significant risk to groundwater resources or other receptors.
