Form C-141
Page 6

March 31, 2021

Re: Closure Report
N-Line Leak 4
GPS: Latitude 32.734159 Longitude -103.769942
UL "G", Sec. 21, T18S, R32E
Lea County, NM
NMOCD Ref. No. NCE2025939679

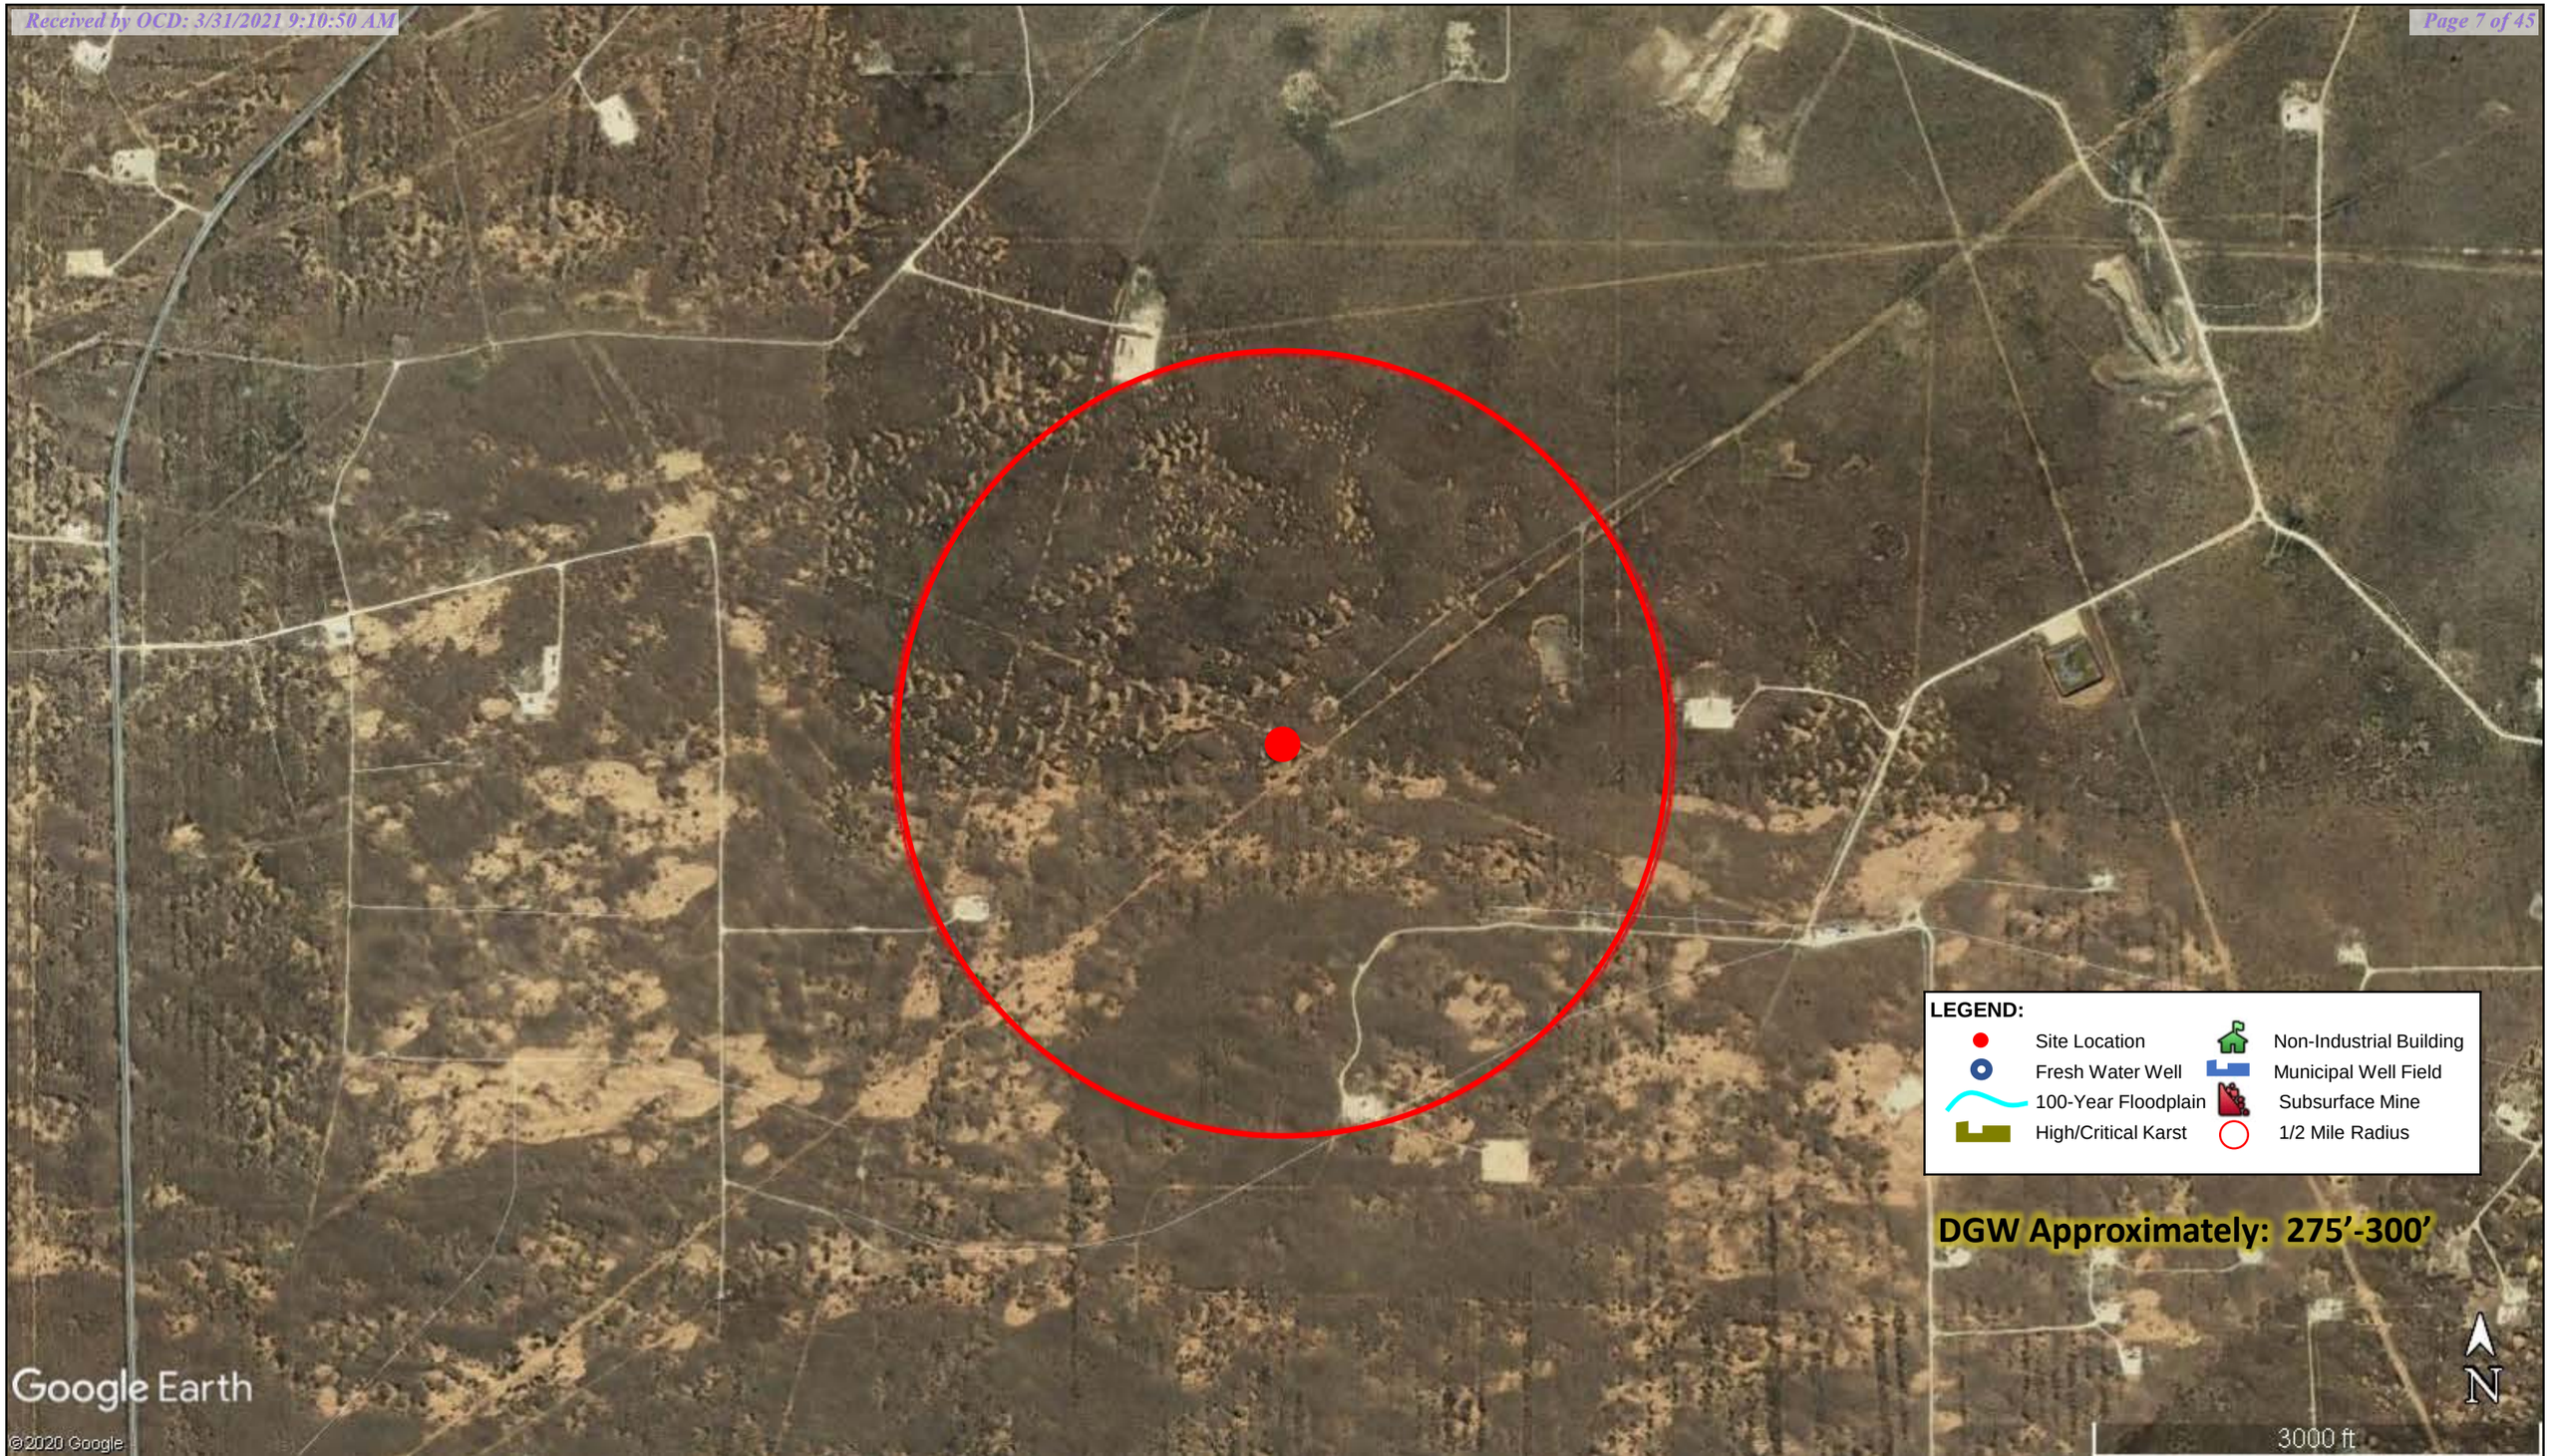
Attachment #1- Figure 1 – Site Characteristics Map

Site Characteristics Map is provided as Attachment #1. General Site Photographs are provided as Attachment #4. A Copy of the Initial Release Notification and Corrective Action (NMOCD Form C-141) is provided as Attachment #6

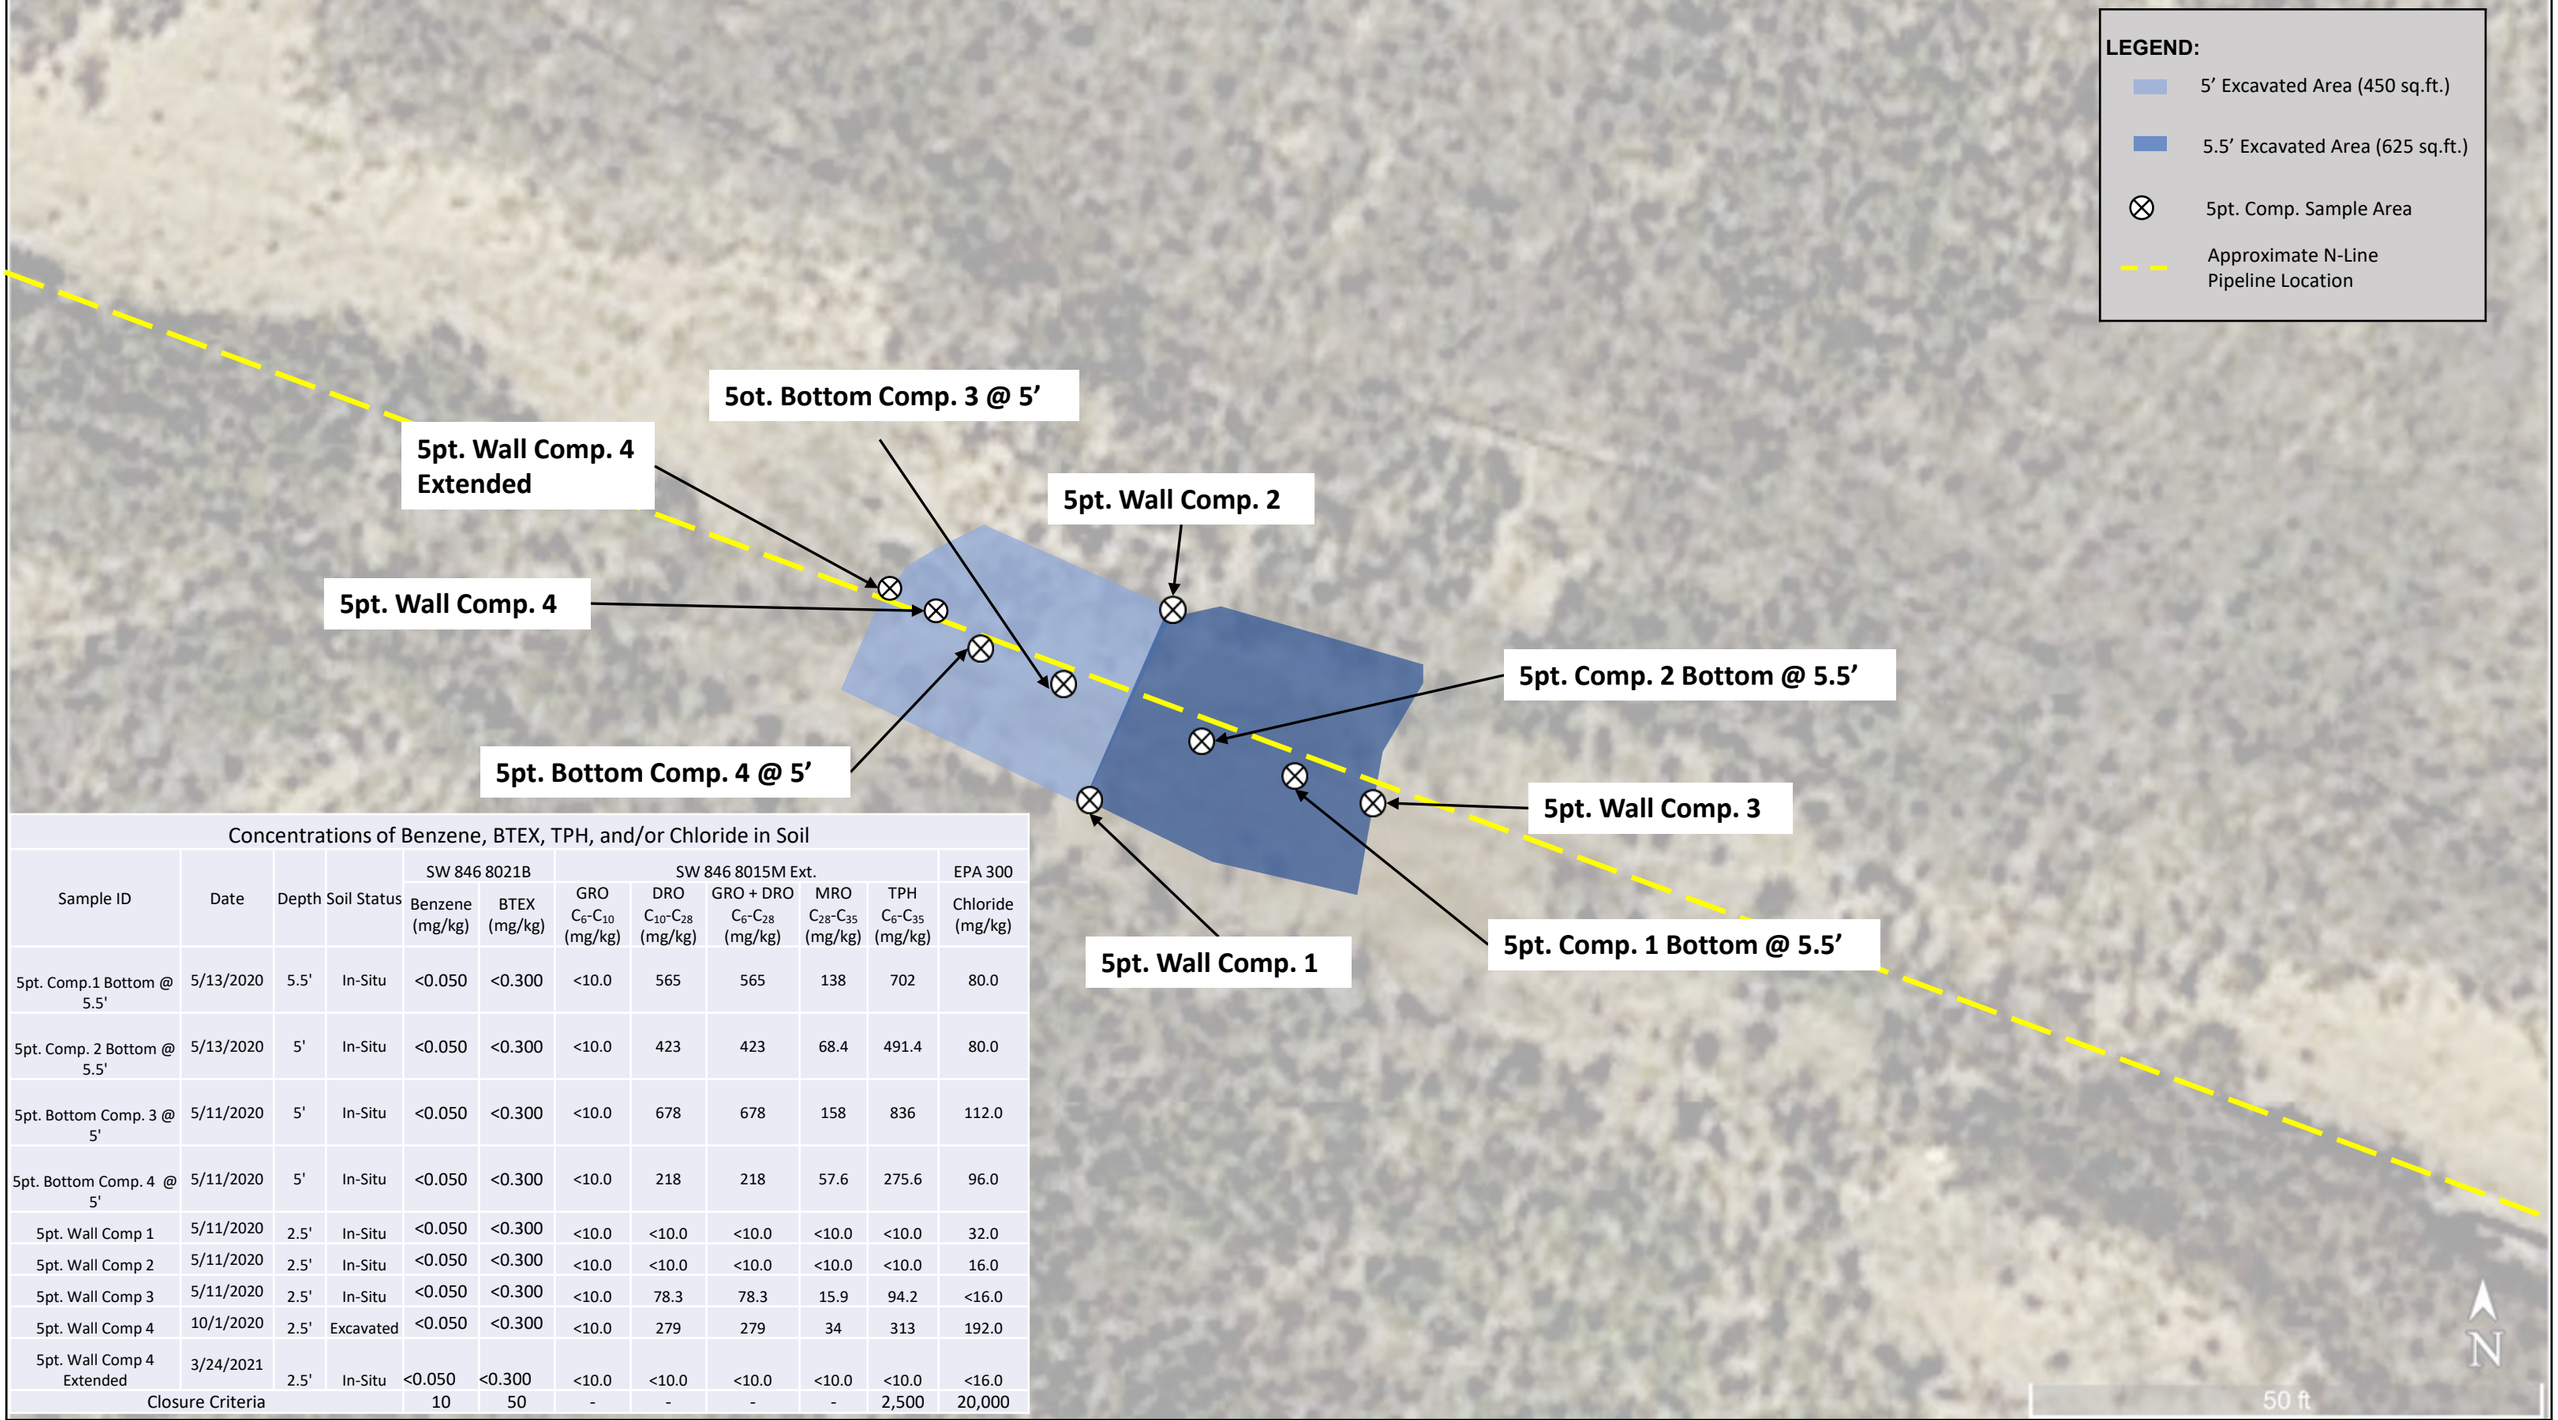
Attachment #2- Figure 2 - Site Sample Location Map

Concentrations of Benzene, BTEX, TPH, and/or Chloride in Soil

Sample ID	Date	Depth	Soil Status	SW 846 8021B		SW 846 8015M Ext.					EPA 300
				Benzene (mg/kg)	BTEX (mg/kg)	GRO C_6-C_{10} (mg/kg)	DRO C_{10}-C_{28} (mg/kg)	GRO + DRO C_6-C_{28} (mg/kg)	MRO C_{28}-C_{35} (mg/kg)	TPH C_6-C_{35} (mg/kg)	Chloride (mg/kg)
5pt. Comp.1 Bottom @ 5.5'	5/13/2020	5.5'	In-Situ	<0.050	<0.300	<10.0	565	565	138	702	80.0
5pt. Comp. 2 Bottom @ 5.5'	5/13/2020	5'	In-Situ	<0.050	<0.300	<10.0	423	423	68.4	491.4	80.0
5pt. Bottom Comp. 3 @ 5'	5/11/2020	5'	In-Situ	<0.050	<0.300	<10.0	678	678	158	836	112.0
5pt. Bottom Comp. 4 @ 5'	5/11/2020	5'	In-Situ	<0.050	<0.300	<10.0	218	218	57.6	275.6	96.0
5pt. Wall Comp 1	5/11/2020	2.5'	In-Situ	<0.050	<0.300	<10.0	<10.0	<10.0	<10.0	<10.0	32.0
5pt. Wall Comp 2	5/11/2020	2.5'	In-Situ	<0.050	<0.300	<10.0	<10.0	<10.0	<10.0	<10.0	16.0
5pt. Wall Comp 3	5/11/2020	2.5'	In-Situ	<0.050	<0.300	<10.0	78.3	78.3	15.9	94.2	<16.0
5pt. Wall Comp 4	10/1/2020	2.5'	Excavated	<0.050	<0.300	<10.0	279	279	34	313	192.0

5pt. Wall Comp 4 Extended	3/24/2021	2.5'	In-Situ	<0.050	<0.300	<10.0	<10.0	<10.0	<10.0	<10.0	<16.0
Closure Criteria				10	50	-	-	-	-	2,500	20,000

Tasman remobilized to the site on March 24, 2021 to excavated the impacted soil on the location of the Wall Comp 4 where the sample collected on October 1, 2021 was above the NMOCD standards. The area was excavated and the soil was exported to an approved NMOCD facility and collected soil sample were submitted to a NMOCD-approved laboratory for analysis of TPH, BTEX, and Cl-. Laboratory analytical results indicated that TPH, BTEX, and CL- concentrations were below the NMOCD closure criteria for all the confirmation soil samples representative of the final limits of the excavation. A table summarizing laboratory analytical results from confirmation soil samples is provided below:
