Souder, Miller & Associates♦201 S. Halagueno St.♦Carlsbad, NM 88220
(575) 689-8801

July 29, 2021

#5E29921-BG4

SUBJECT: Remediation Closure Report for the Line A-9 Release (NAPP2114534777), Eddy County, New Mexico

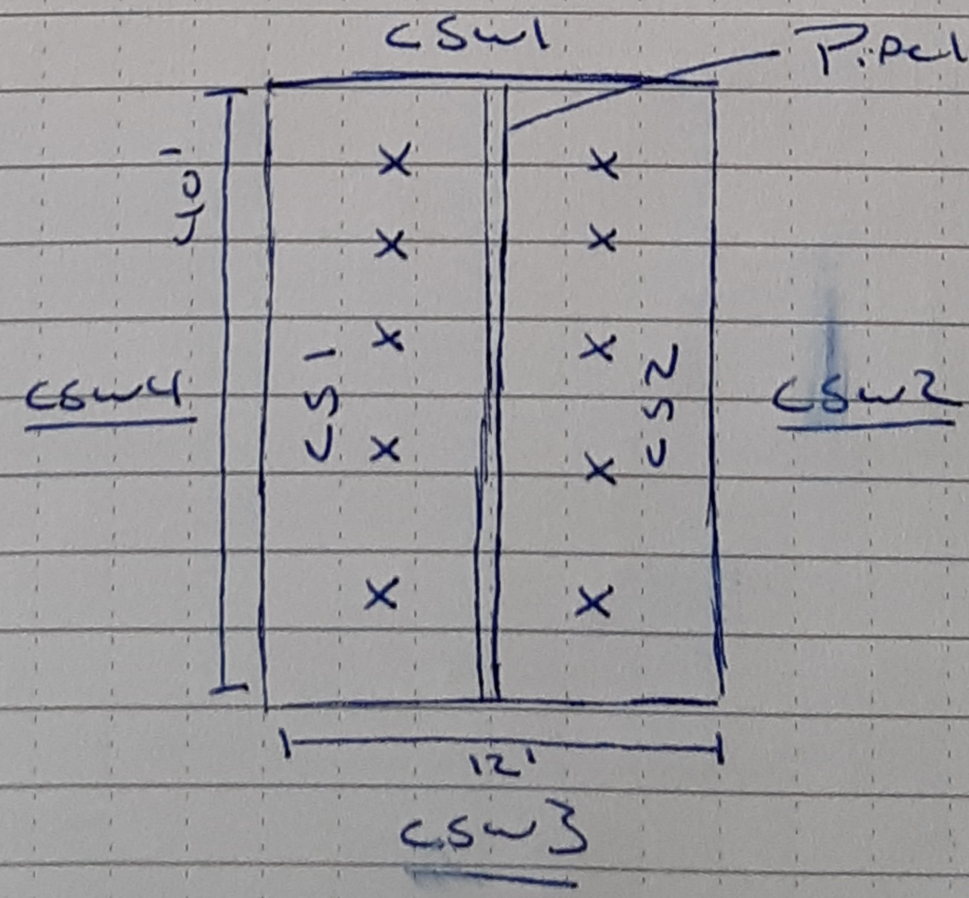
5/14/21 — One base and four sidewall samples were collected and field-screened. Further excavation required.

Initial Excavation measurements: 20 x 10 x 5.5

5/21/21 — Base had been excavated down to 15.5'. Dig area contains boulder-sized rocks. Sidewalls 1, 3 and 4 were extended.

5/24/21 — New release near Sidewall 1 was discovered. David Seal.110 and Robert Deraney with Enterprise were notified of release following discovery.

6/11/21 — Collected two base samples (CS1, CS2) and three sidewall samples (SSW1, SSW2, SSW3) and field-screened for contaminates.

6/25/21 — Collected two confirmation samples CS1 and CSW1 and field-screened for contaminates.

Final Excavation measurements: 40 x 12 x 16
