State of New Mexico
Oil Conservation Division

Incident ID	nAPP2123242125
District RP	
Facility ID	
Application ID

RE: Closure Request
EVGSAU 2801-002
Incident Number NAPP2123242125
Lea County, New Mexico

PHOTOGRAPHIC LOG		
ConocoPhillips Company	EVGSAU 2801-002 Lea County, New Mexico	NAPP2123242125

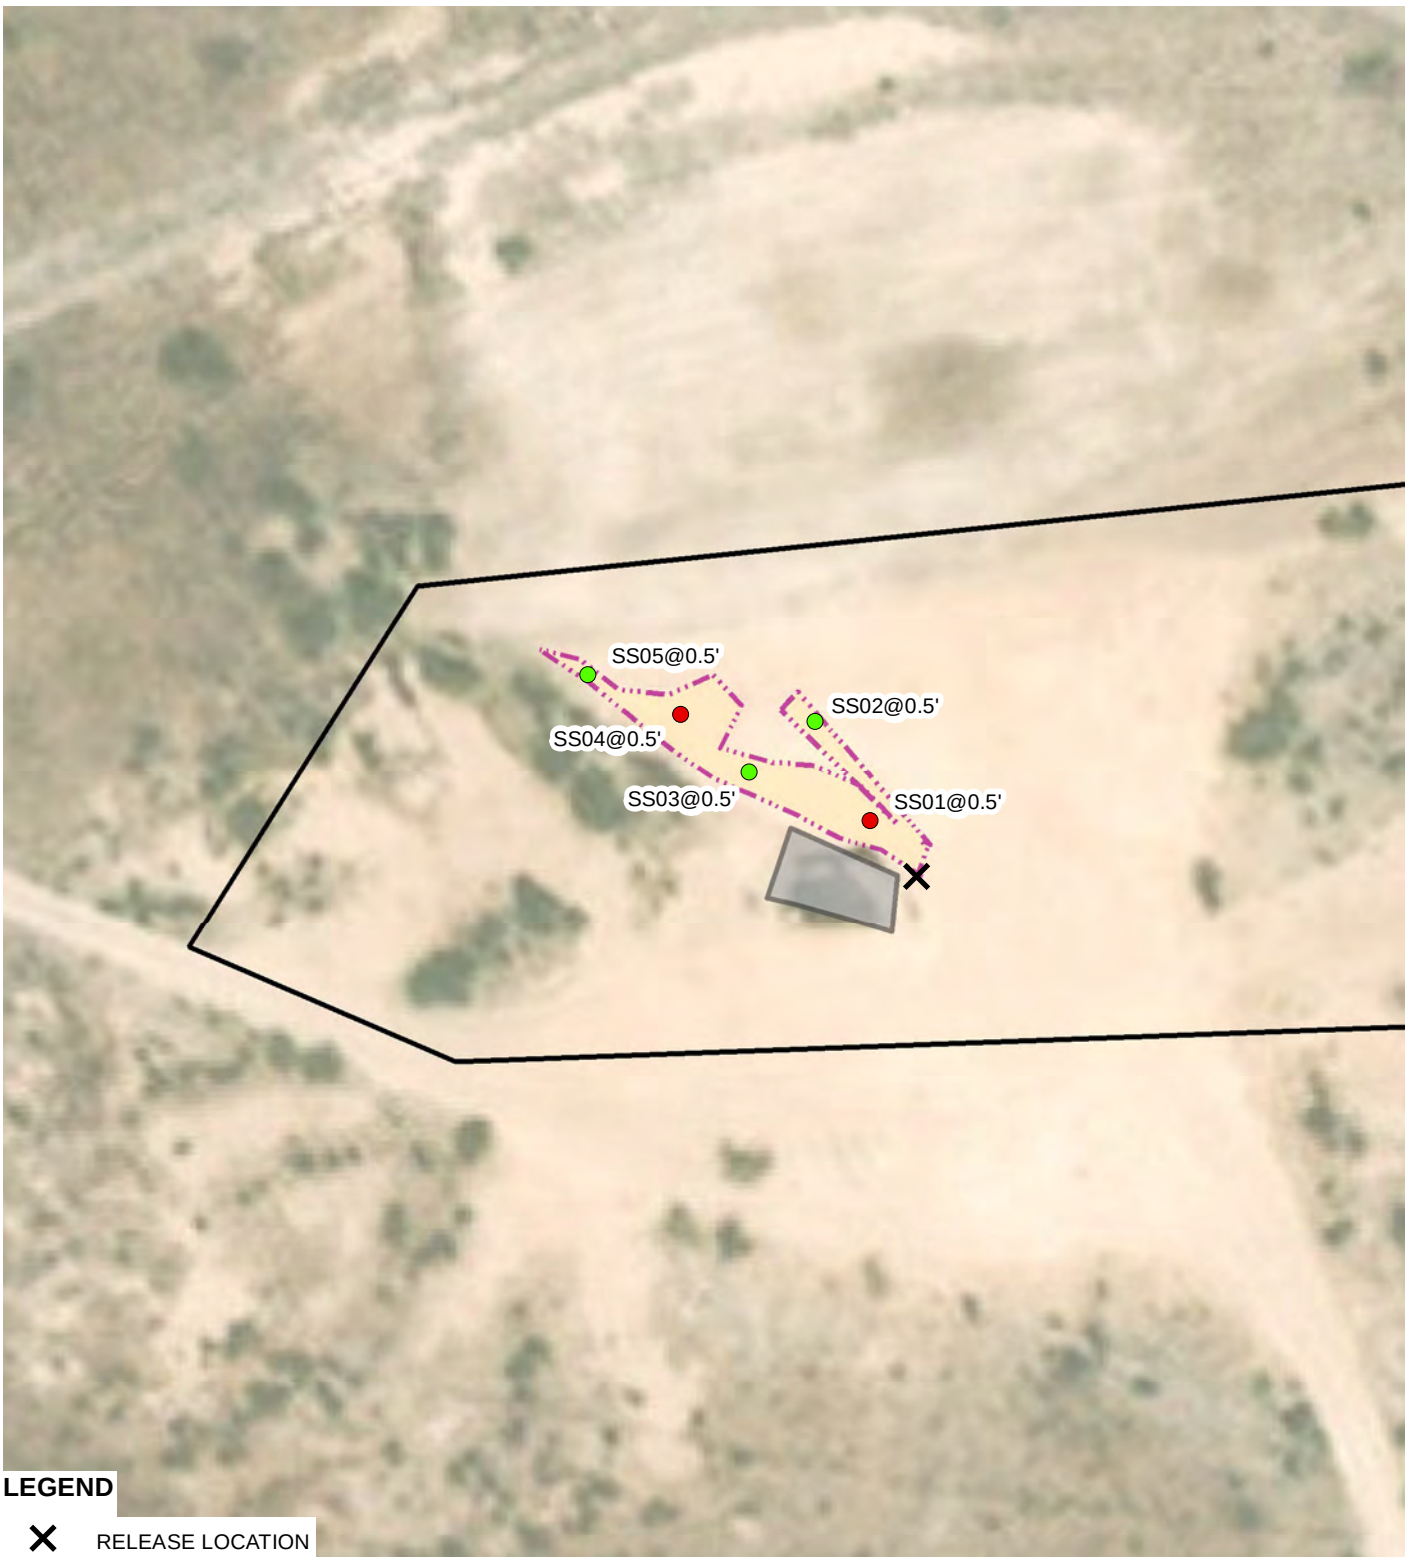
FIGURE 2
PRELIMINARY SOIL SAMPLE LOCATIONS
EVGSAU 2801-002
UNIT M SEC 28 T17S R35E
LEA COUNTY, NEW MEXICO
CONOCOPHILLIPS COMPANY

Laboratory analytical results for preliminary soil samples SS02, SS03, and SS05 indicated benzene, BTEX, TPH-GRO/TPH-DRO, TPH, and chloride concentrations were compliant with the Closure Criteria. Laboratory analytical results for preliminary soil samples SS01 and SS04 indicated chloride concentrations exceeded the Closure Criteria. Based on visible staining in the release area, field screening activities, and laboratory analytical results for the preliminary soil samples, excavation activities were warranted.

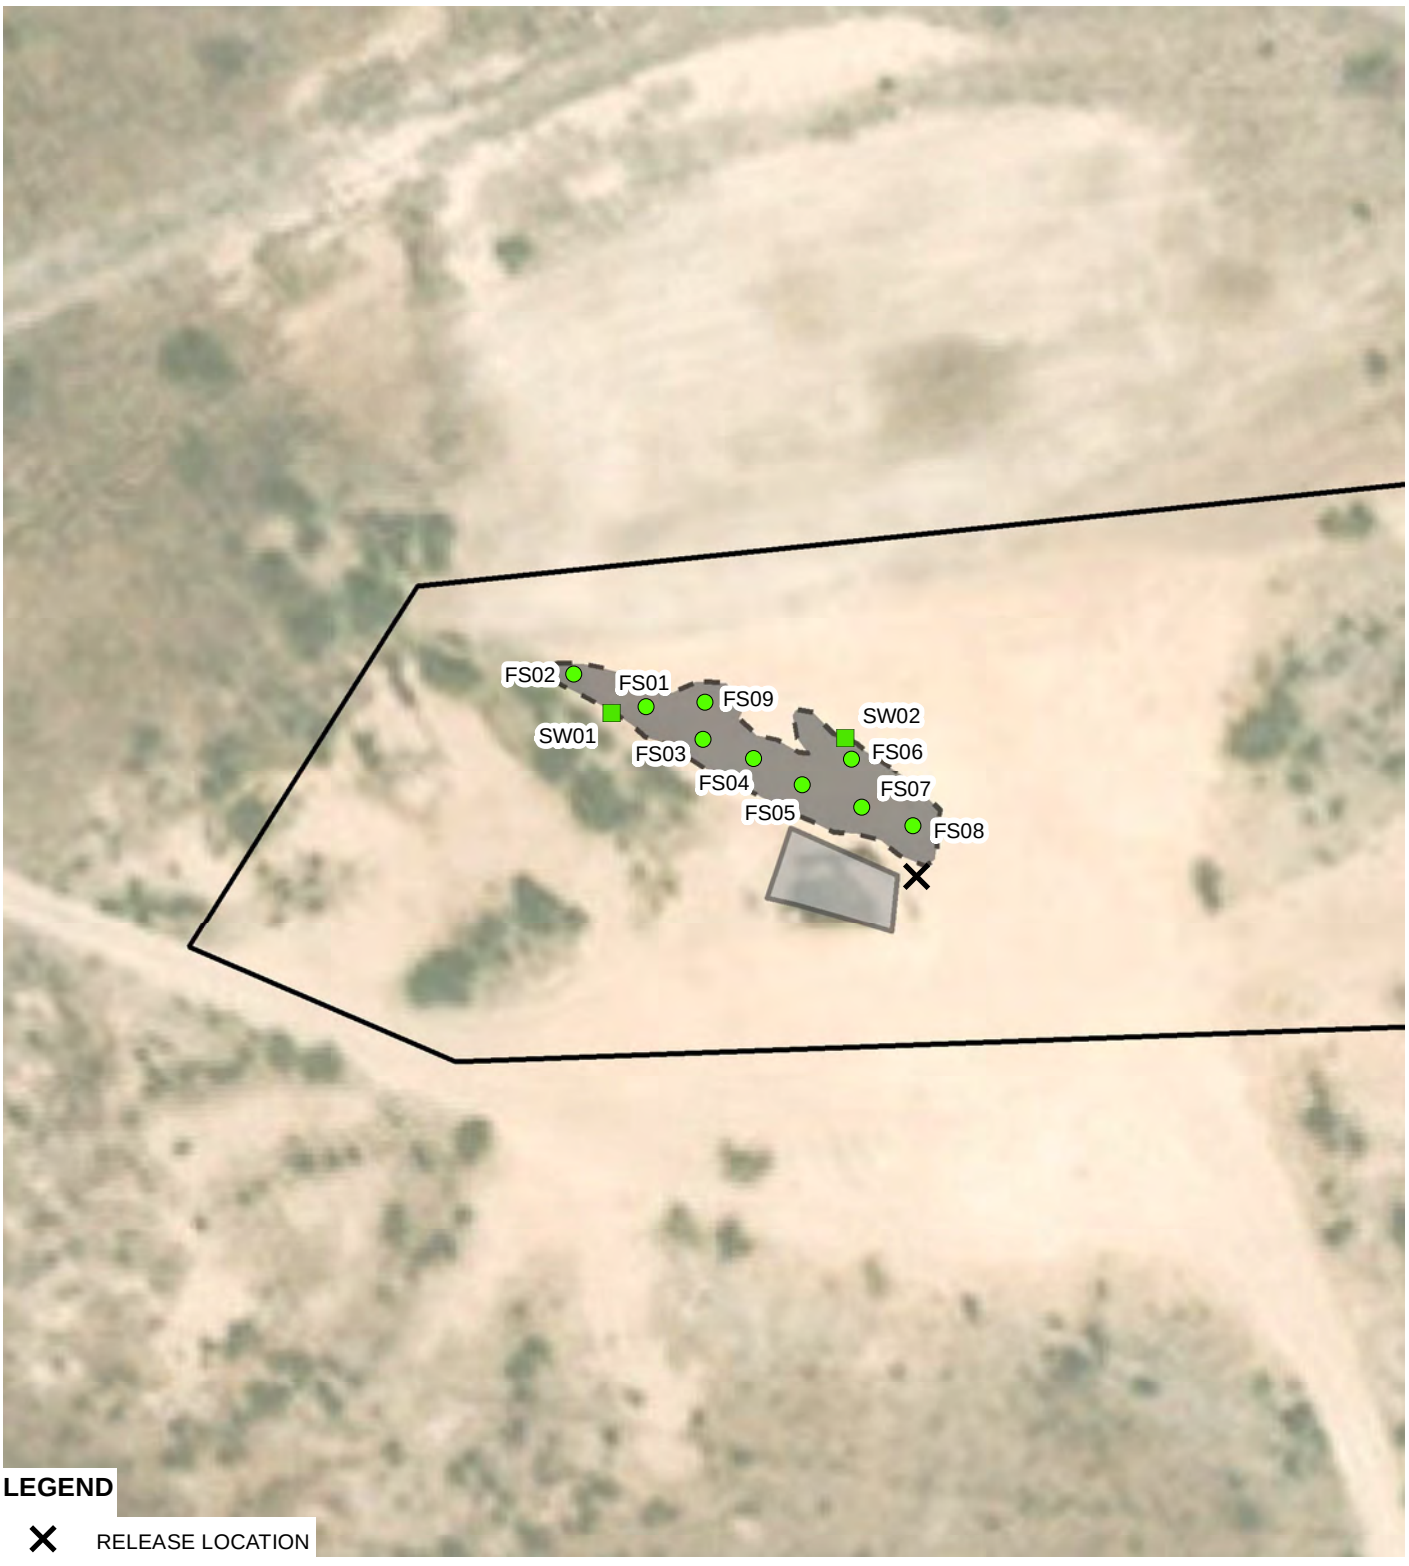
FIGURE 3
EXCAVATION SOIL SAMPLE LOCATIONS
EVGSAU 2801-002
UNIT M SEC 28 T17S R35E
LEA COUNTY, NEW MEXICO
CONOCOPHILLIPS COMPANY

Laboratory analytical results for excavation sidewall samples SW01 and SW02 and excavation floor samples FS01 through FS09, indicated benzene, BTEX, TPH-GRO/TPH-DRO, TPH, and chloride concentrations were compliant with the Closure Criteria. Laboratory analytical results are summarized in Table 1 and laboratory analytical reports are included as Attachment 3.

On October 13, 2021, WSP personnel returned to the Site to oversee excavation activities as indicated by surficial staining in the release footprint and laboratory analytical results for the preliminary soil samples. Excavation activities were performed using a track hoe and transport vehicle. To direct excavation activities, WSP screened soil for volatile aromatic hydrocarbons and chloride utilizing a PID and Hach® chloride QuanTab® test strips, respectively. The excavation was completed to a depth of 1-foot bgs.

The excavation area measured approximately 1,786 square feet. A total of approximately 66 cubic yards of impacted soil were removed during the excavation activities. The impacted soil was transported and properly disposed of at the Northern Delaware Basin Landfill located in Jal, New Mexico. After completion of confirmation sampling, the excavation area was backfilled.
